**SPUTO AND LAMMERT ENGINEERING, LLC**  
**STRUCTURAL ENGINEERS**  
 1731 NW 6<sup>th</sup> STREET, SUITE D, GAINESVILLE, FL 32609  
 PHONE: 352-378-0448 FAX: 352-373-1331  
 E-MAIL: salestructures@gmail.com

26 October 2021

Re: Thelma Boltin Center, 516 NE 2 Ave, Gainesville, FL - Partial Roof Collapse

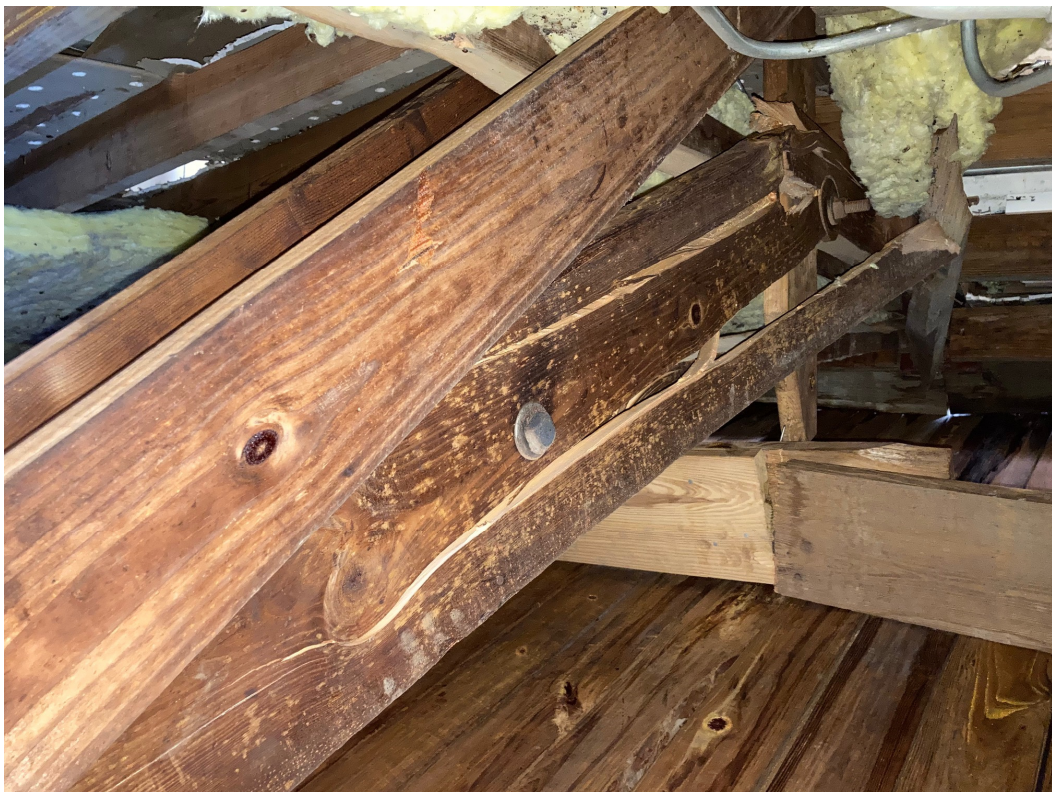
During the initial observation visit on 08 January, it was apparent that the roof over the auditorium stage had sagged approximately 8 to 12 inches. Accessing the above-ceiling space showed that the truss over the stage had suffered a catastrophic failure at the west end. The last two truss panels had failed and had wedged themselves into a temporarily stable condition by pressing against themselves and the exterior wall. I recommended that the truss be properly shored to prevent a sudden complete collapse.

Due to the limited access and safety concerns, I was unable to definitively determine where the failure began, however from previous experience with similar damaged trusses and from the literature, the failure may have originated where a longitudinal crack intersected a bolt at a connection.

Figure 2. West end of truss

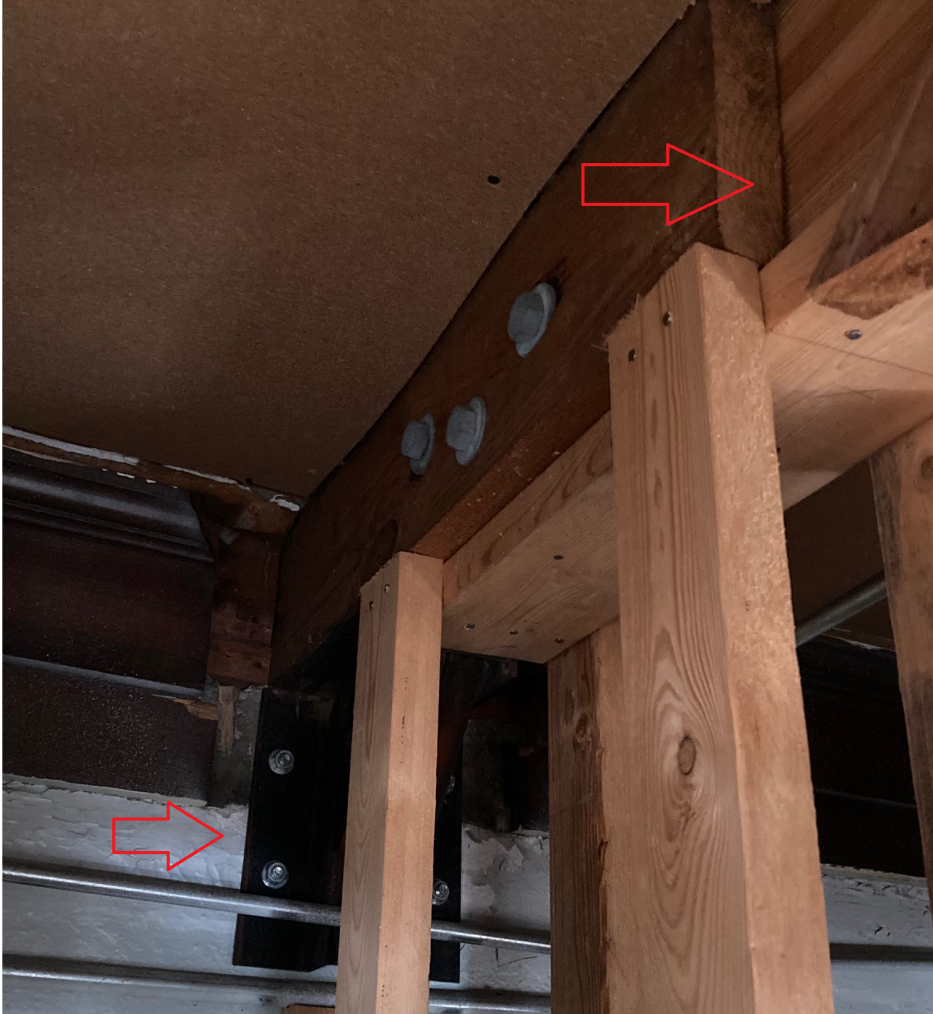
The truss closest to the south wall was repaired at some point in the past. Most likely this repair was performed prior to a collapse of the truss. The bottom chord and some over the truss webs were replaced at the east end, and a new steel bracket was attached to the masonry wall to support the east end of the truss. Termite damage to the wood, to both the original and replacement material, was readily seen.

Figure 6. Retrofit seat and repaired (spliced) truss chord at south truss

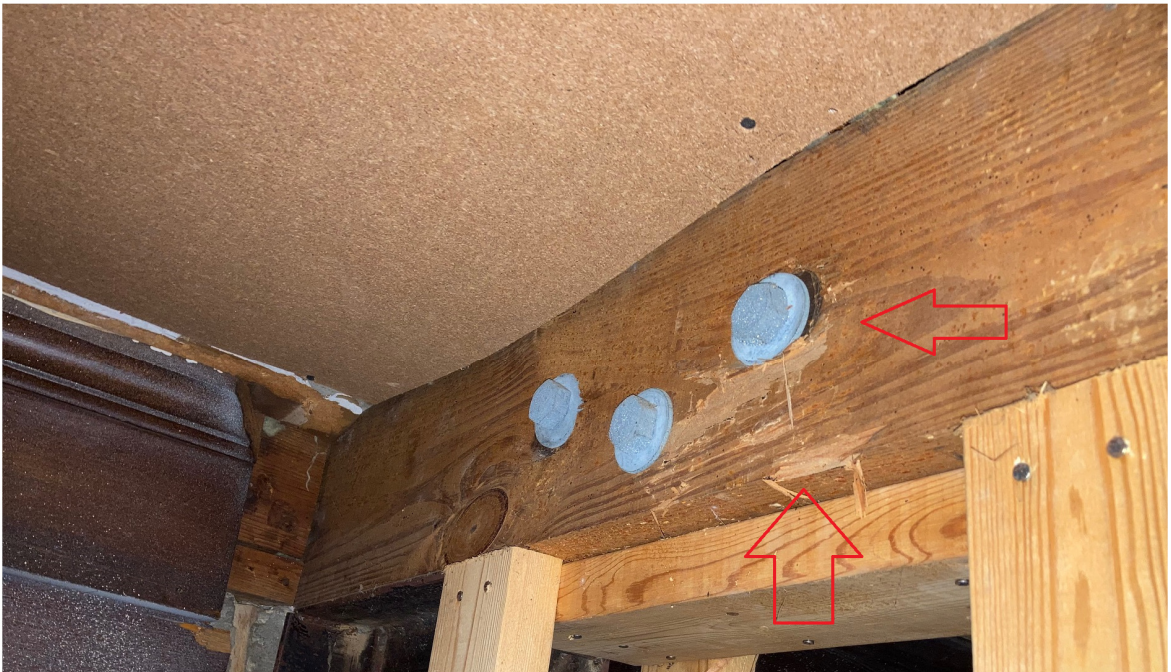
Figure 11. Termite damage to truss chord, including under bolt heads
