THELMA A BOLTIN CENTER / HISTORIC GAINESVILLE

516 NE 2ND AVE, GAINESVILLE, FL 32601

SCOPE OF WORK

EXISTING CONDITIONS PLANS /
CONCEPTUAL - ADA ACCESSIBILITY/
STRUCTURAL ANALYSIS / CIVIL ANALYSIS
HISTORIC PRESERVATION

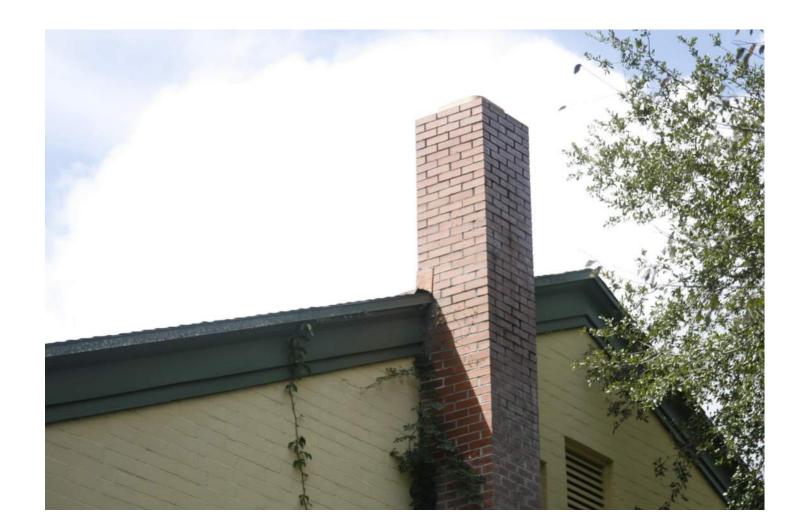
1 CHIMNEY AT NORTH

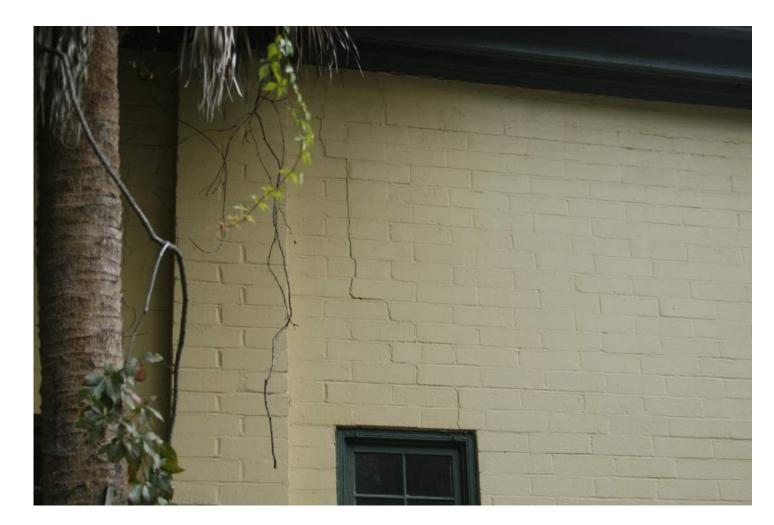
4 CRACK THROUGH BRICK AT WEST

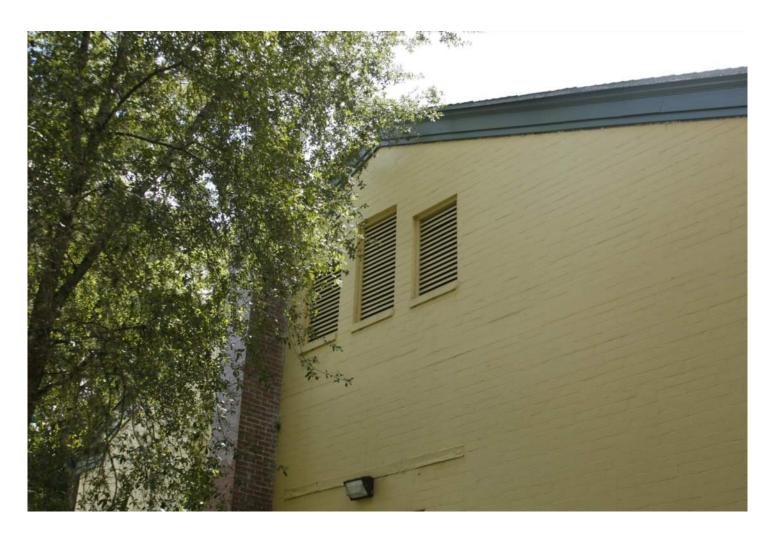
2 CHIMNEY AND ATTIC VENTS AT NORTH

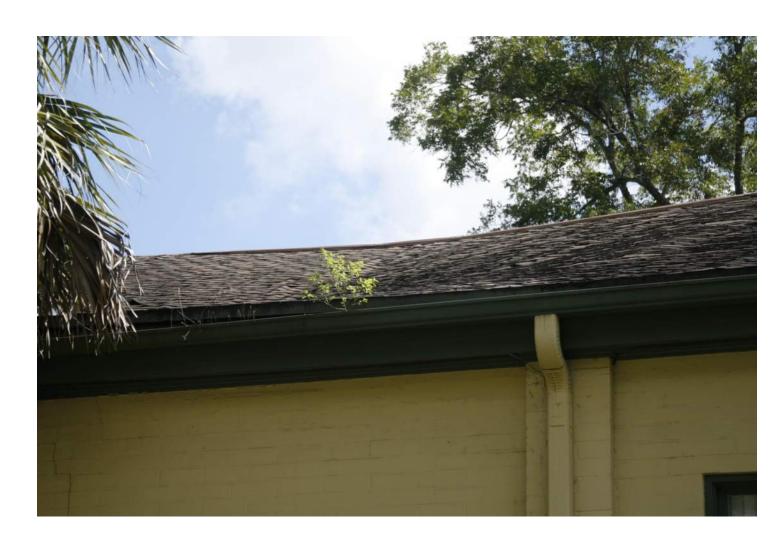
3 GUTTER AND ROOF CONDITIONS AT WEST

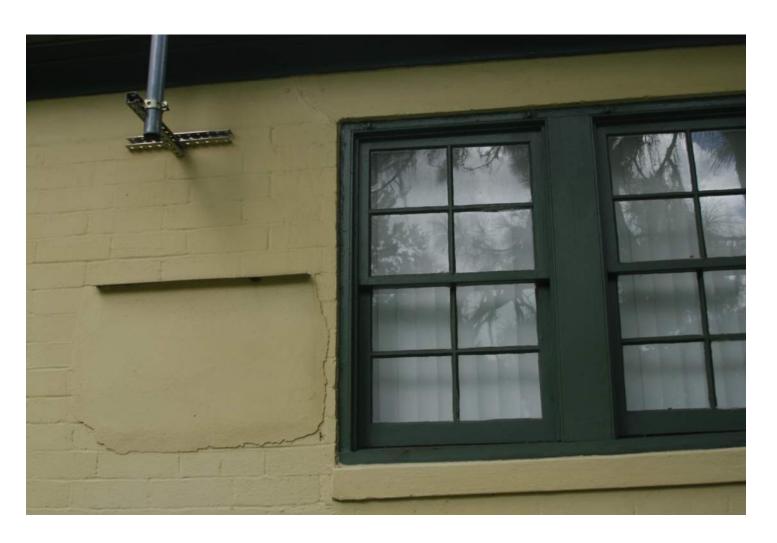
6 WALL PATCH AT EAST

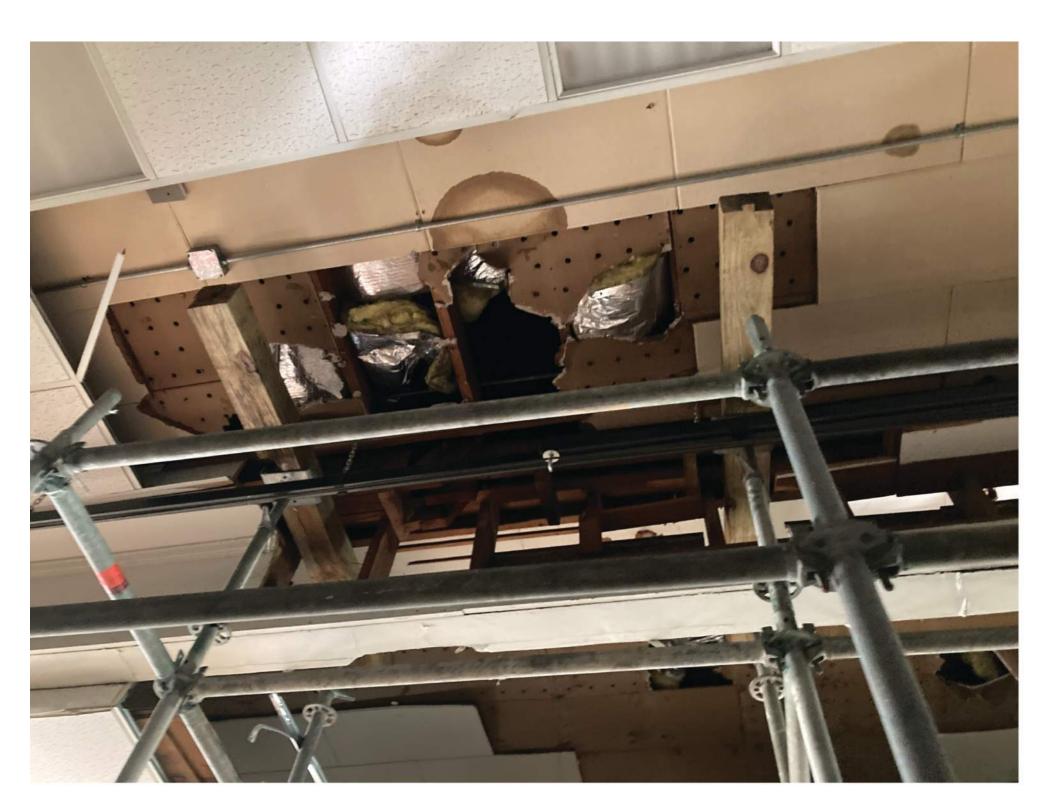
1 CEILING ABOVE THE STAGE, FIRST FLOOR

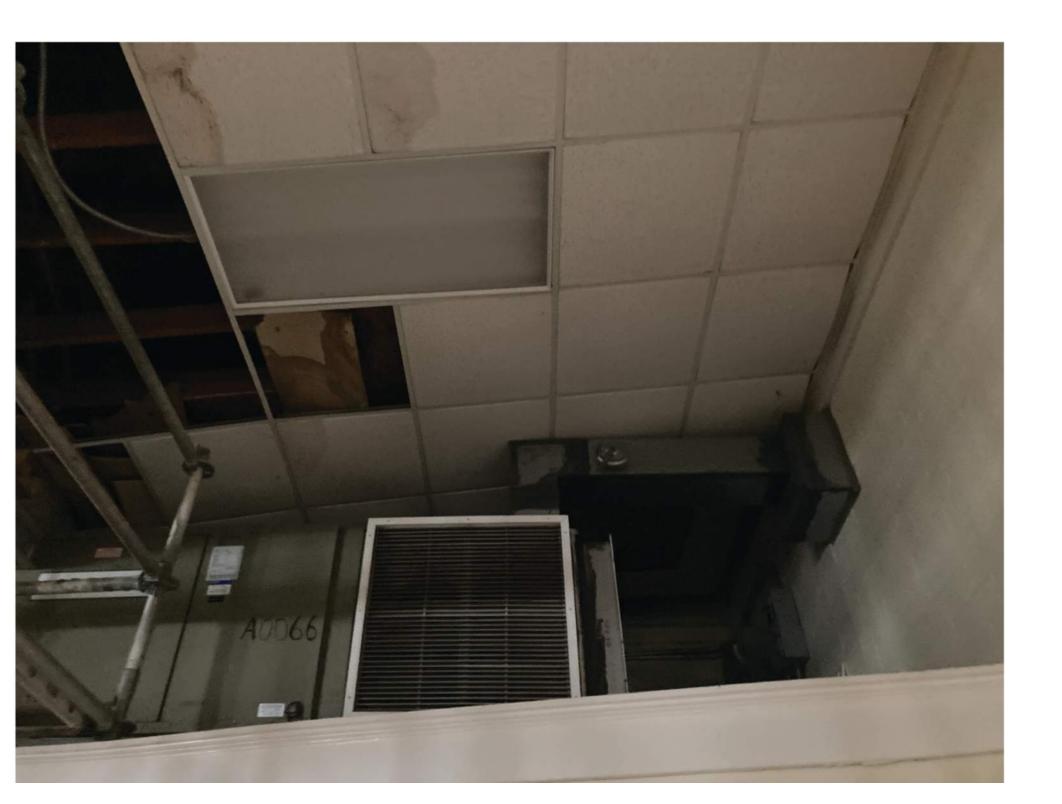
4 STAGE CEILING, FIRST FLOOR

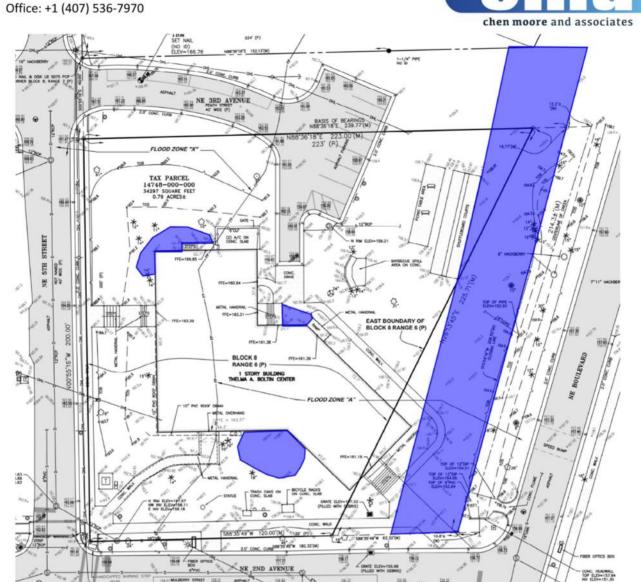
Figure 1. Existing Conditions

Area of known or suspected flooding/ponding/poor drainage.

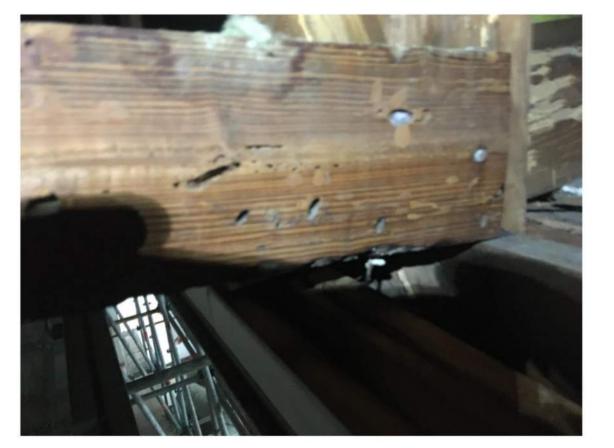
Exhibit 13

Roof at main hall is partially visible and access to roof is limited. Roof in main hall is currently shored. Two girder trusses at stage has failed and is fully shored. Some termite damaged, wood was also observed. (Exhibit 13)

1. The two shored girder wood trusses over the stage area will require replacement. The remaining girder wood trusses can be repaired (e.g double wood scabbing, additional metal plate connections, etc.). The extent of repair will depend on the as-built condition of the wood. A design analysis will also reveal if the girder trusses/ purlins will require additional reinforcement to support loads per the current code. Additional column supports/ footings at the girder truss bearing ends will be required to properly transmit all loads to the ground per the current code. These new columns can also provide some lateral bracing to the existing exterior walls. New plywood sheathing above the existing wood planks (to be fasten into the roof framing members) will be required to provide an adequate roof diaphragm to resist lateral loads per the current code. Mechanical uplift connectors will be required throughout the roof framing which were found missing.
