SPUTO AND LAMMERT ENGINEERING, LLC
STRUCTURAL ENGINEERS
 1731 NW 6th STREET, SUITE D, GAINESVILLE, FL 32609
 PHONE: 352-378-0448 FAX: 352-373-1331
 E-MAIL: salestructures@gmail.com

26 October 2021

Re: Thelma Boltin Center, 516 NE 2 Ave, Gainesville, FL - Partial Roof Collapse

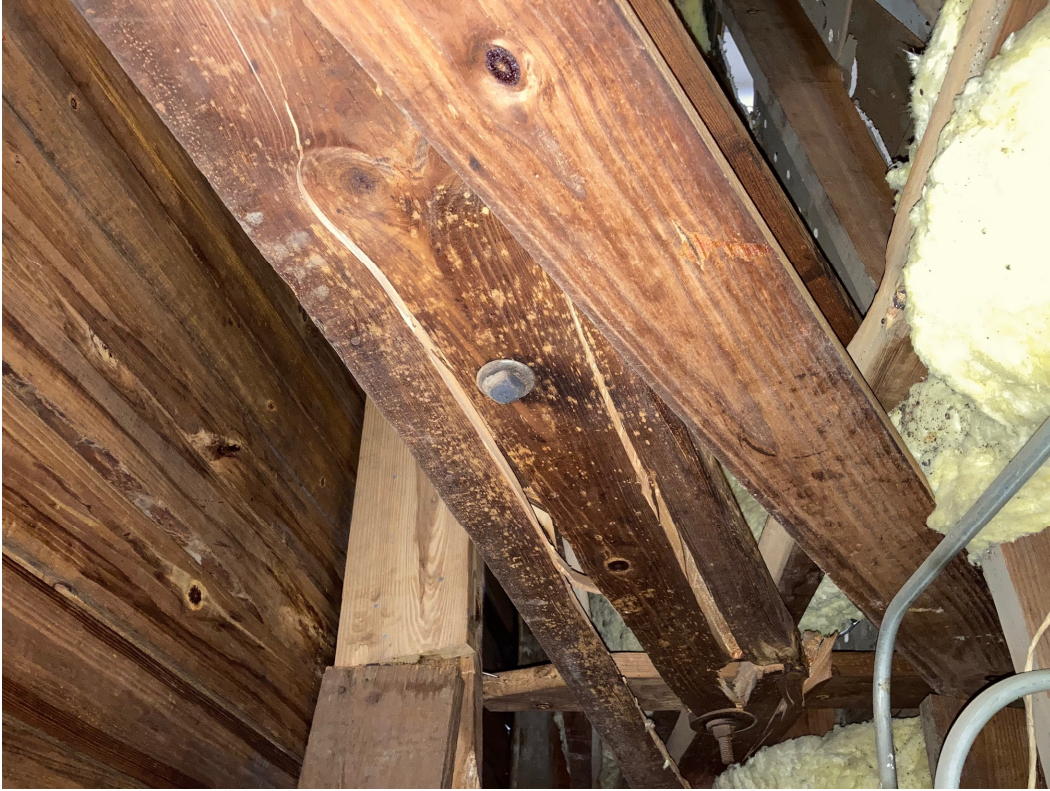
During the initial observation visit on 08 January, it was apparent that the roof over the auditorium stage had sagged approximately 8 to 12 inches. Accessing the above-ceiling space showed that the truss over the stage had suffered a catastrophic failure at the west end. The last two truss panels had failed and had wedged themselves into a temporarily stable condition by pressing against themselves and the exterior wall. I recommended that the truss be properly shored to prevent a sudden complete collapse.

Due to the limited access and safety concerns, I was unable to definitively determine where the failure began, however from previous experience with similar damaged trusses and from the literature, the failure may have originated where a longitudinal crack intersected a bolt at a connection.

Figure 1. West end of truss

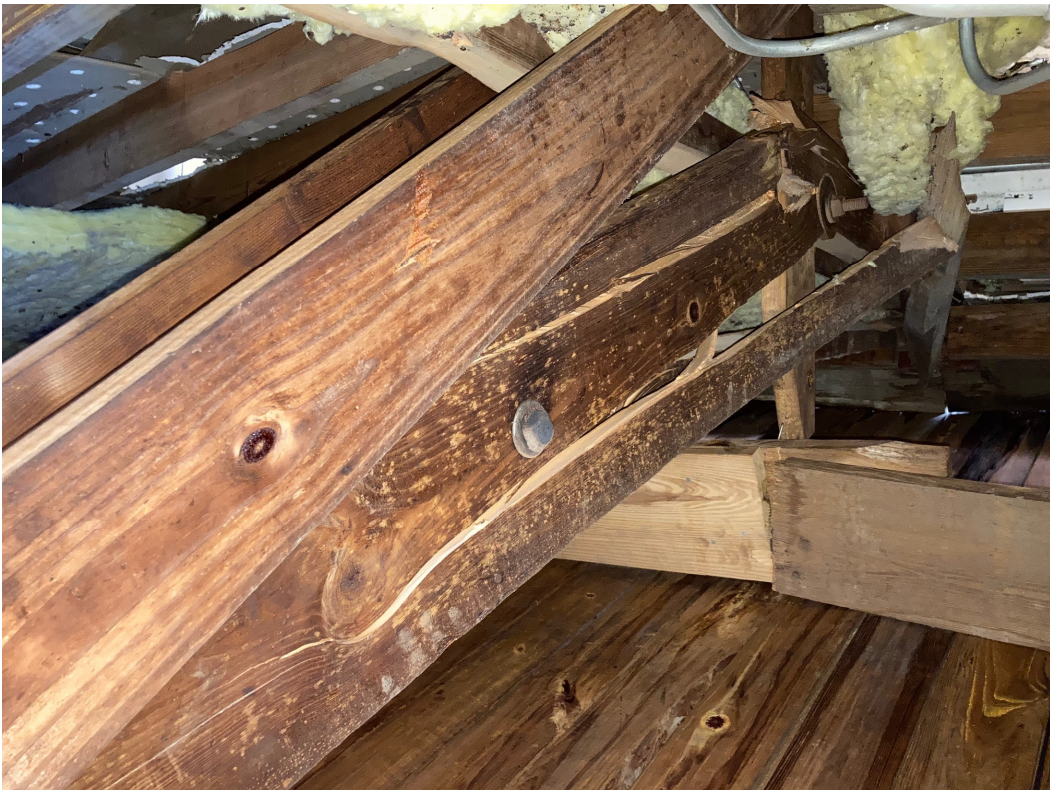
Figure 2. West end of truss

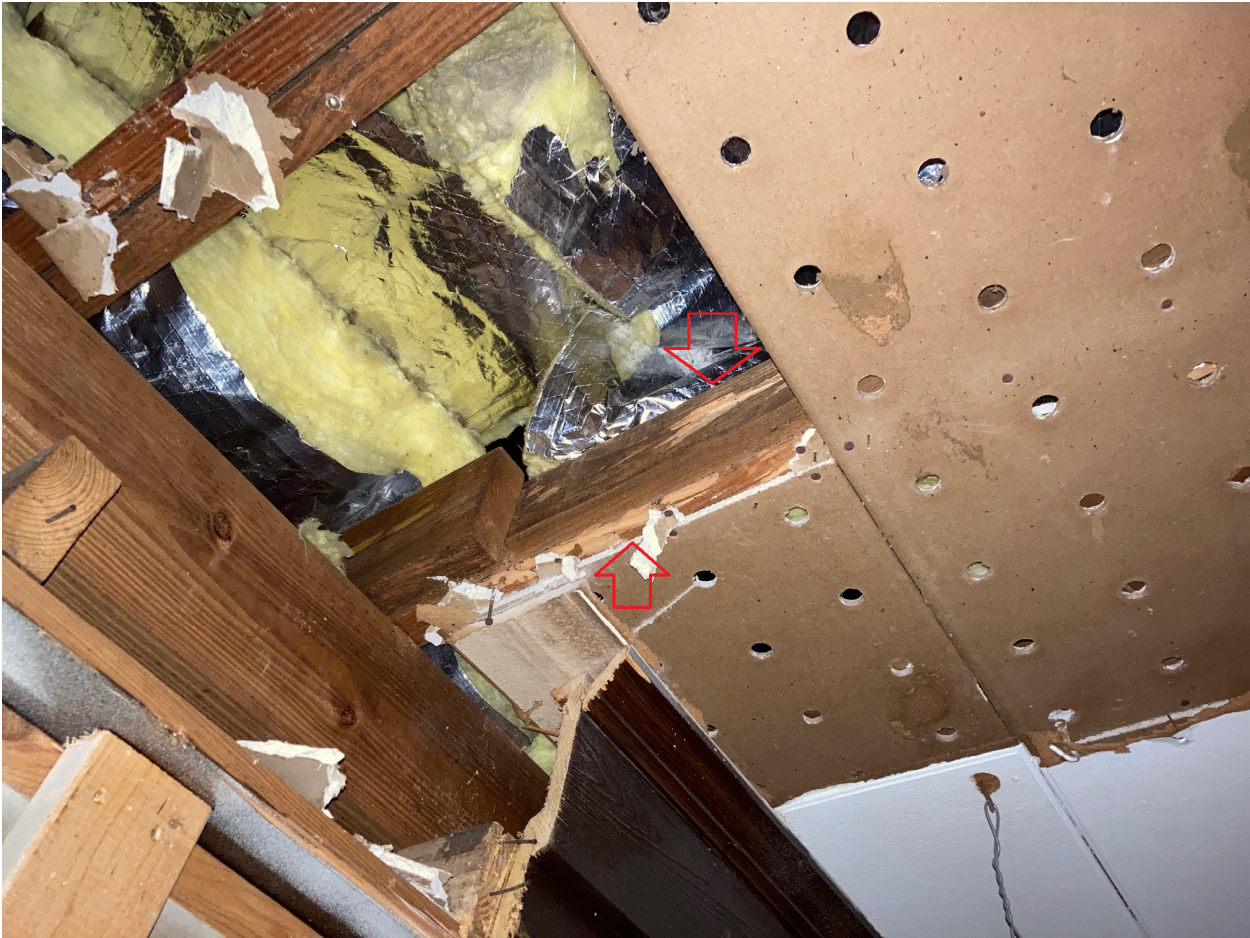
Figure 5. Termite damage to ceiling joist

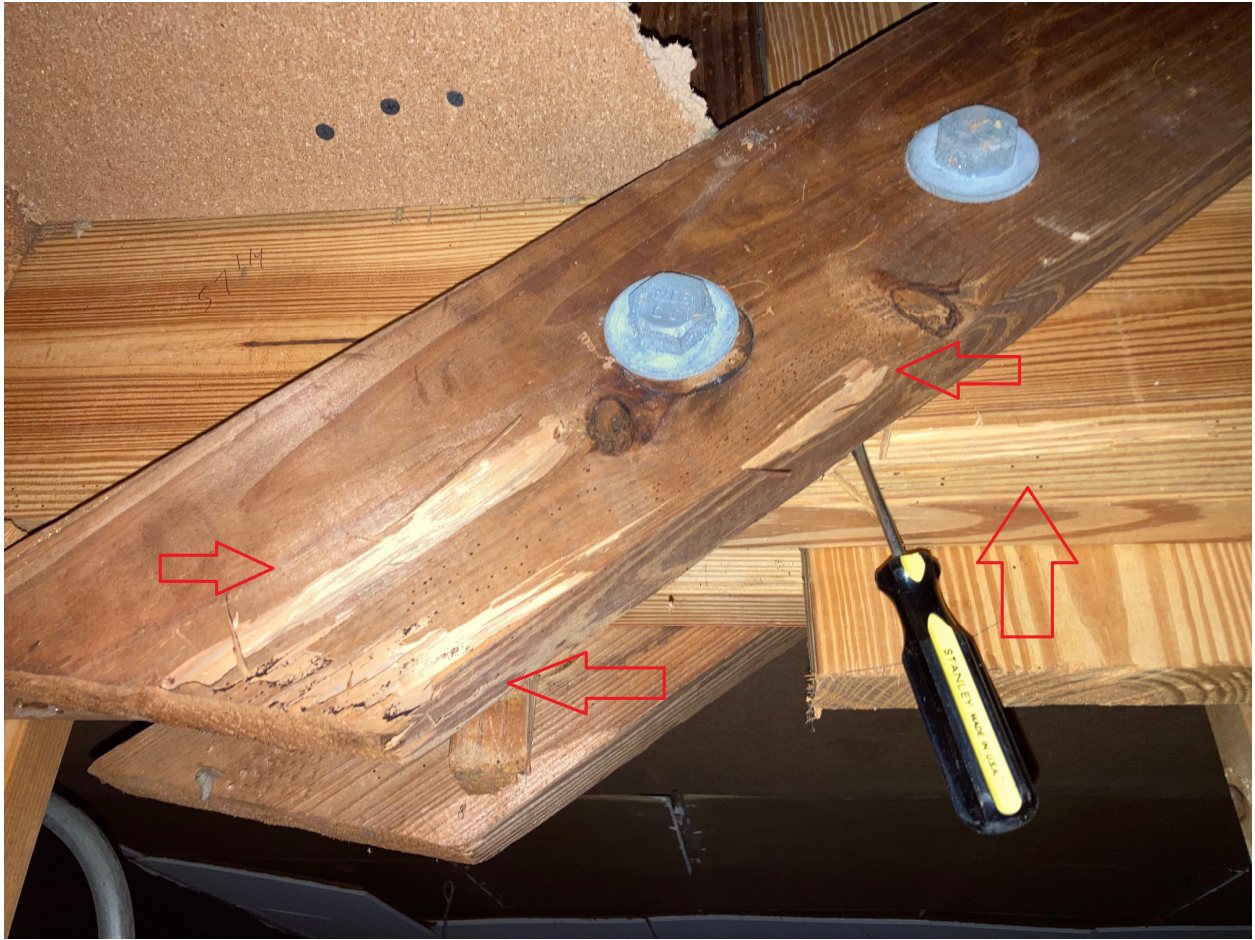
Figure 8. South truss. Note visible termite damage to both old and replacement wood. When the screwdriver was inserted between the plies, black pellets dropped, indicating the probability of termite activity and damage between the wood plies.
