**SPUTO AND LAMMERT ENGINEERING, LLC**  
STRUCTURAL ENGINEERS  
1731 NW 6<sup>th</sup> STREET, SUITE D, GAINESVILLE, FL 32609  
PHONE: 352-378-0448 FAX: 352-373-1331  
E-MAIL: salestructures@gmail.com

26 October 2021

Re: Thelma Boltin Center, 516 NE 2 Ave, Gainesville, FL - Partial Roof Collapse

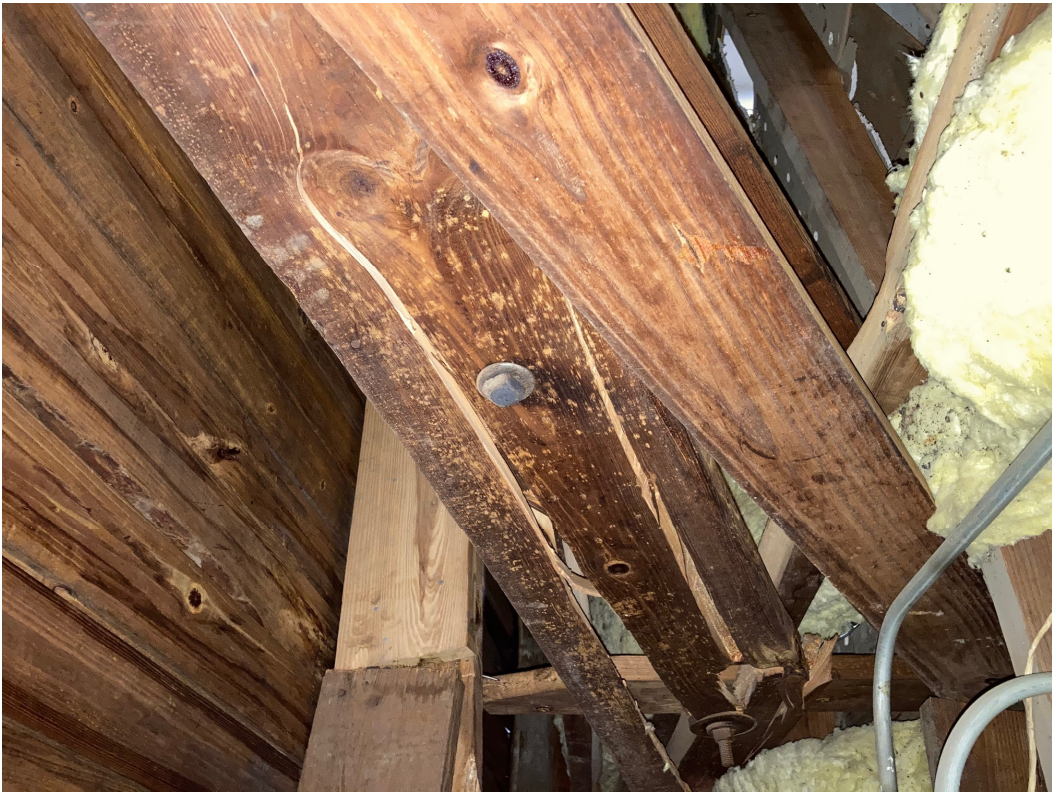
During the initial observation visit on 08 January, it was apparent that the roof over the auditorium stage had sagged approximately 8 to 12 inches. Accessing the above-ceiling space showed that the truss over the stage had suffered a catastrophic failure at the west end. The last two truss panels had failed and had wedged themselves into a temporarily stable condition by pressing against themselves and the exterior wall. I recommended that the truss be properly shored to prevent a sudden complete collapse.

Due to the limited access and safety concerns, I was unable to definitively determine where the failure began, however from previous experience with similar damaged trusses and from the literature, the failure may have originated where a longitudinal crack intersected a bolt at a connection.

Figure 1. West end of truss

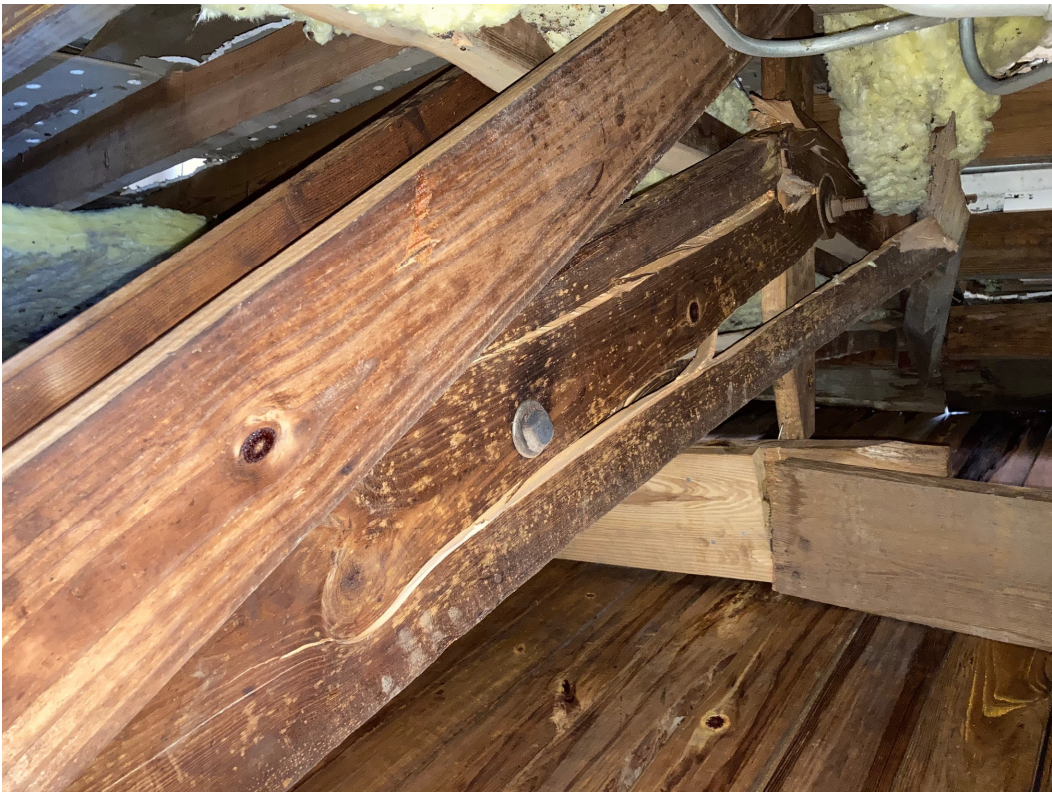
Figure 2. West end of truss

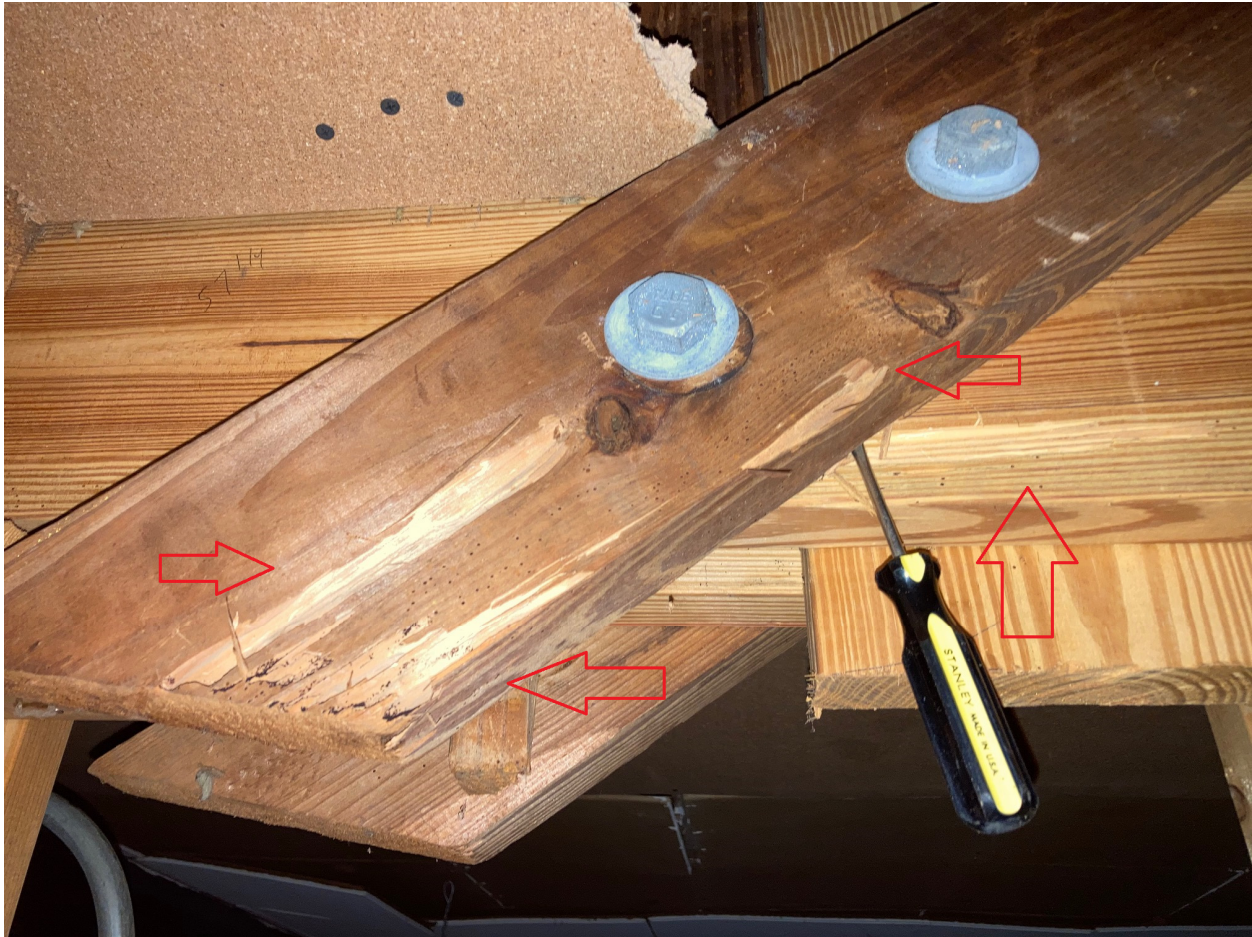
The truss closest to the south wall was repaired at some point in the past. Most likely this repair was performed prior to a collapse of the truss. The bottom chord and some over the truss webs were replaced at the east end, and a new steel bracket was attached to the masonry wall to support the east end of the truss. Termite damage to the wood, to both the original and replacement material, was readily seen.

Figure 8. South truss. Note visible termite damage to both old and replacement wood. When the screwdriver was inserted between the plies, black pellets dropped, indicating the probability of termite activity and damage between the wood plies.

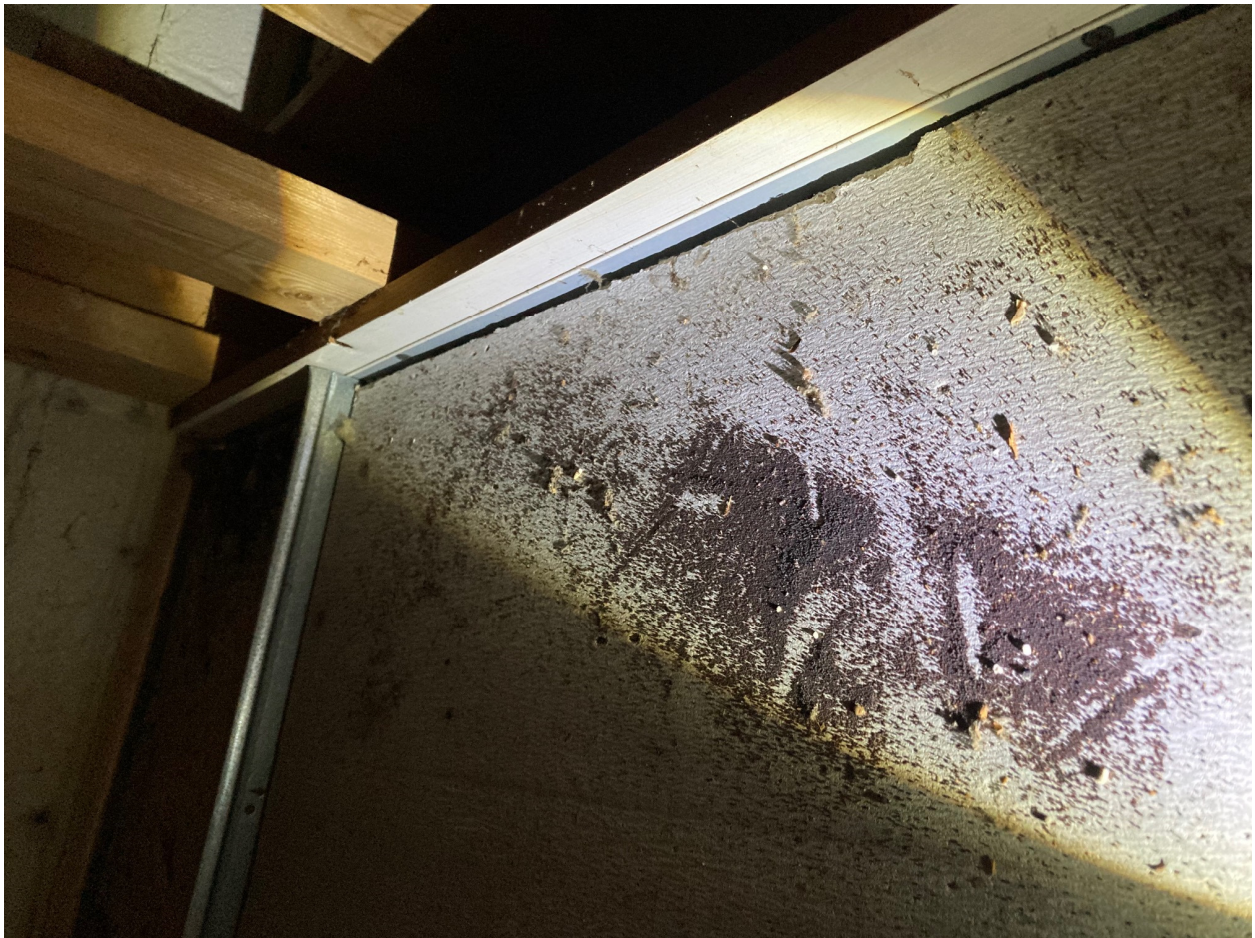
Since there were fairly large amounts of the black pellets on the acoustical ceiling and in the wood trim (both items added during the 1990's renovation) I can surmise that there was an infestation since that renovation, which may or may not be currently active.

Figure 9. Example of black pellets from suspected termites on suspended ceiling added during 1990's renovation.

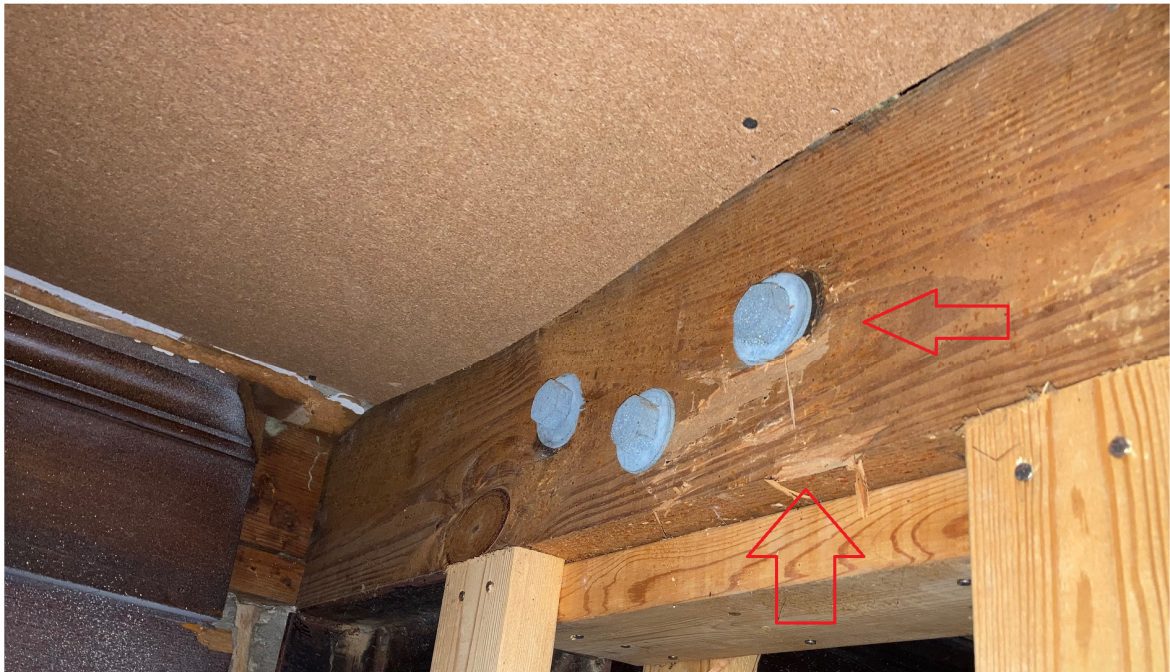
Figure 11. Termite damage to truss chord, including under bolt heads

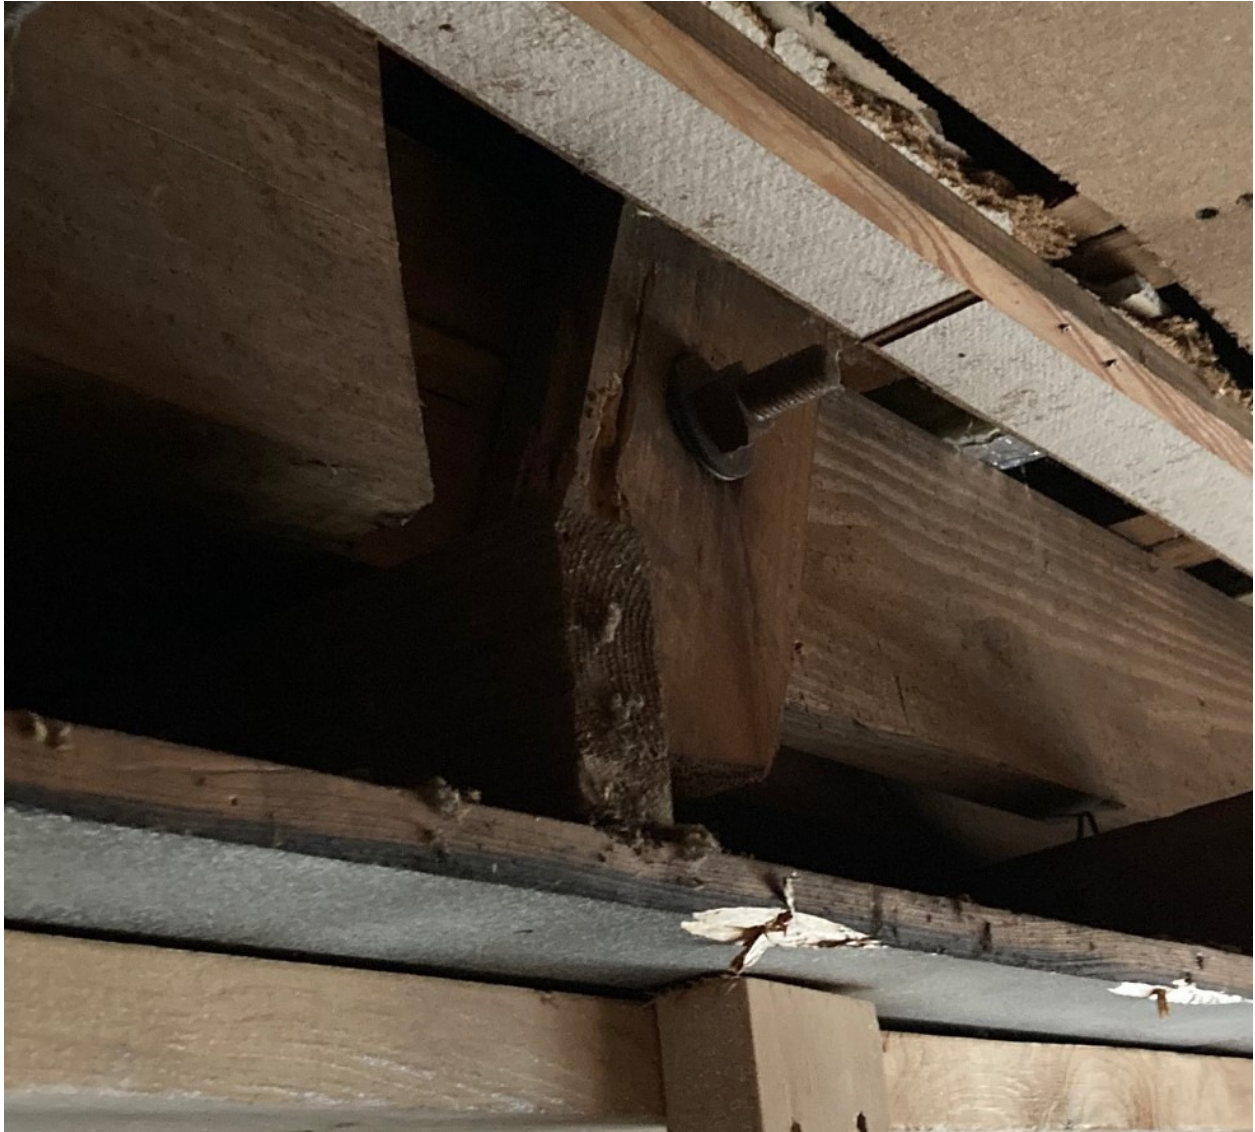
Figure 12. Termite damage extending into connection
