Plum Creek Development Company Planning Parcel

**Conservation Management Area
Management Plan**

May 15, 2018

Revised 9-9-2022

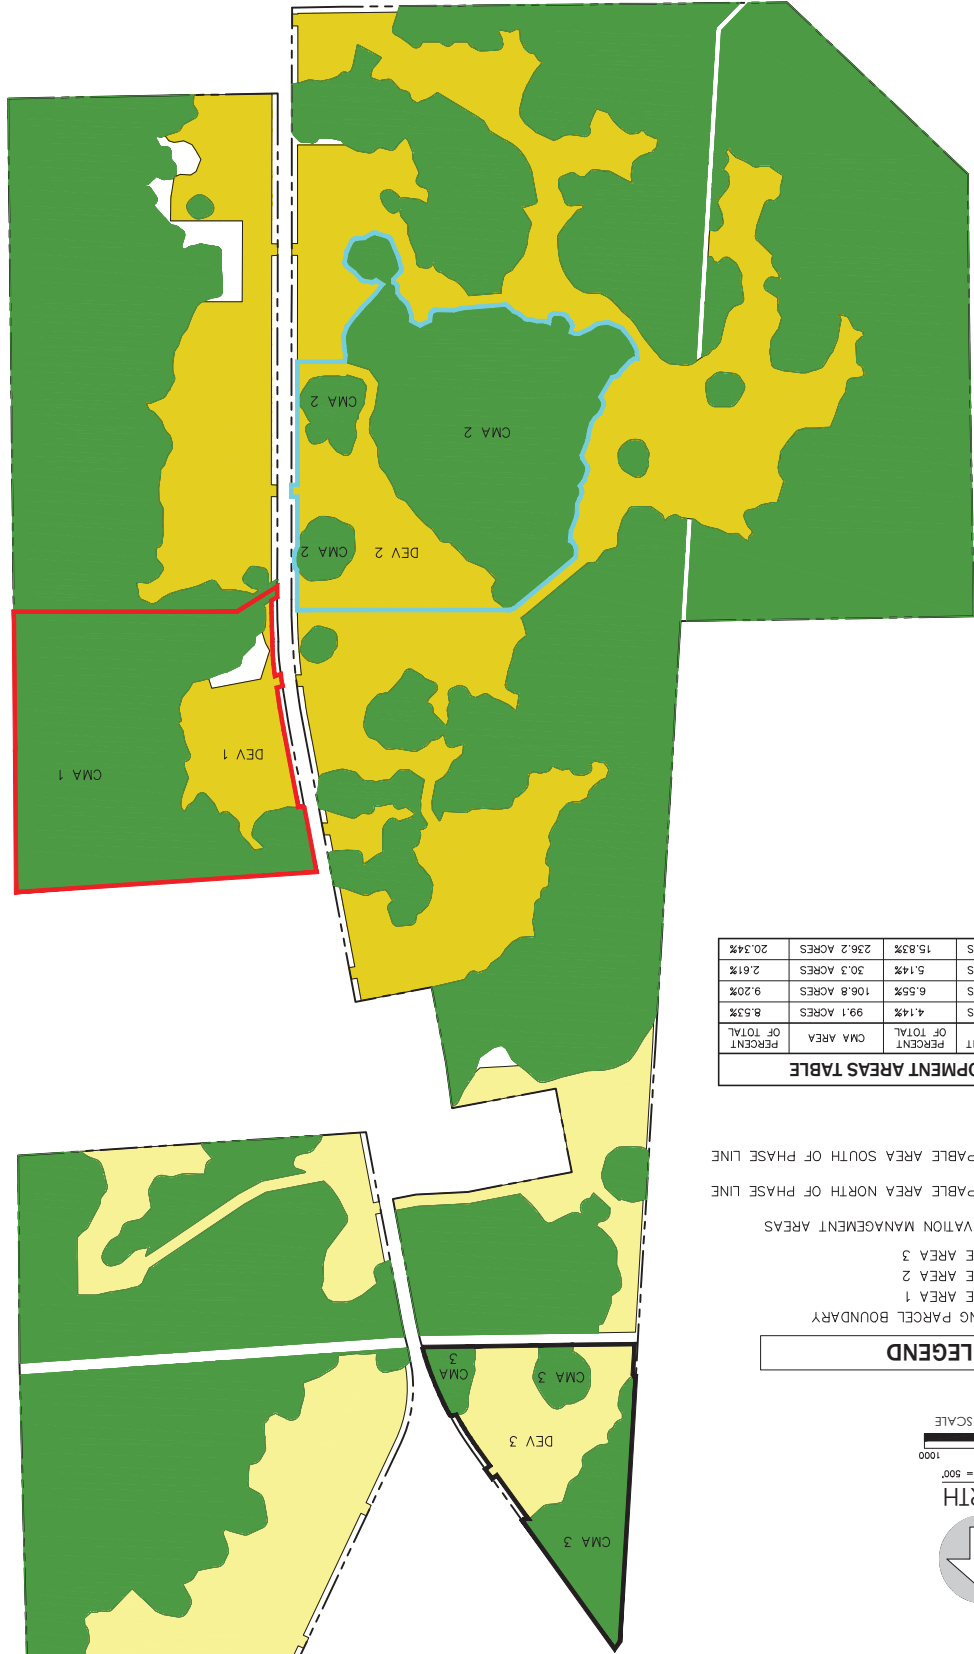
FIGURE 7: ILLUSTRATIVE PHASING OF CONSERVATION EASEMENT CONVEYANCE

DEVELOPMENT AREAS TABLE				
	DEVELOPMENT AREA OF TOTAL	PERCENT OF TOTAL	CMA AREA	PERCENT OF TOTAL
1	23.5 ACRES	4.14%	99.1 ACRES	8.53%
2	37.2 ACRES	6.55%	106.8 ACRES	9.20%
3	29.2 ACRES	5.14%	30.3 ACRES	2.61%
TOTAL	89.9 ACRES	15.83%	226.2 ACRES	20.34%

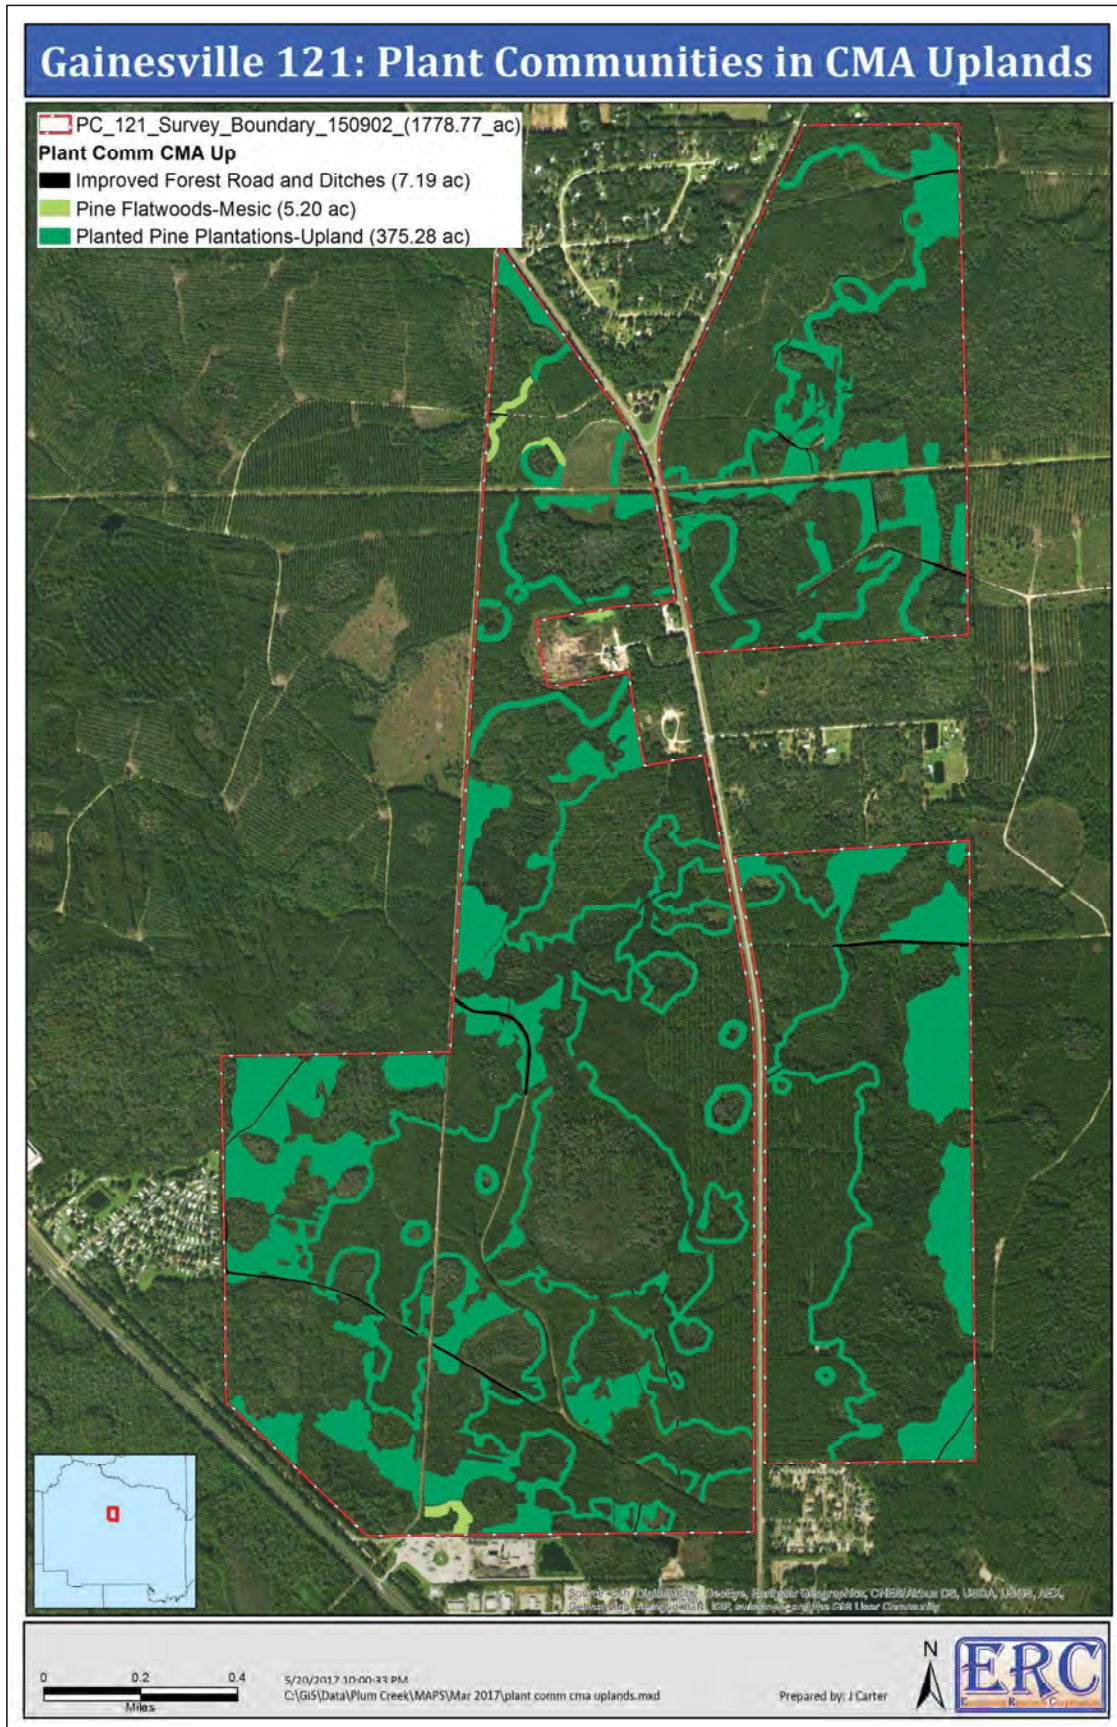
Figure 10. Plant communities occurring within the upland areas of the Conservation Management Areas.

The plant communities as shown for the CMA uplands only are provided on **Figure 10** and the wetland communities designated within the CMA areas is provided on **Figure 11**. The wetland communities as described are dominated by Planted Pine Plantations (261.98 acres), however, there is considerable acreage of Cypress–Hardwood–Bay Swamps which exist both in a logged condition (**259.90** acres) and unlogged condition (**170.93** acres). The wetland community in which slash pine (*Pinus elliottii* Engelm.) is a dominant canopy species is the Slash Pine–Cypress–Hardwood–Bay association and totals **74.71** acres.

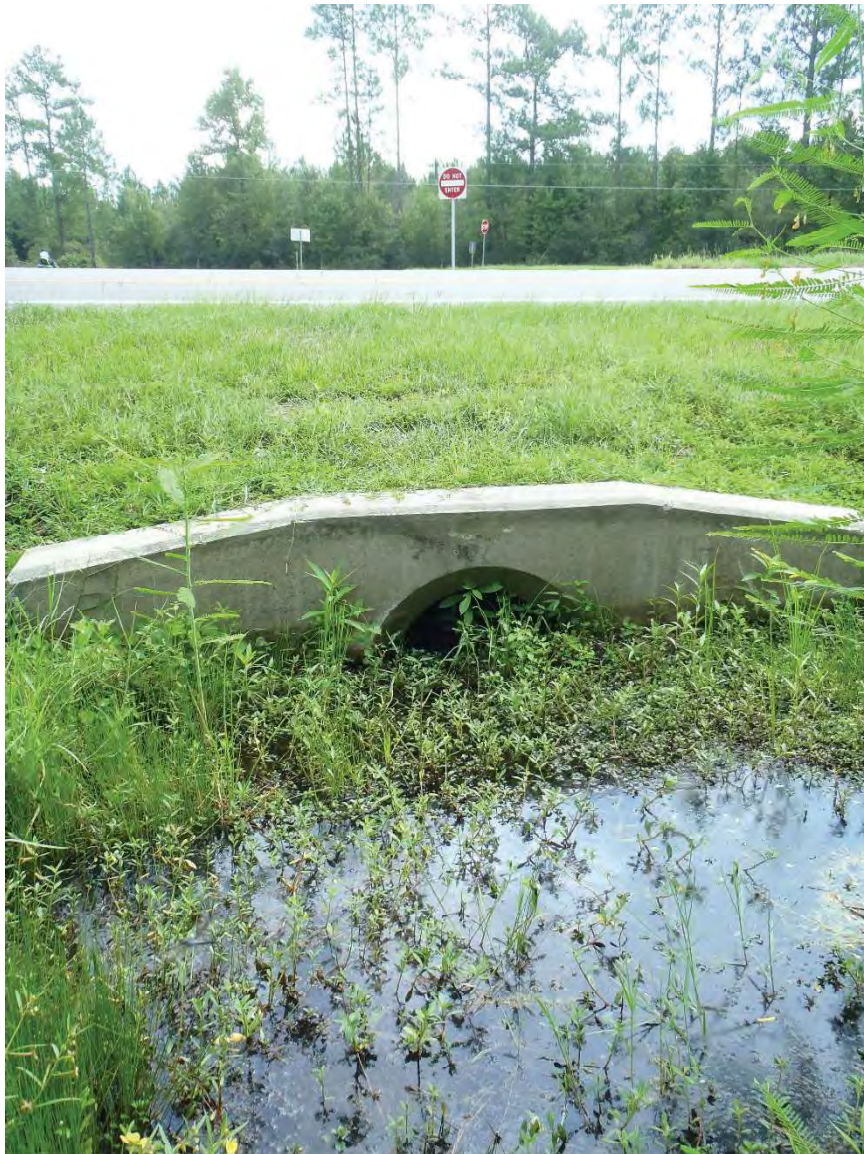
Photo 126. View of Physical Feature: Culvert as seen looking west from GPS location 2340 (Frames 1743-1744; 08/26/15).

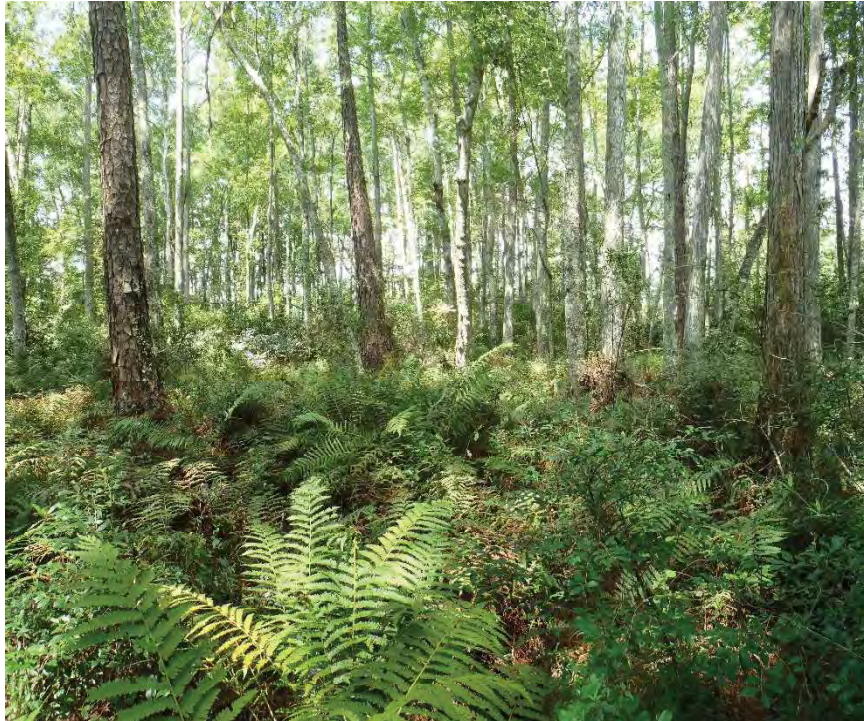
Photo 127. View of Physical Feature: Culvert at GPS location 2340 (Frame 1745; 08/26/15).

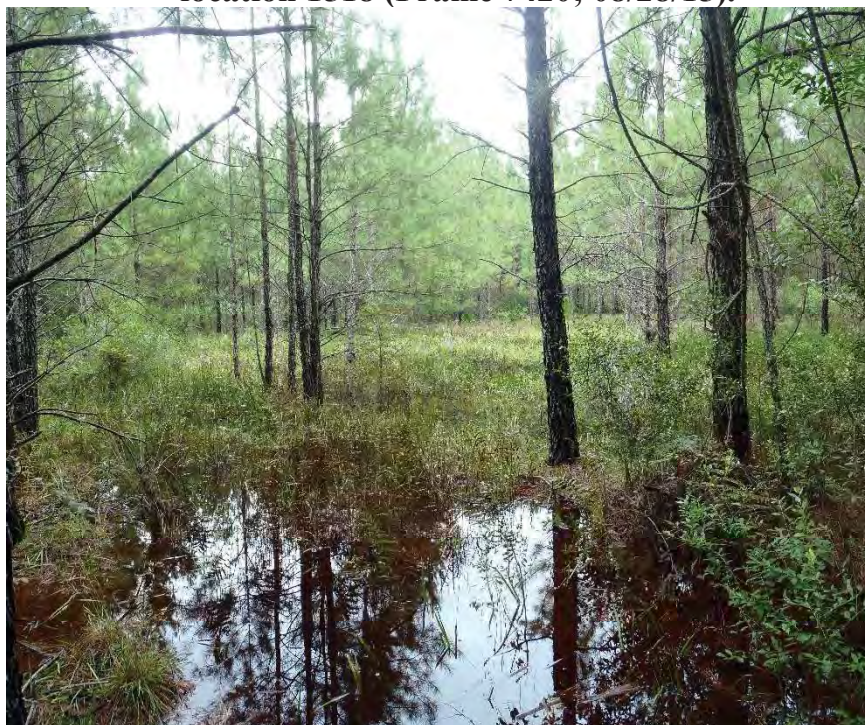
Photo 200. Rocky Creek: view to north along CR 231 of west side of box culverts located at GPS location 1518 (Frame 7420; 08/28/15).
