Ecosystem Research Corporation

Natural Area Resource Assessment of the Gainesville 121 Project Site

Provided in support of a current
application for Planned Development

City of Gainesville, Florida

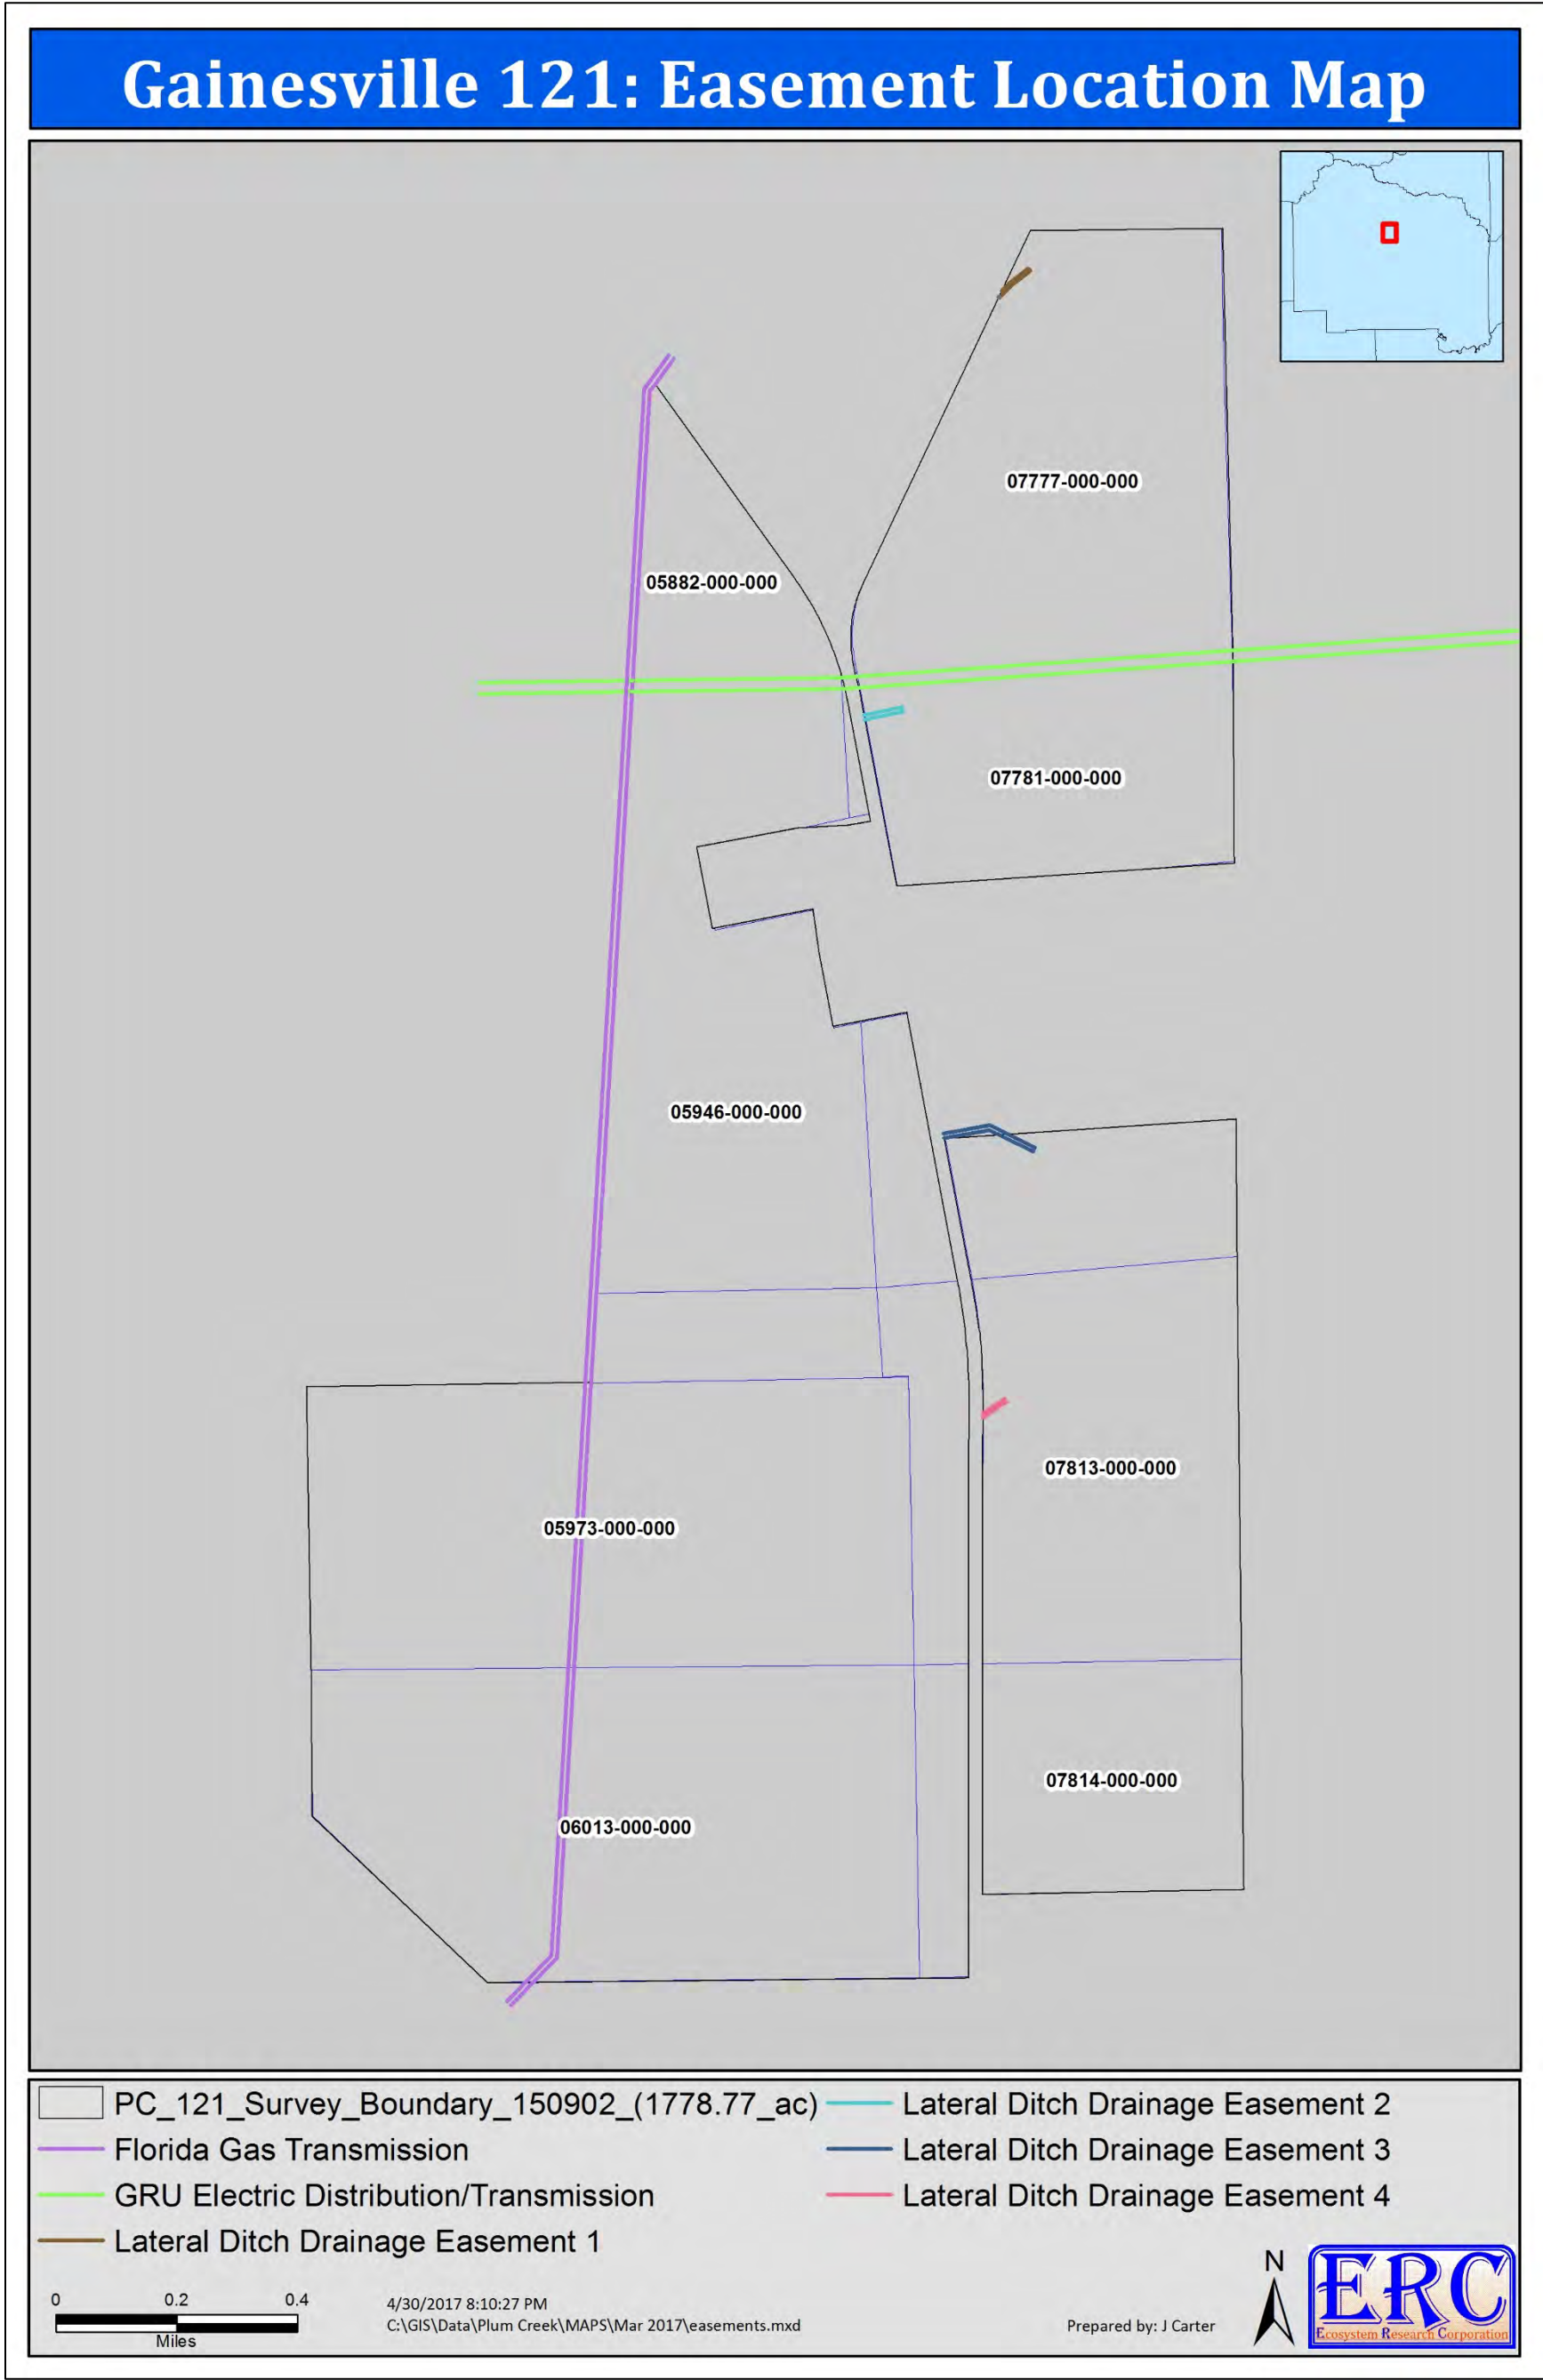
Figure 6. Utility easements located within the Gainesville 121 Project Site.

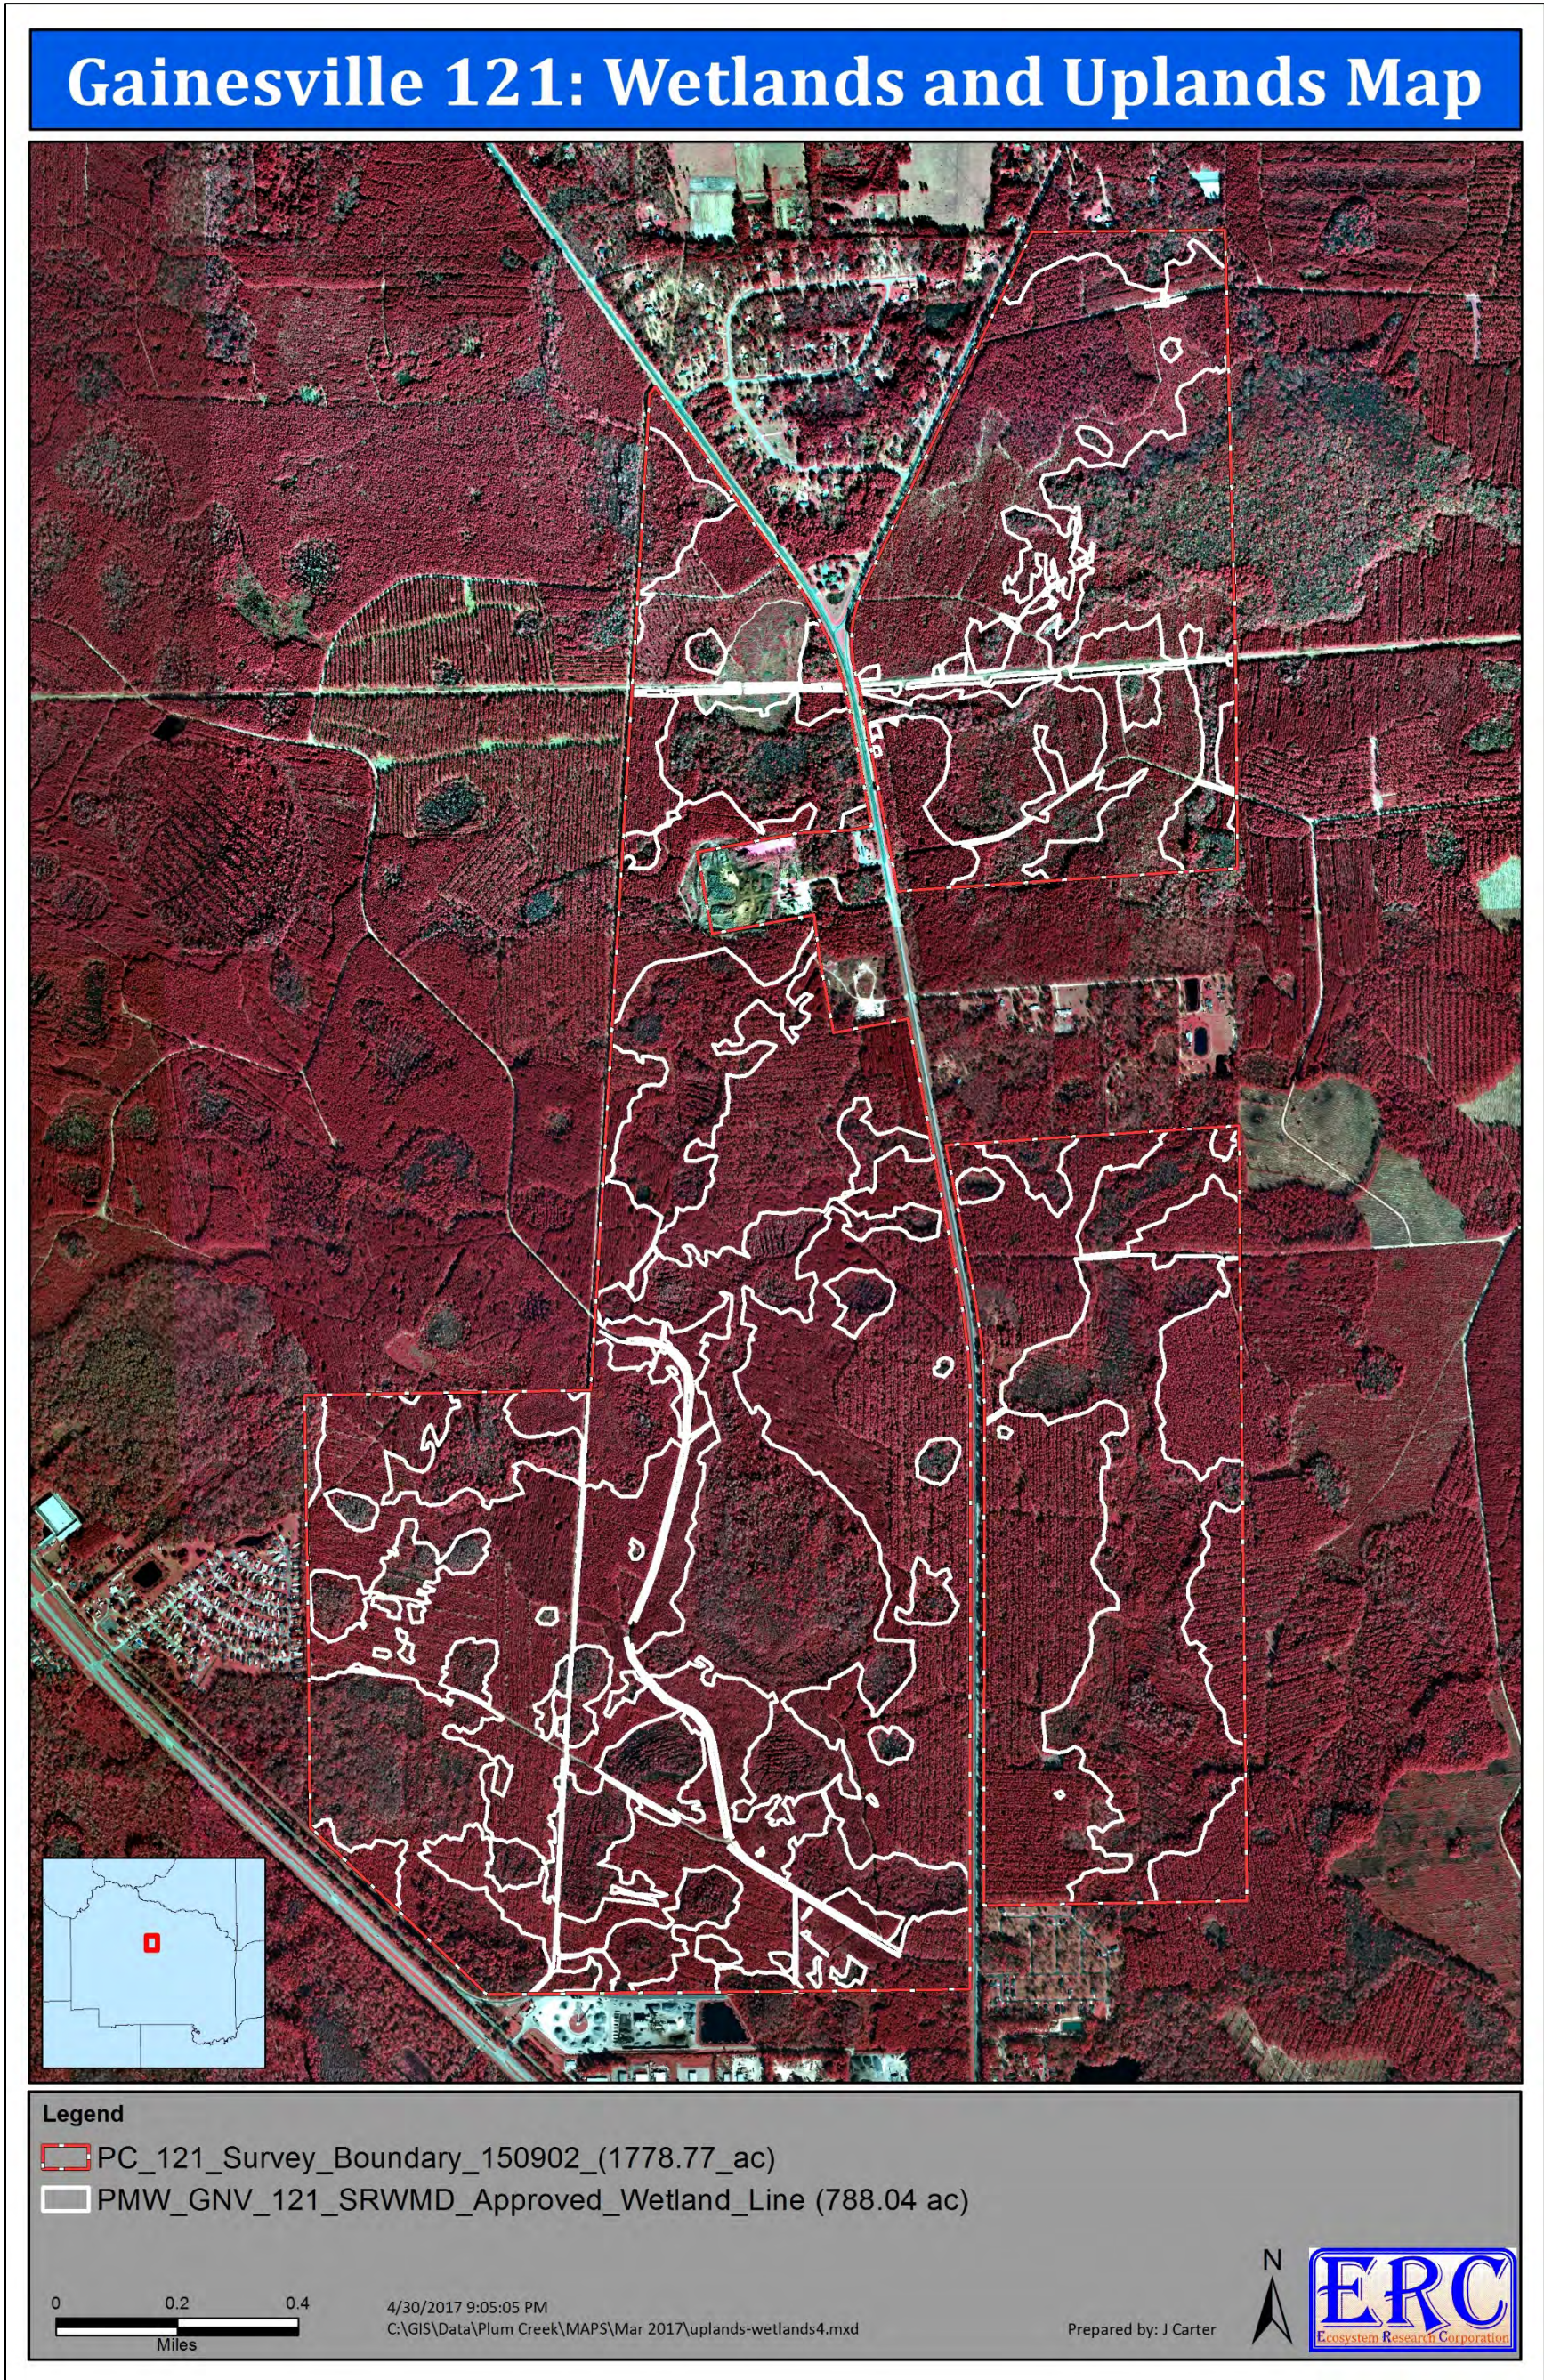
Figure 10. Wetlands and uplands map of the Gainesville 121 Project Site as shown on a 2013 false color infrared aerial.

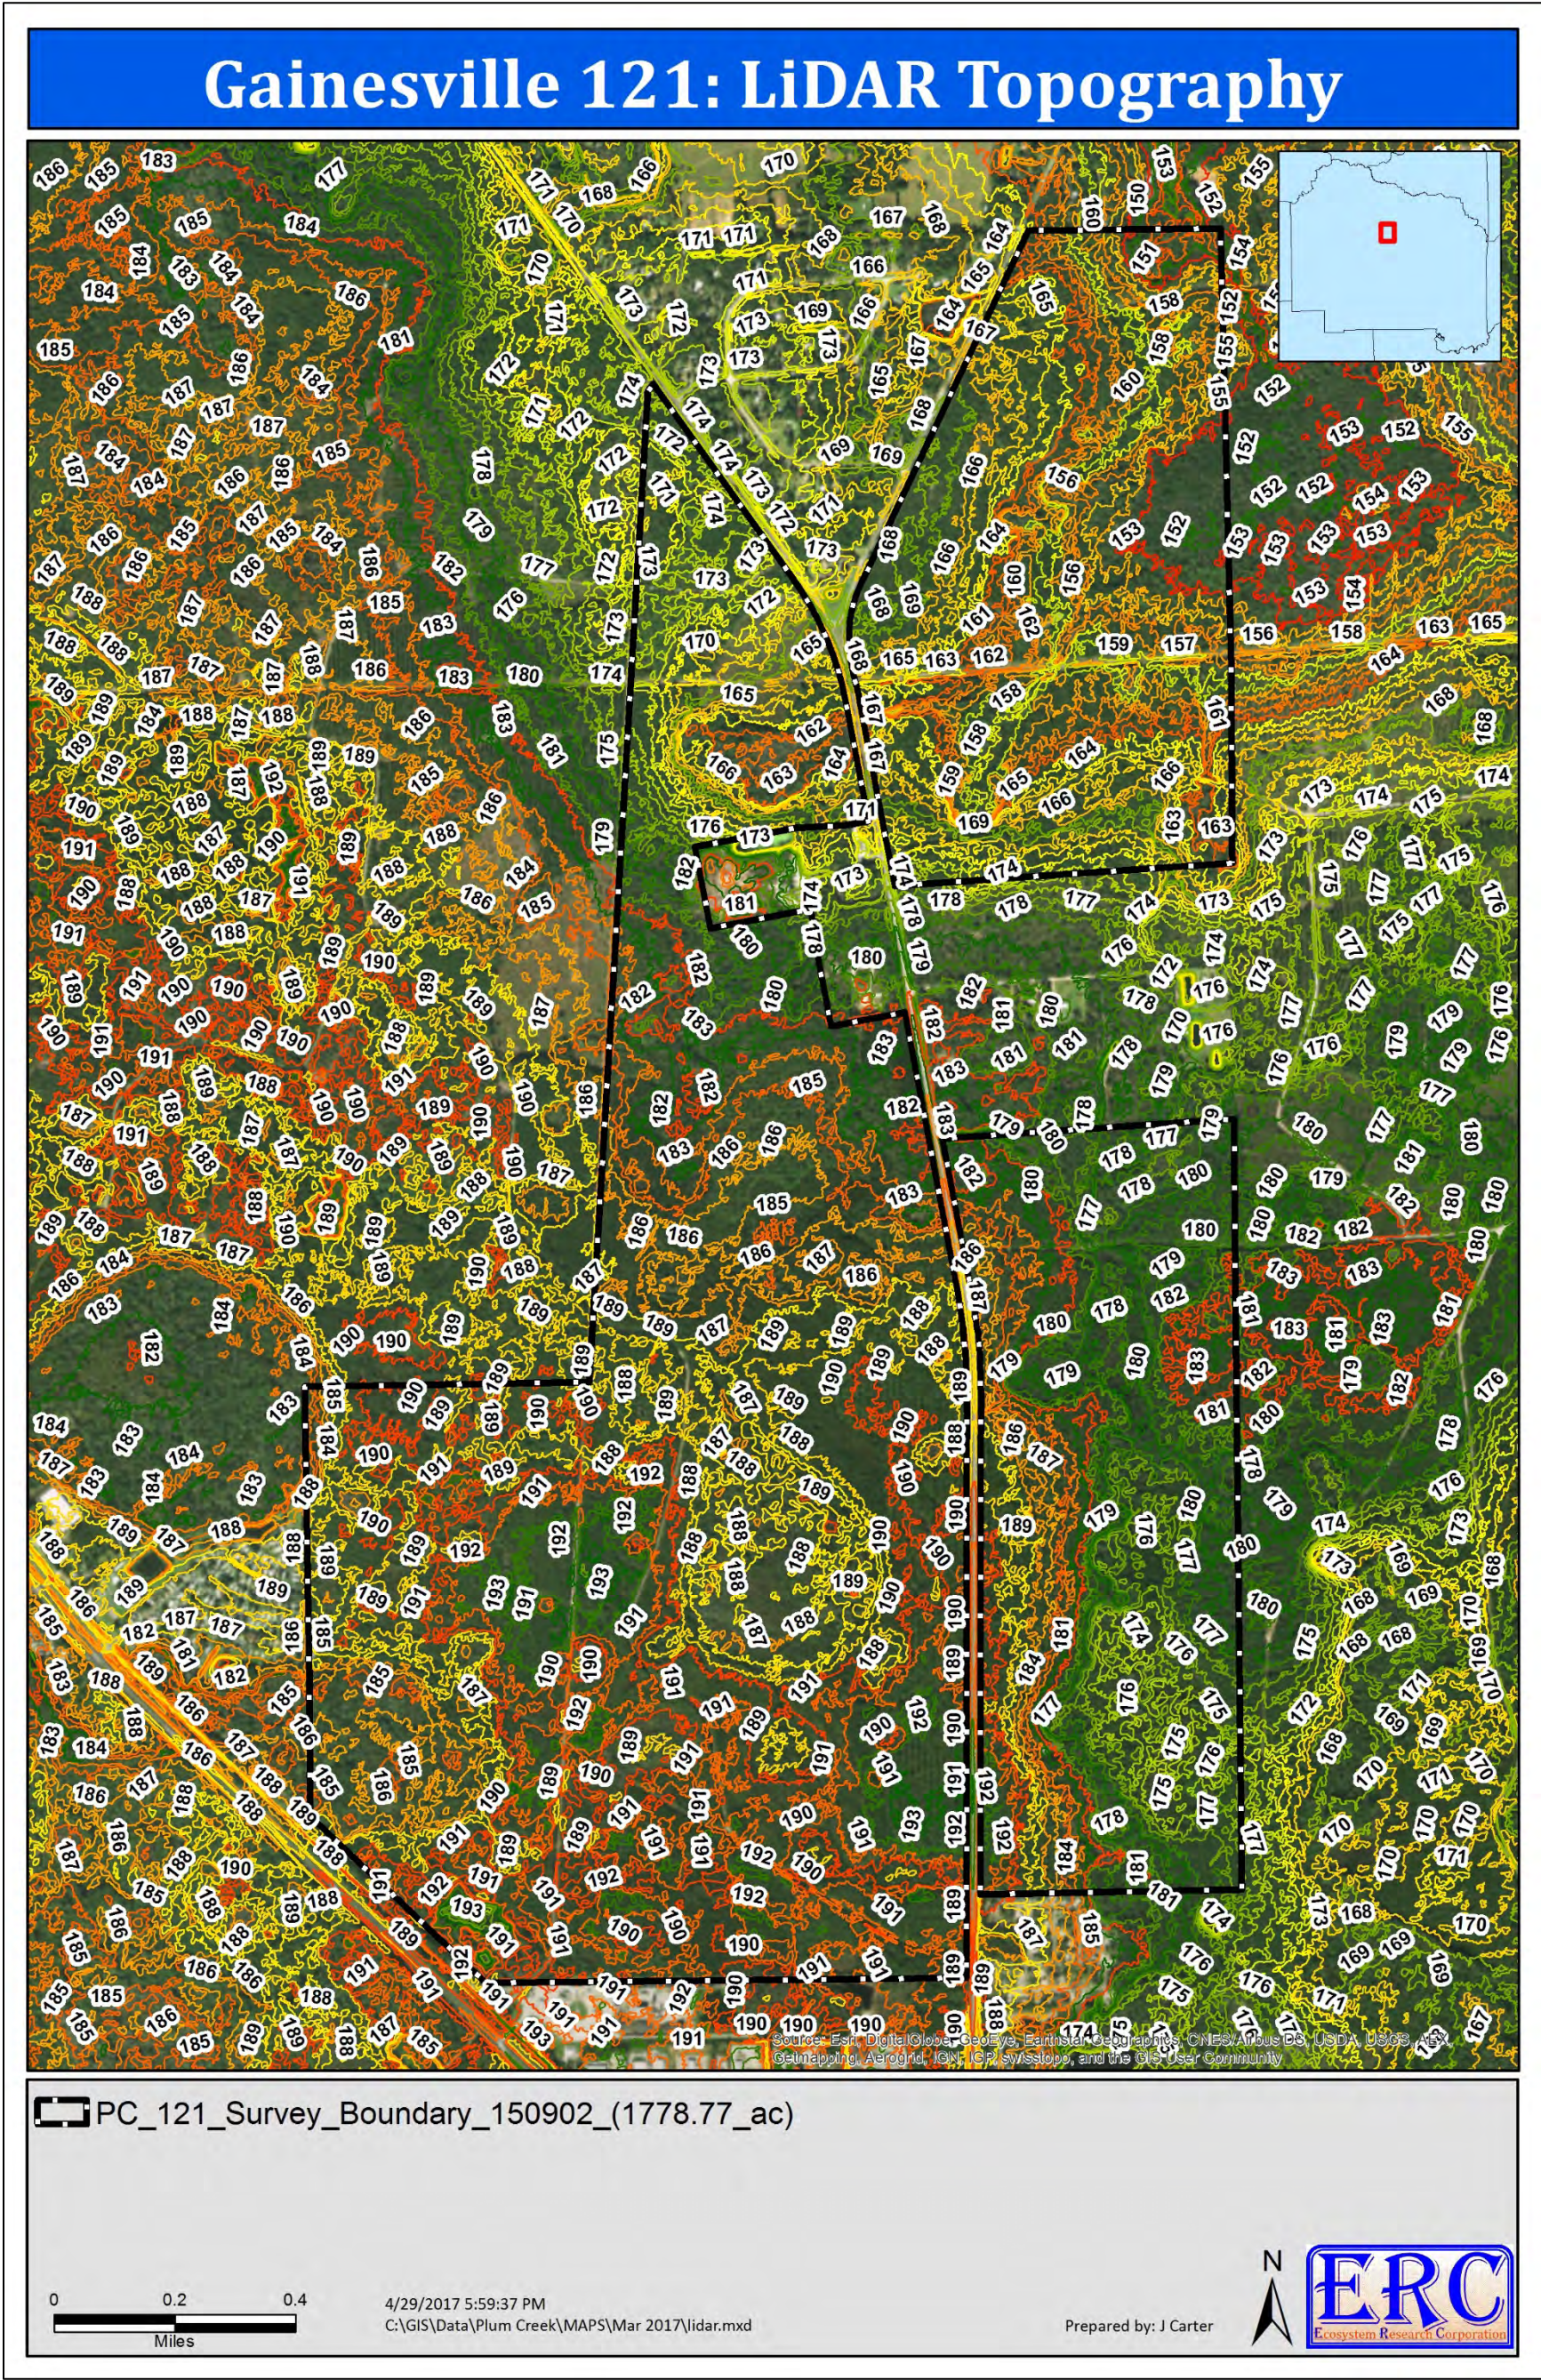
Figure 15. LiDAR topography map of the Gainesville 121 Project Site and surrounding area.

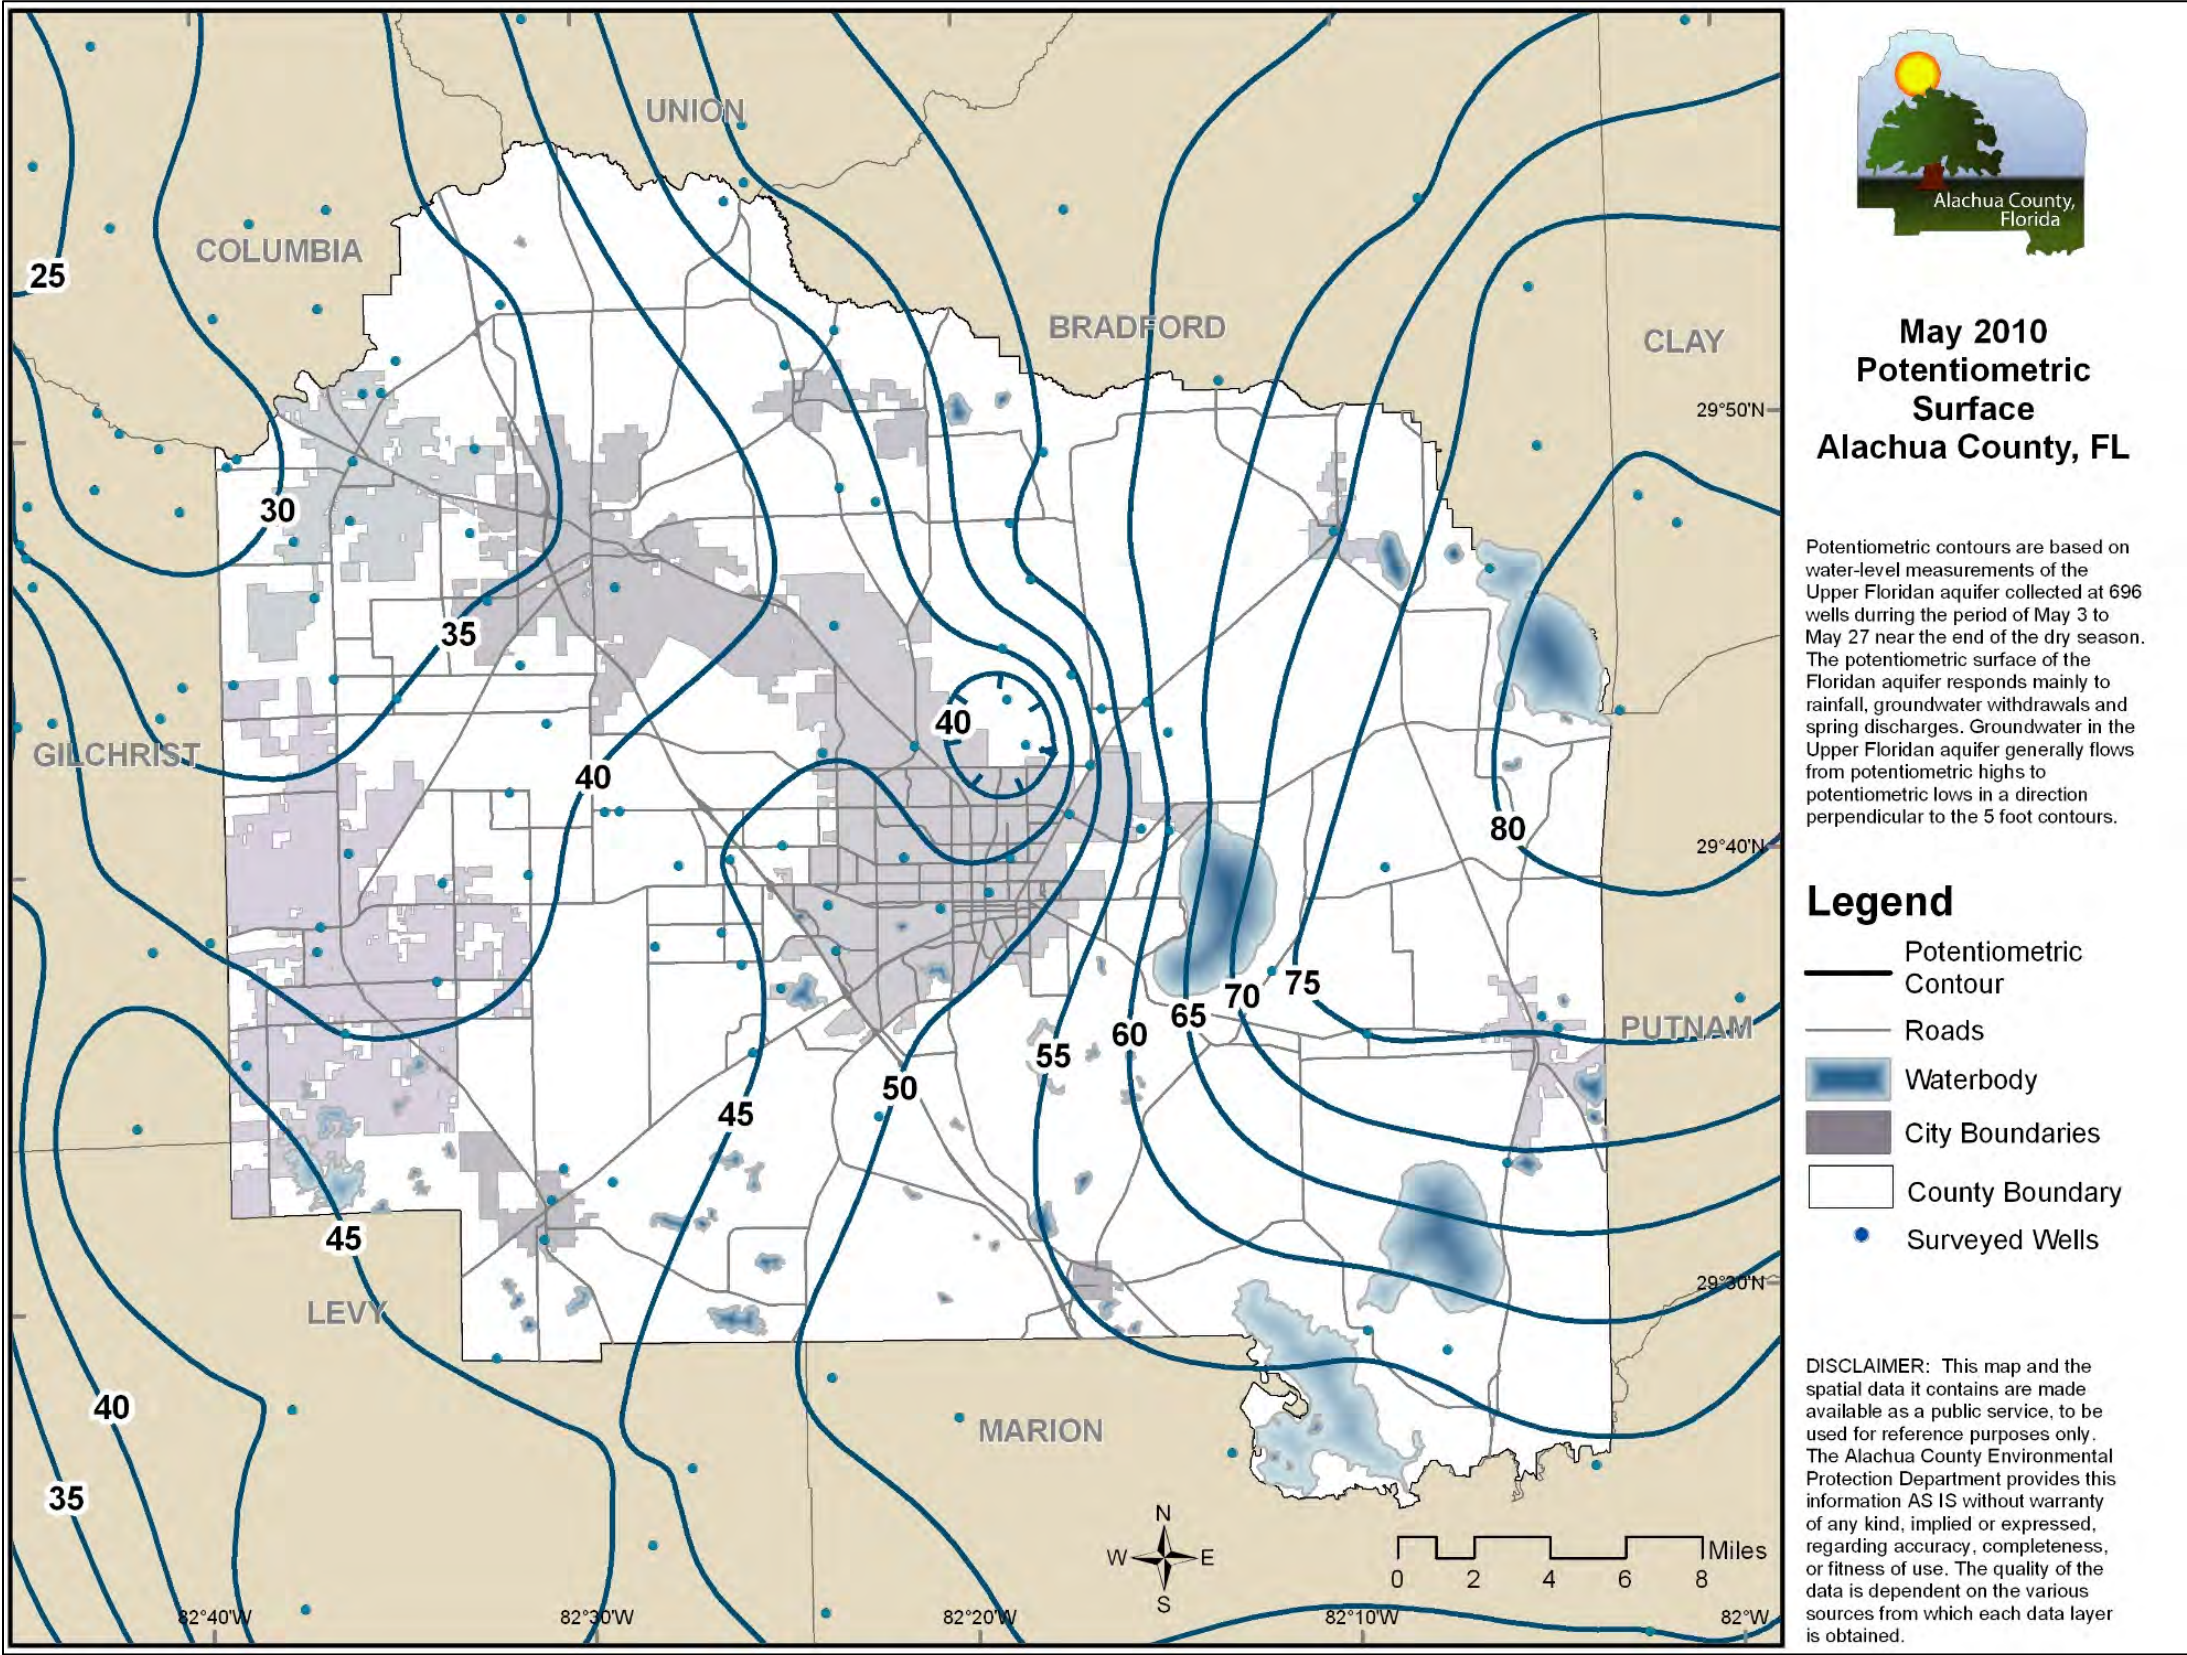
Figure 31. Potentiometric surface map of the Floridan aquifer in Alachua County, Florida, May 2010.

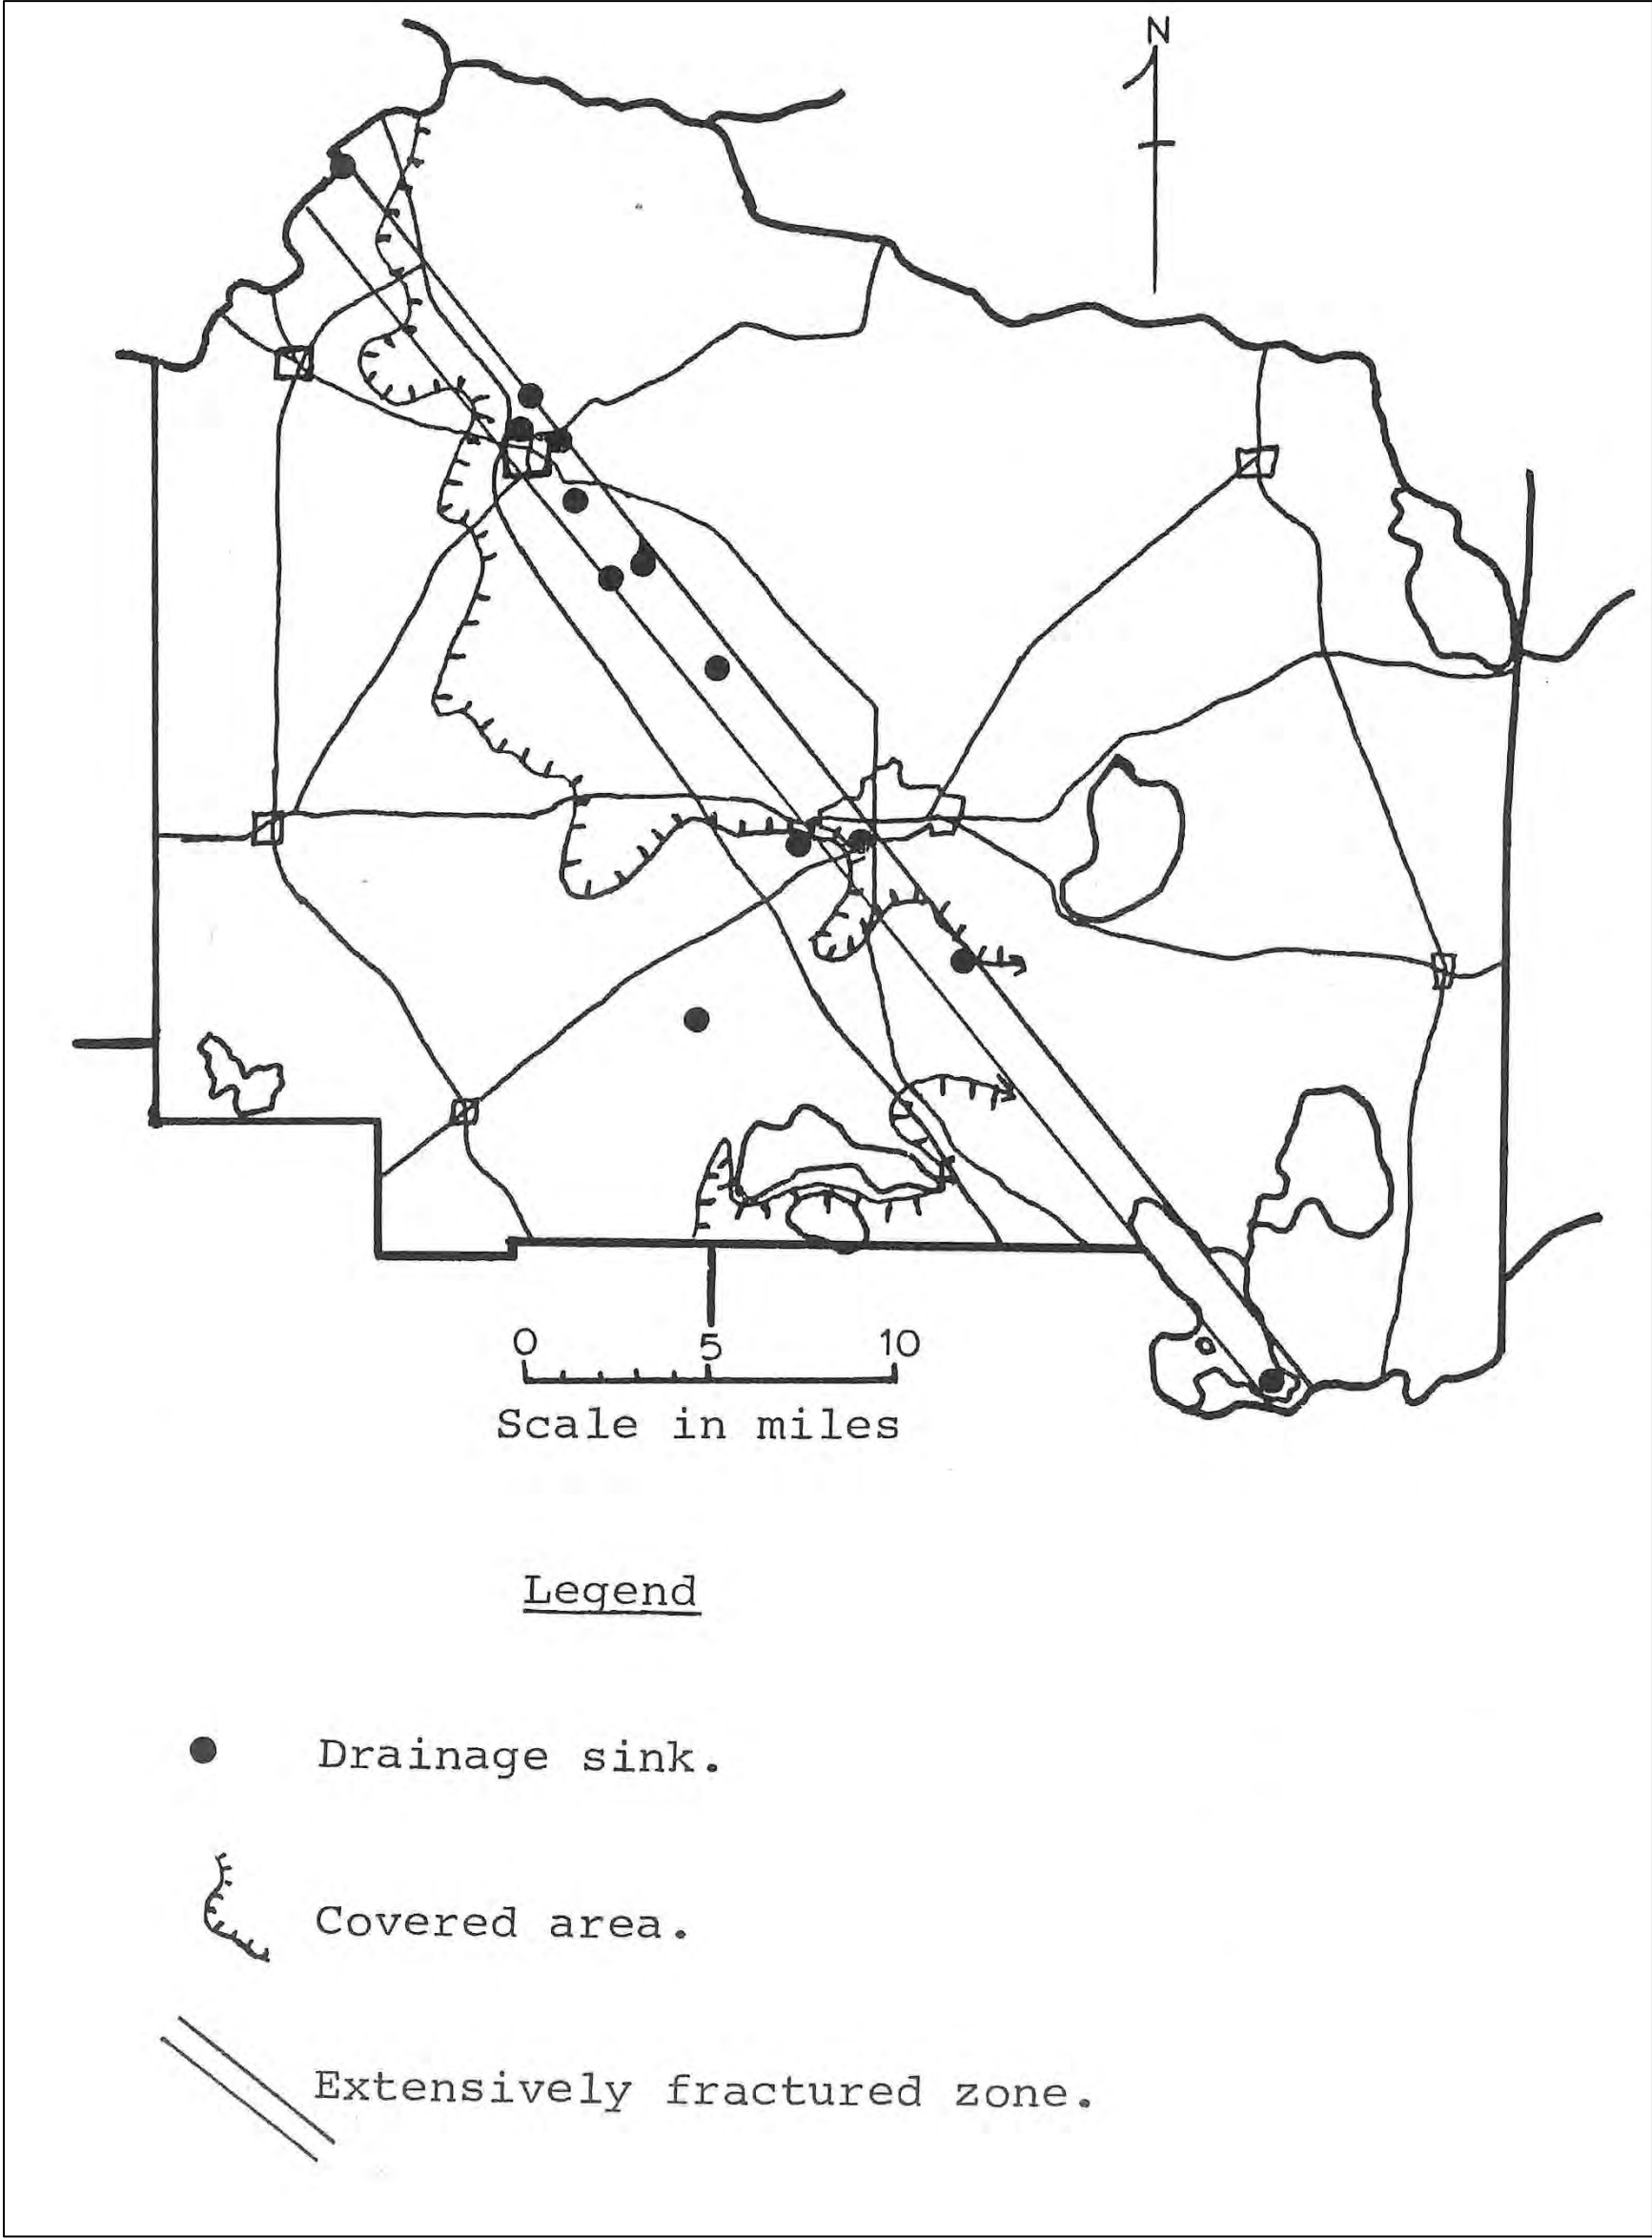
Figure 32. Cross county fracture zone. This image is a scanned image of Figure 10: Cross County Fracture Zone (pg 30) obtained from The Geology of the Western Part of Alachua County, Florida.

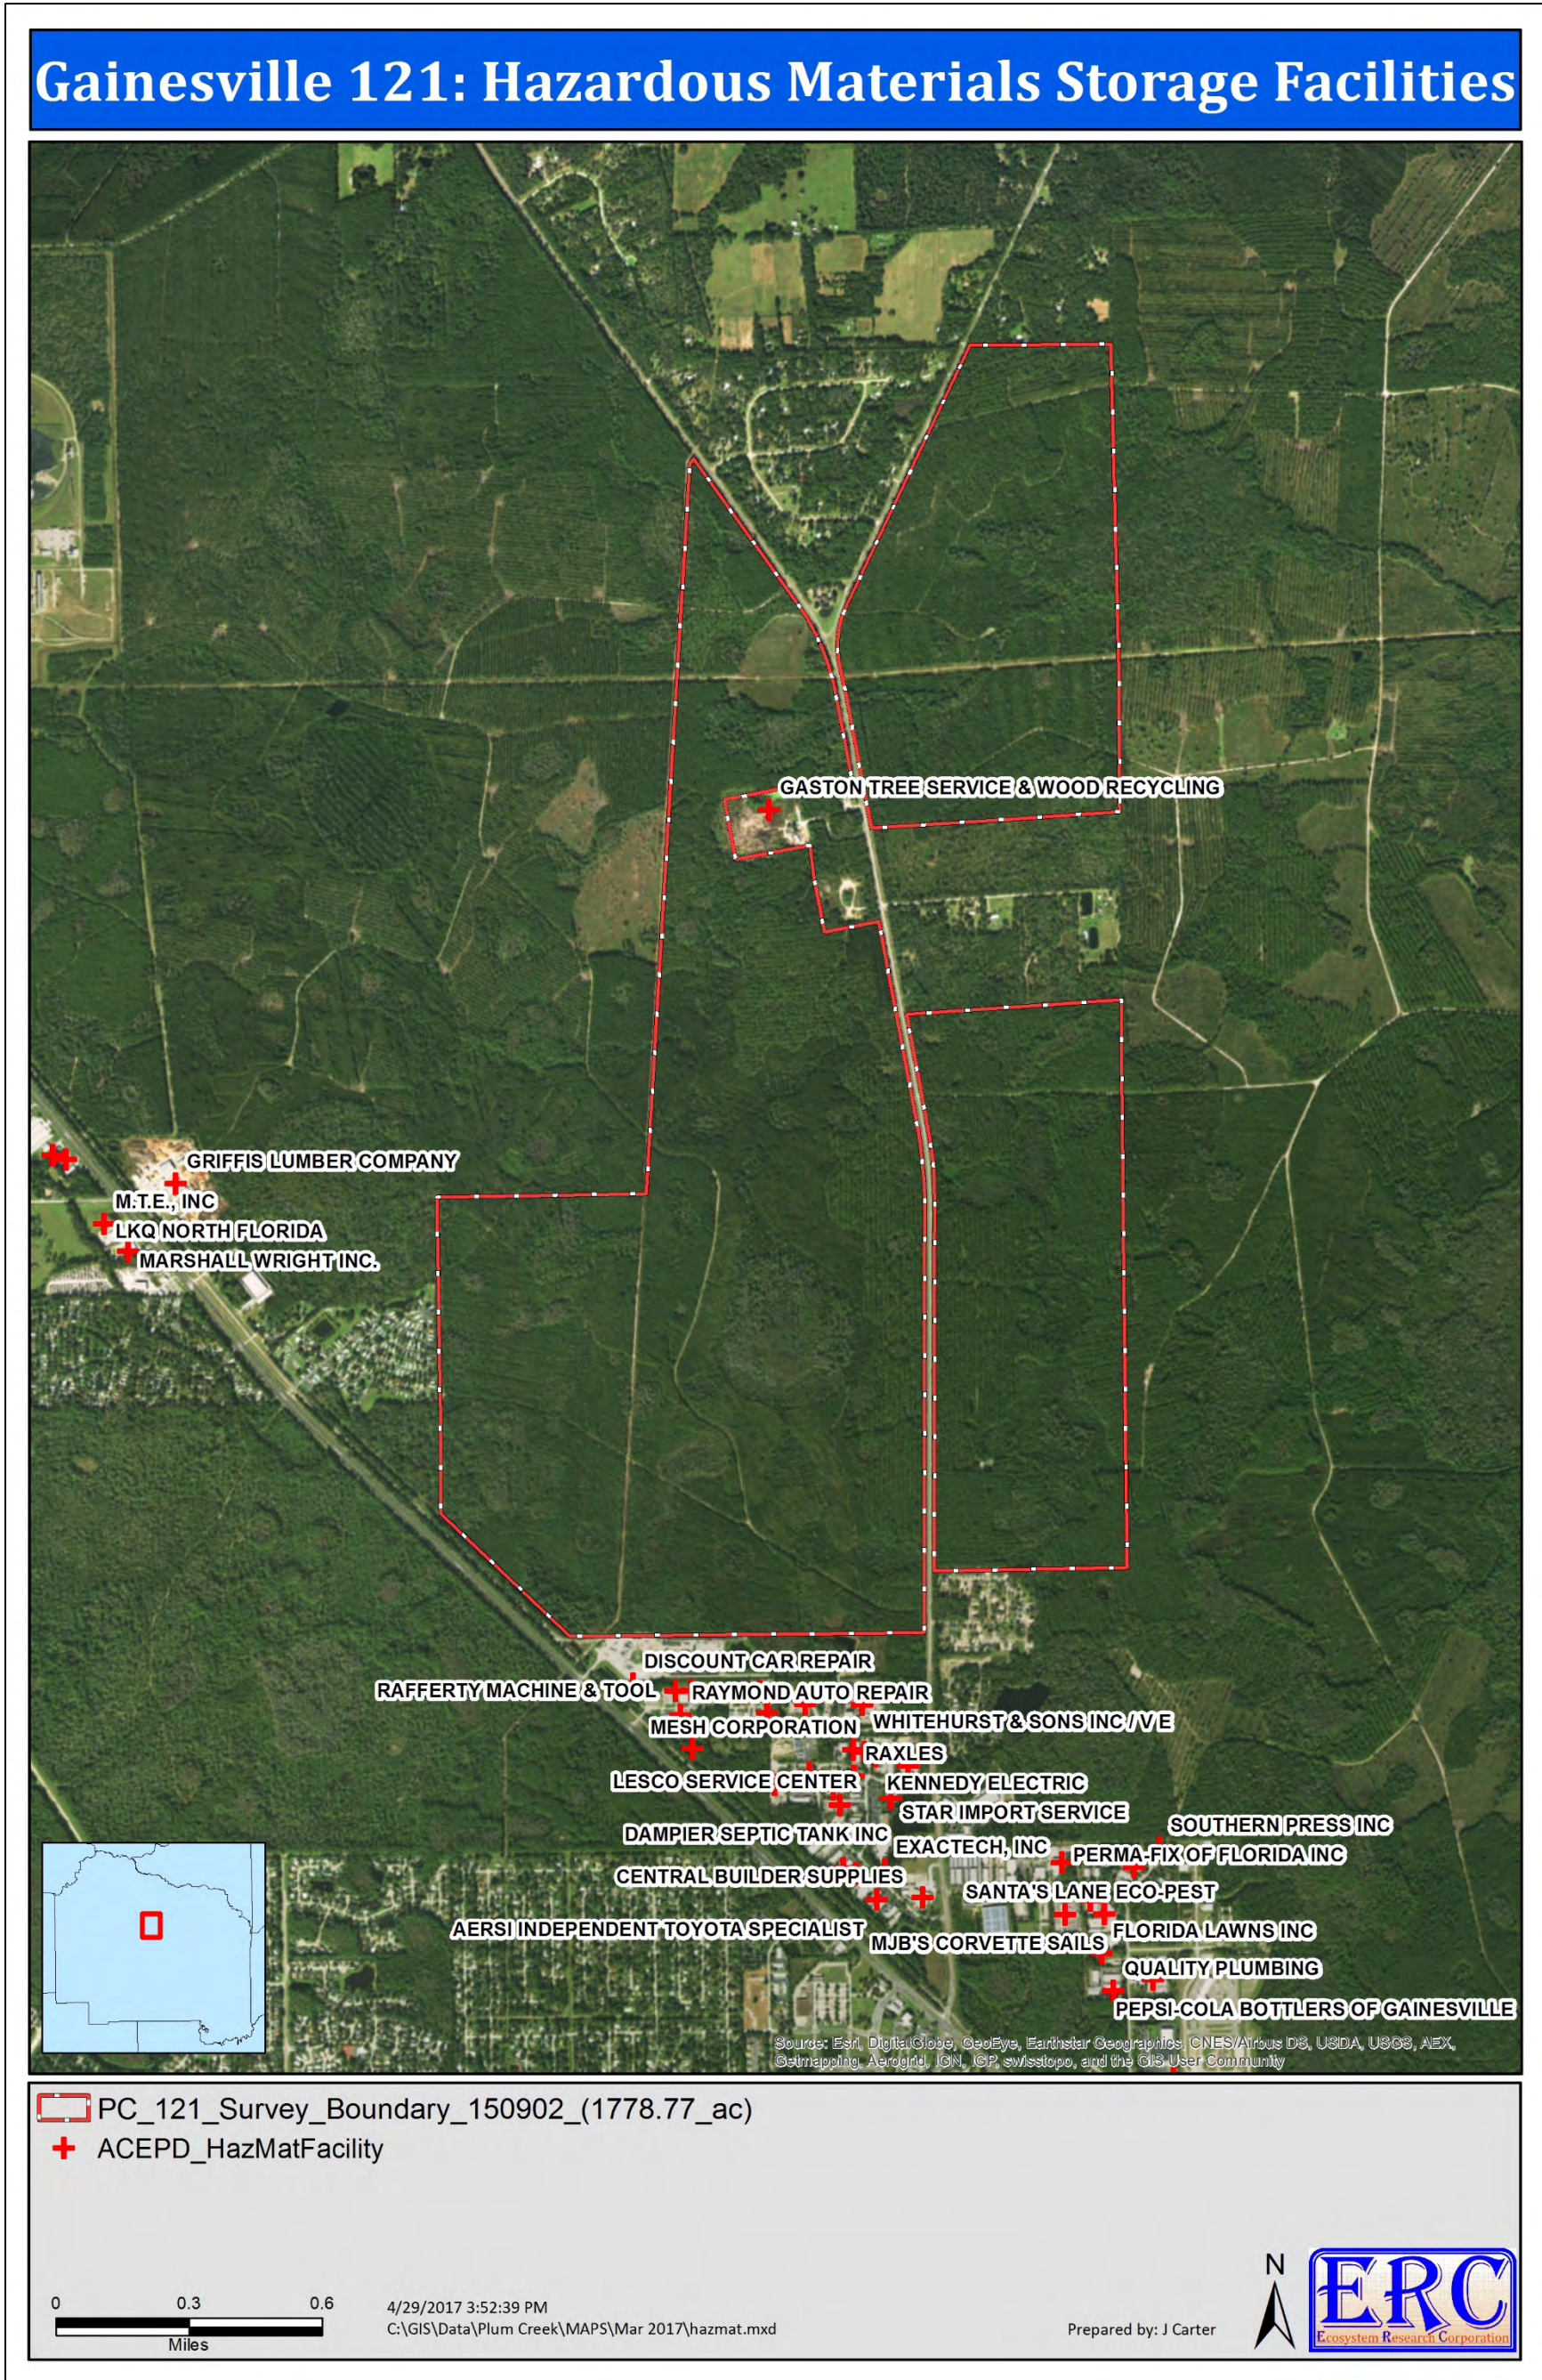
Figure 37. Alachua County hazardous materials storage facilities shown in relation to the Gainesville 121 Project Site and surrounding area.

The locations of the hazardous materials storage facilities that are monitored by Alachua County are shown on **Figure 37**. The map shows that there is one facility located within a parcel surrounded by the Project Site. In addition, there are a host of storage facilities located within the industrial parcels that lie south of the Project Site.
