Ecosystem Research Corporation

Natural Area Resource Assessment of the Gainesville 121 Project Site

Provided in support of a current
application for Planned Development

City of Gainesville, Florida

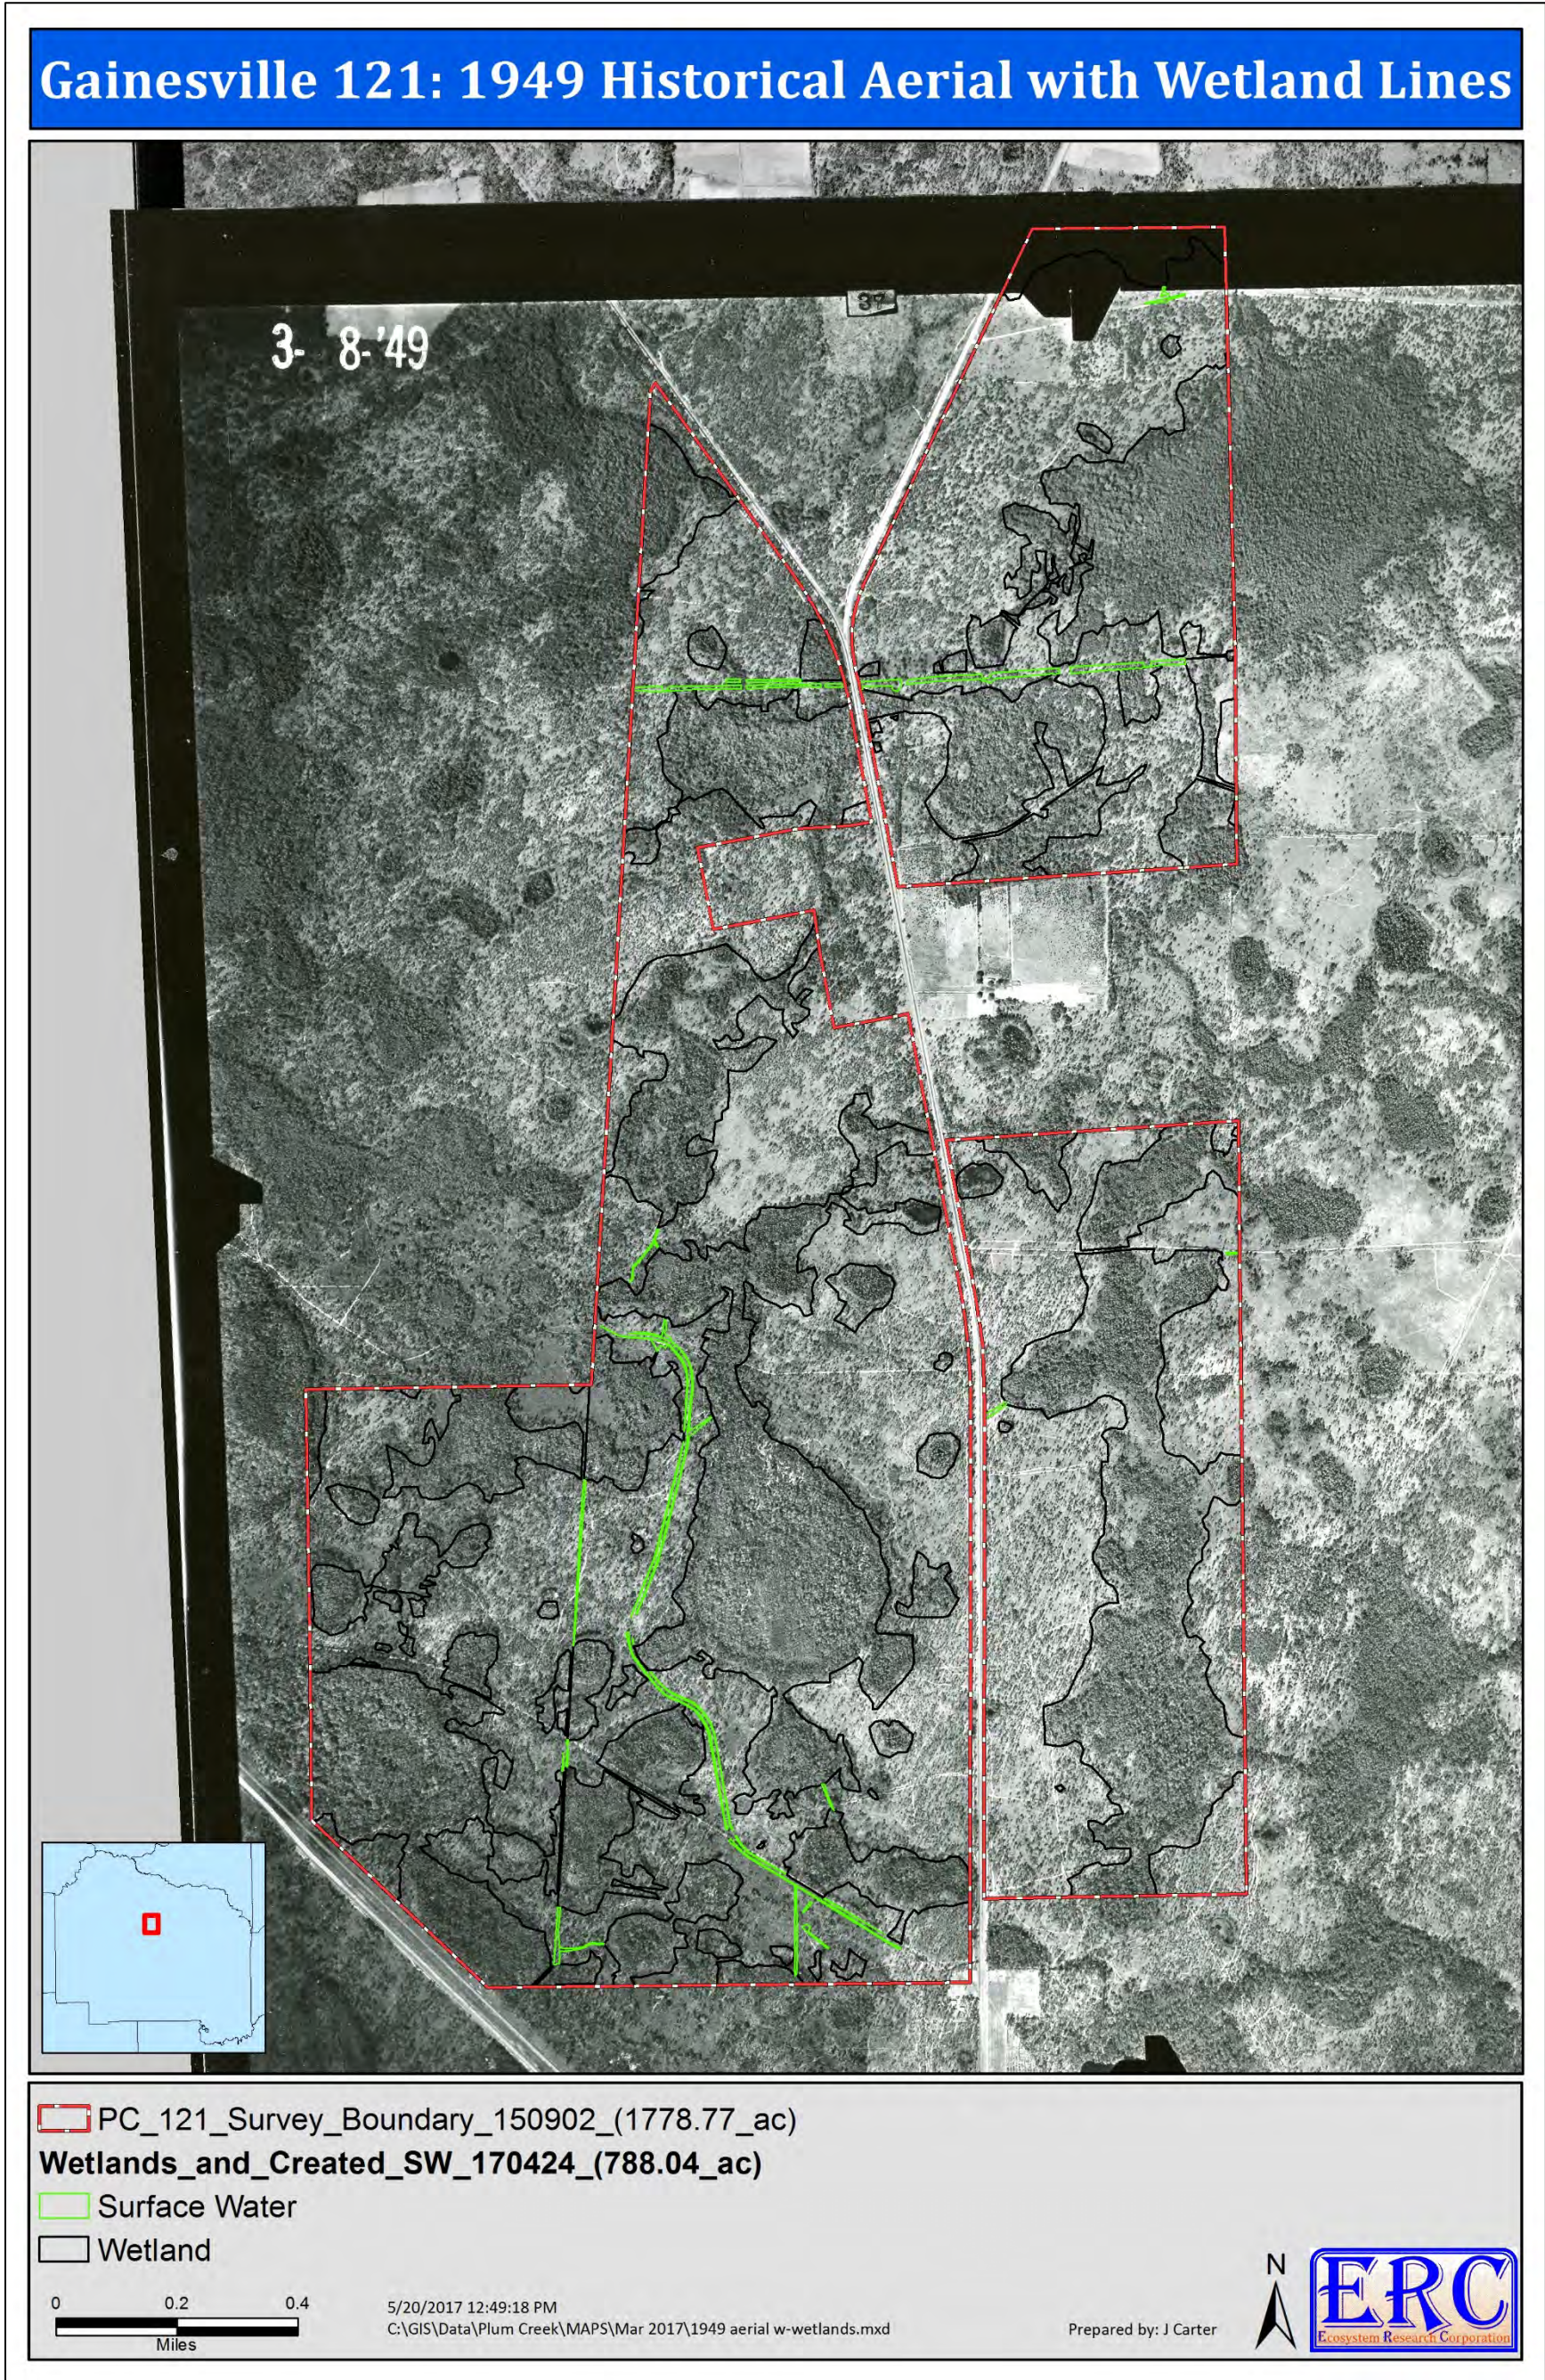
Figure 42. 1949 historical aerial photograph showing the wetlands lines within the Gainesville 121 Project Site.

1949 Historical Aerial (Figure 42)

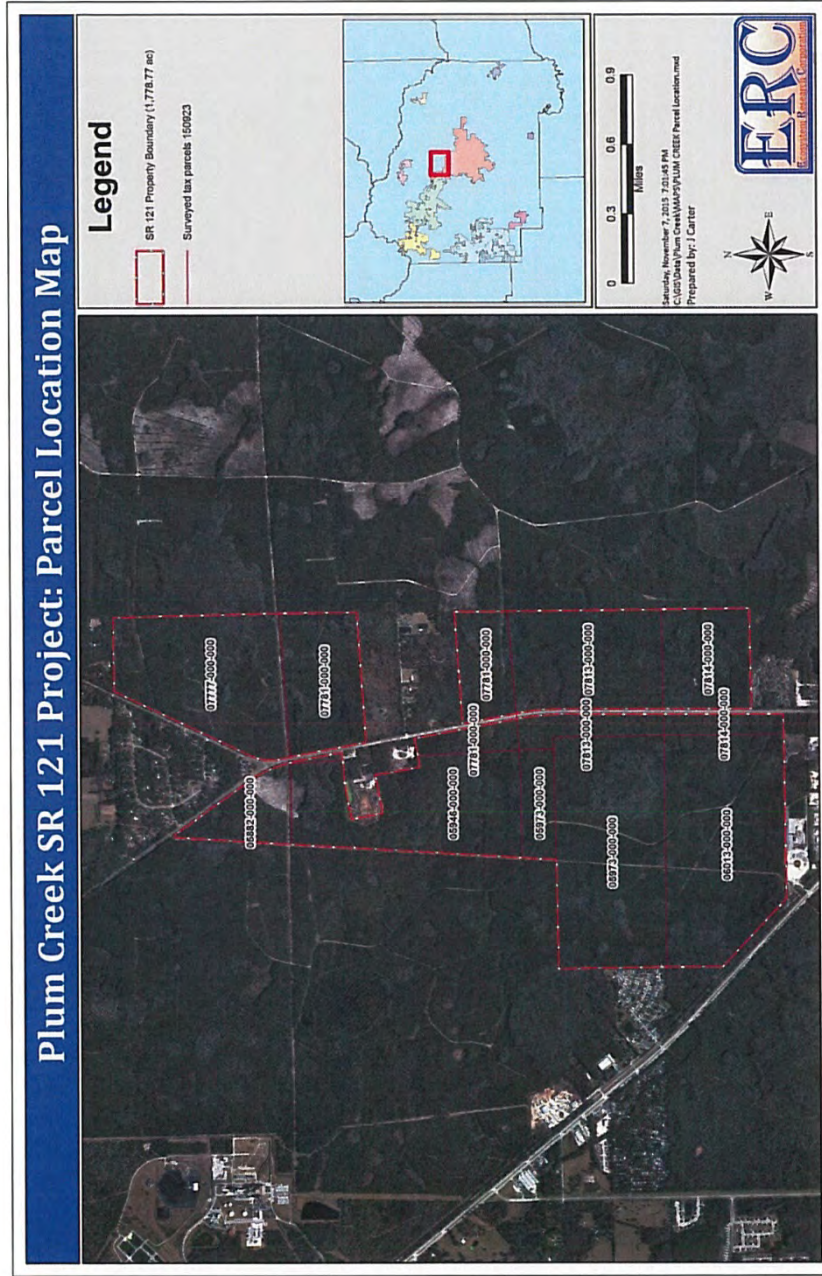
Figure 2. Parcel location map for the Plum Creek SR121 Development project site. The Resource Assessment Area and Planning Parcel are represented by the Project Site boundary.

The Planning Parcel for the project is equivalent to the Development Site boundary and consists of nine (9) Alachua County tax parcels, which total ±1778.77 acres (**Figure 2**). The proposed Development Site and Planning Parcel is contained within the following parcels described with associated acreages, as follows:

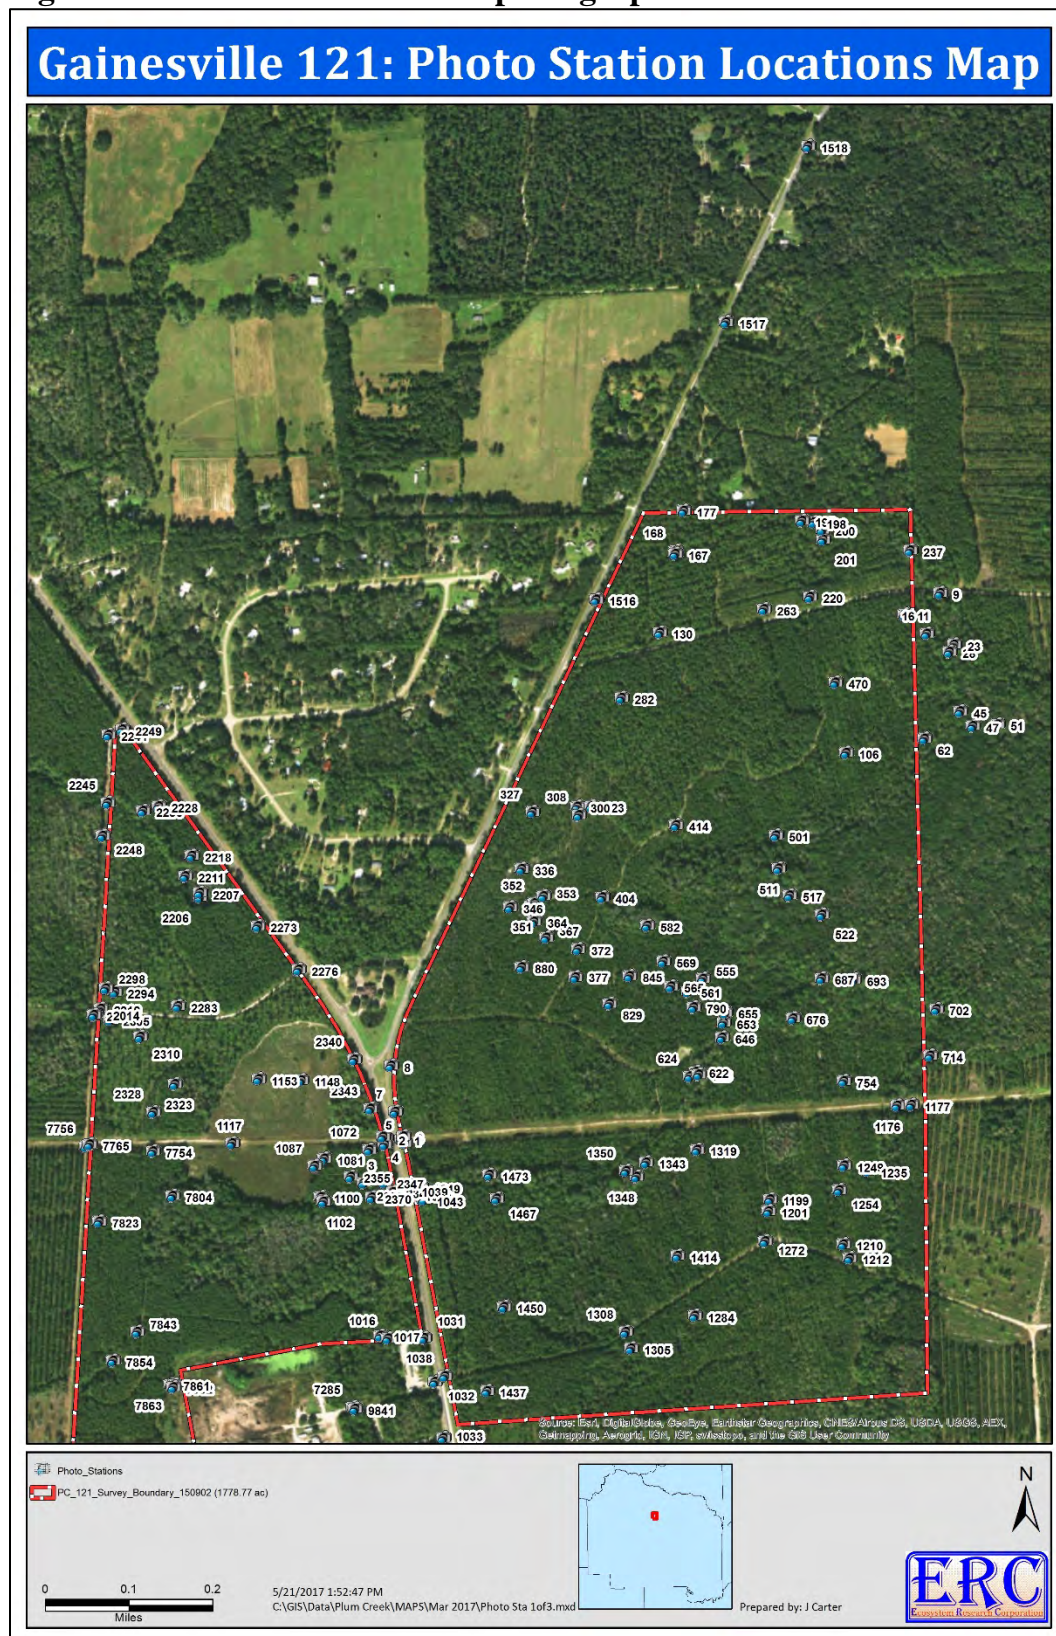
Figure A1. GPS locations where photographs were taken.
