THELMA A BOLTIN CENTER / HISTORIC GAINESVILLE

516 NE 2ND AVE, GAINESVILLE, FL 32601

SCOPE OF WORK

EXISTING CONDITIONS PLANS /
CONCEPTUAL - ADA ACCESSIBILITY/
STRUCTURAL ANALYSIS / CIVIL ANALYSIS
HISTORIC PRESERVATION

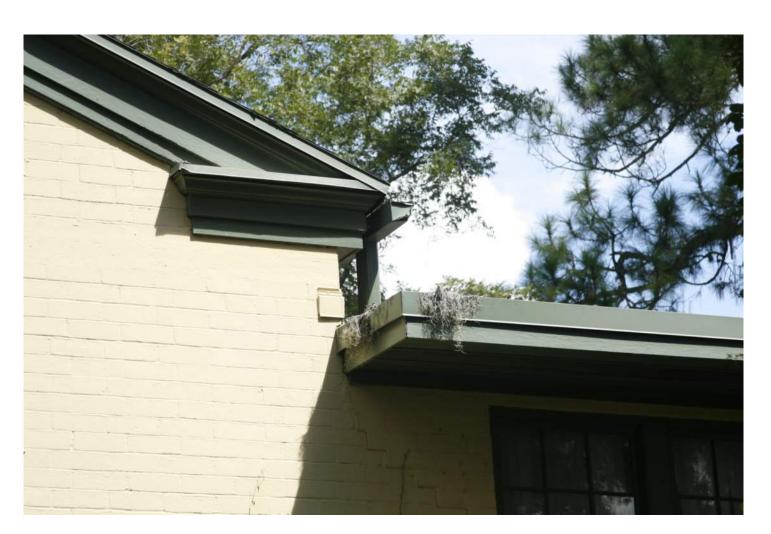
5 EAVE RETURN DETAIL AT SOUTH

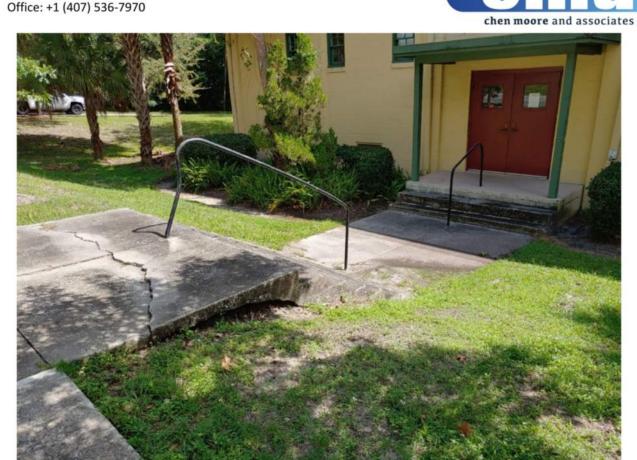
Figure 2. Stairway Undermining

Due to unevenness in the sidewalks and concrete areas around the building, drainage ponding and even washing out of near the western access stairs has occurred (see Figure 2).

Proposed improvements to the site paving and grading are anticipated to consist of harmonization to connect the existing hardscaping, parking lot, and structure. The site grading shall consider elevation constraints, such as the adjacent roadways, public sidewalks, the existing onsite parking lot, historic flood levels, and the existing structure. Site grading shall promote positive drainage away from habitable spaces towards the stormwater inlets (catch basins). A minimum slope of 0.5% shall be maintained to create a dry swale around the perimeter of the building footprint and to minimize surface water ponding. The existing culverts under the southwest landing should be further investigated with regards to increasing their diameter. Due to historic flooding, a decorative retaining wall/planter shall be considered in the area adjacent to the southeast portion of the building. The hardscaping (walkways, parking lots, etc.) should be re-graded and replaced in-kind to eliminate ponding locations. The existing mechanical maintenance pad should be replaced with a further elevated pad to minimize drainage sheet flow across the maintenance pad. Maximum site slopes shall consider ADA criteria (typically 2% maximum slope) and slopes conducive to facility operations. These general improvements are shown in Figure 3.

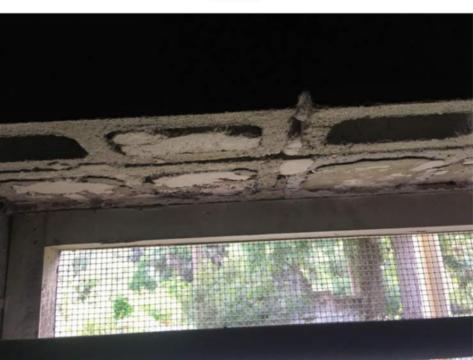
Exhibit 2

- 1. Exterior walls are painted CMU block. Block is in satisfactory condition except at northwest corner of the building. A crack is visible in the wall where the corner of the building has settled. It appears
- a repair was performed on the gable end in a continuous strip pattern located above the windows. 2. Wood framing around doors and windows are painted. The wood behind the paint has weathered over the years. Vertical cells of block are grouted in the header area of the door/ window openings and no other steel angle reinforcement is visible. (Exhibit 2)
- 3. Exterior walls of main hall are constructed of 8"x12"x4" CMU with two hollow cells with a second wythe of 4"x12"x4". The roof girders are supported on pilasters integral with all four walls of the main hall. (Exhibits 3 & 4)

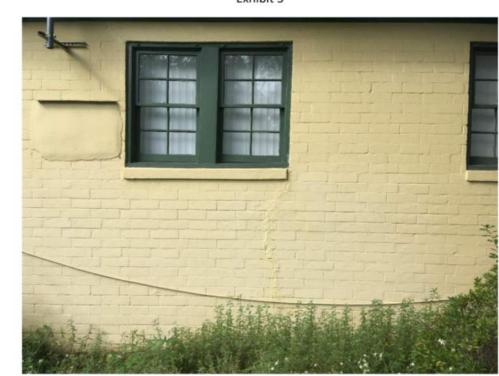
Exhibit 6

- 1. Exterior walls are painted CMU block. East elevation includes the main hall which connects to the adjacent building section at a 45-degree angle. A previous crack in the masonry wall has been patched over. (Exhibit 6)
- 2. Wood framing at doors and windows are painted. Previous weathering and some rot noticeable on the wood frames (Exhibit 7)

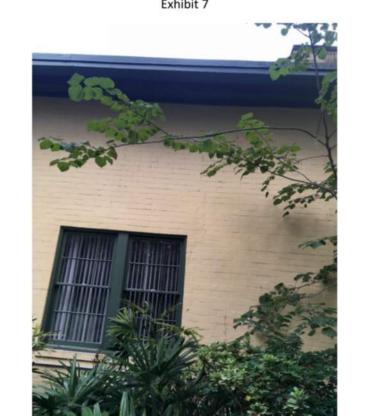
Exhibit 8

- 1. Exterior walls are painted CMU and are in satisfactory condition. There are several cracks in the masonry walls that have been previously patched but no further cracking is visible. There is a low
- spot in the grade where water collects to the east of the hall entrance. (Exhibit 8) 2. Wood framing at doors and windows are painted. Paint is covering weathered wood. Entrance
- canopy is in satisfactory condition. 3. There are open vents to ventilate the crawl space under the ground wood floor. (Exhibit 9)

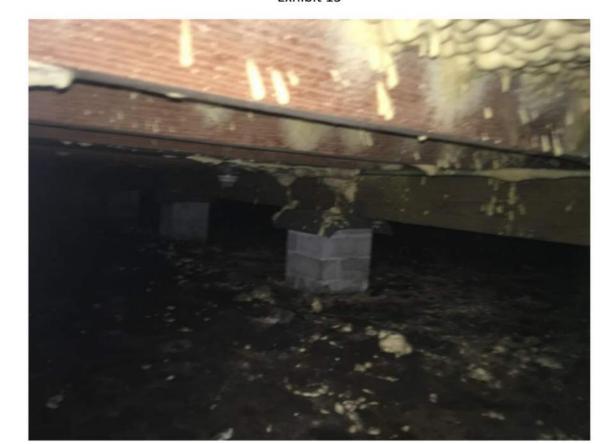
Exhibit 13

Roof at main hall is partially visible and access to roof is limited. Roof in main hall is currently shored. Two girder trusses at stage has failed and is fully shored. Some termite damaged, wood was also observed. (Exhibit 13)

1. The two shored girder wood trusses over the stage area will require replacement. The remaining girder wood trusses can be repaired (e.g double wood scabbing, additional metal plate connections, etc.). The extent of repair will depend on the as-built condition of the wood. A design analysis will also reveal if the girder trusses/ purlins will require additional reinforcement to support loads per the current code. Additional column supports/ footings at the girder truss bearing ends will be required to properly transmit all loads to the ground per the current code. These new columns can also provide some lateral bracing to the existing exterior walls. New plywood sheathing above the existing wood planks (to be fasten into the roof framing members) will be required to provide an adequate roof diaphragm to resist lateral loads per the current code. Mechanical uplift connectors will be required throughout the roof framing which were found missing.

Ceiling wood joists will also have to be repaired/ replaced as required.

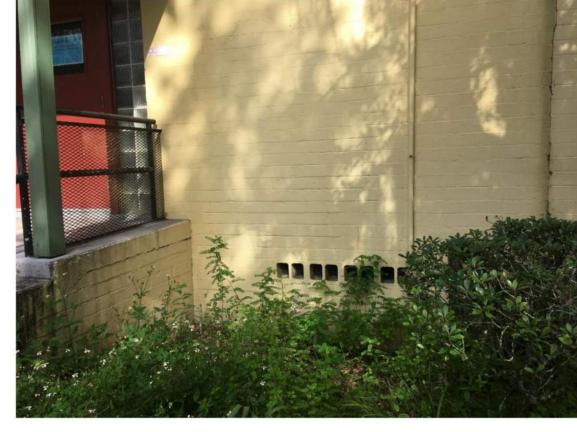
Exhibit 14

1. The wood floor appears to be level and solid. They are supported by a wood beam/ joist frame system supported by 12" x 12" CMU piers. Flooring that is visible appears to be in satisfactory condition. (Exhibit 14)
