Natural Area Resource Assessment of the Gainesville 121 Project Site

Provided in support of a current
application for Planned Development

City of Gainesville, Florida

Ecosystem Research Corporation
2906 NW 142 Avenue
Gainesville, FL 32609

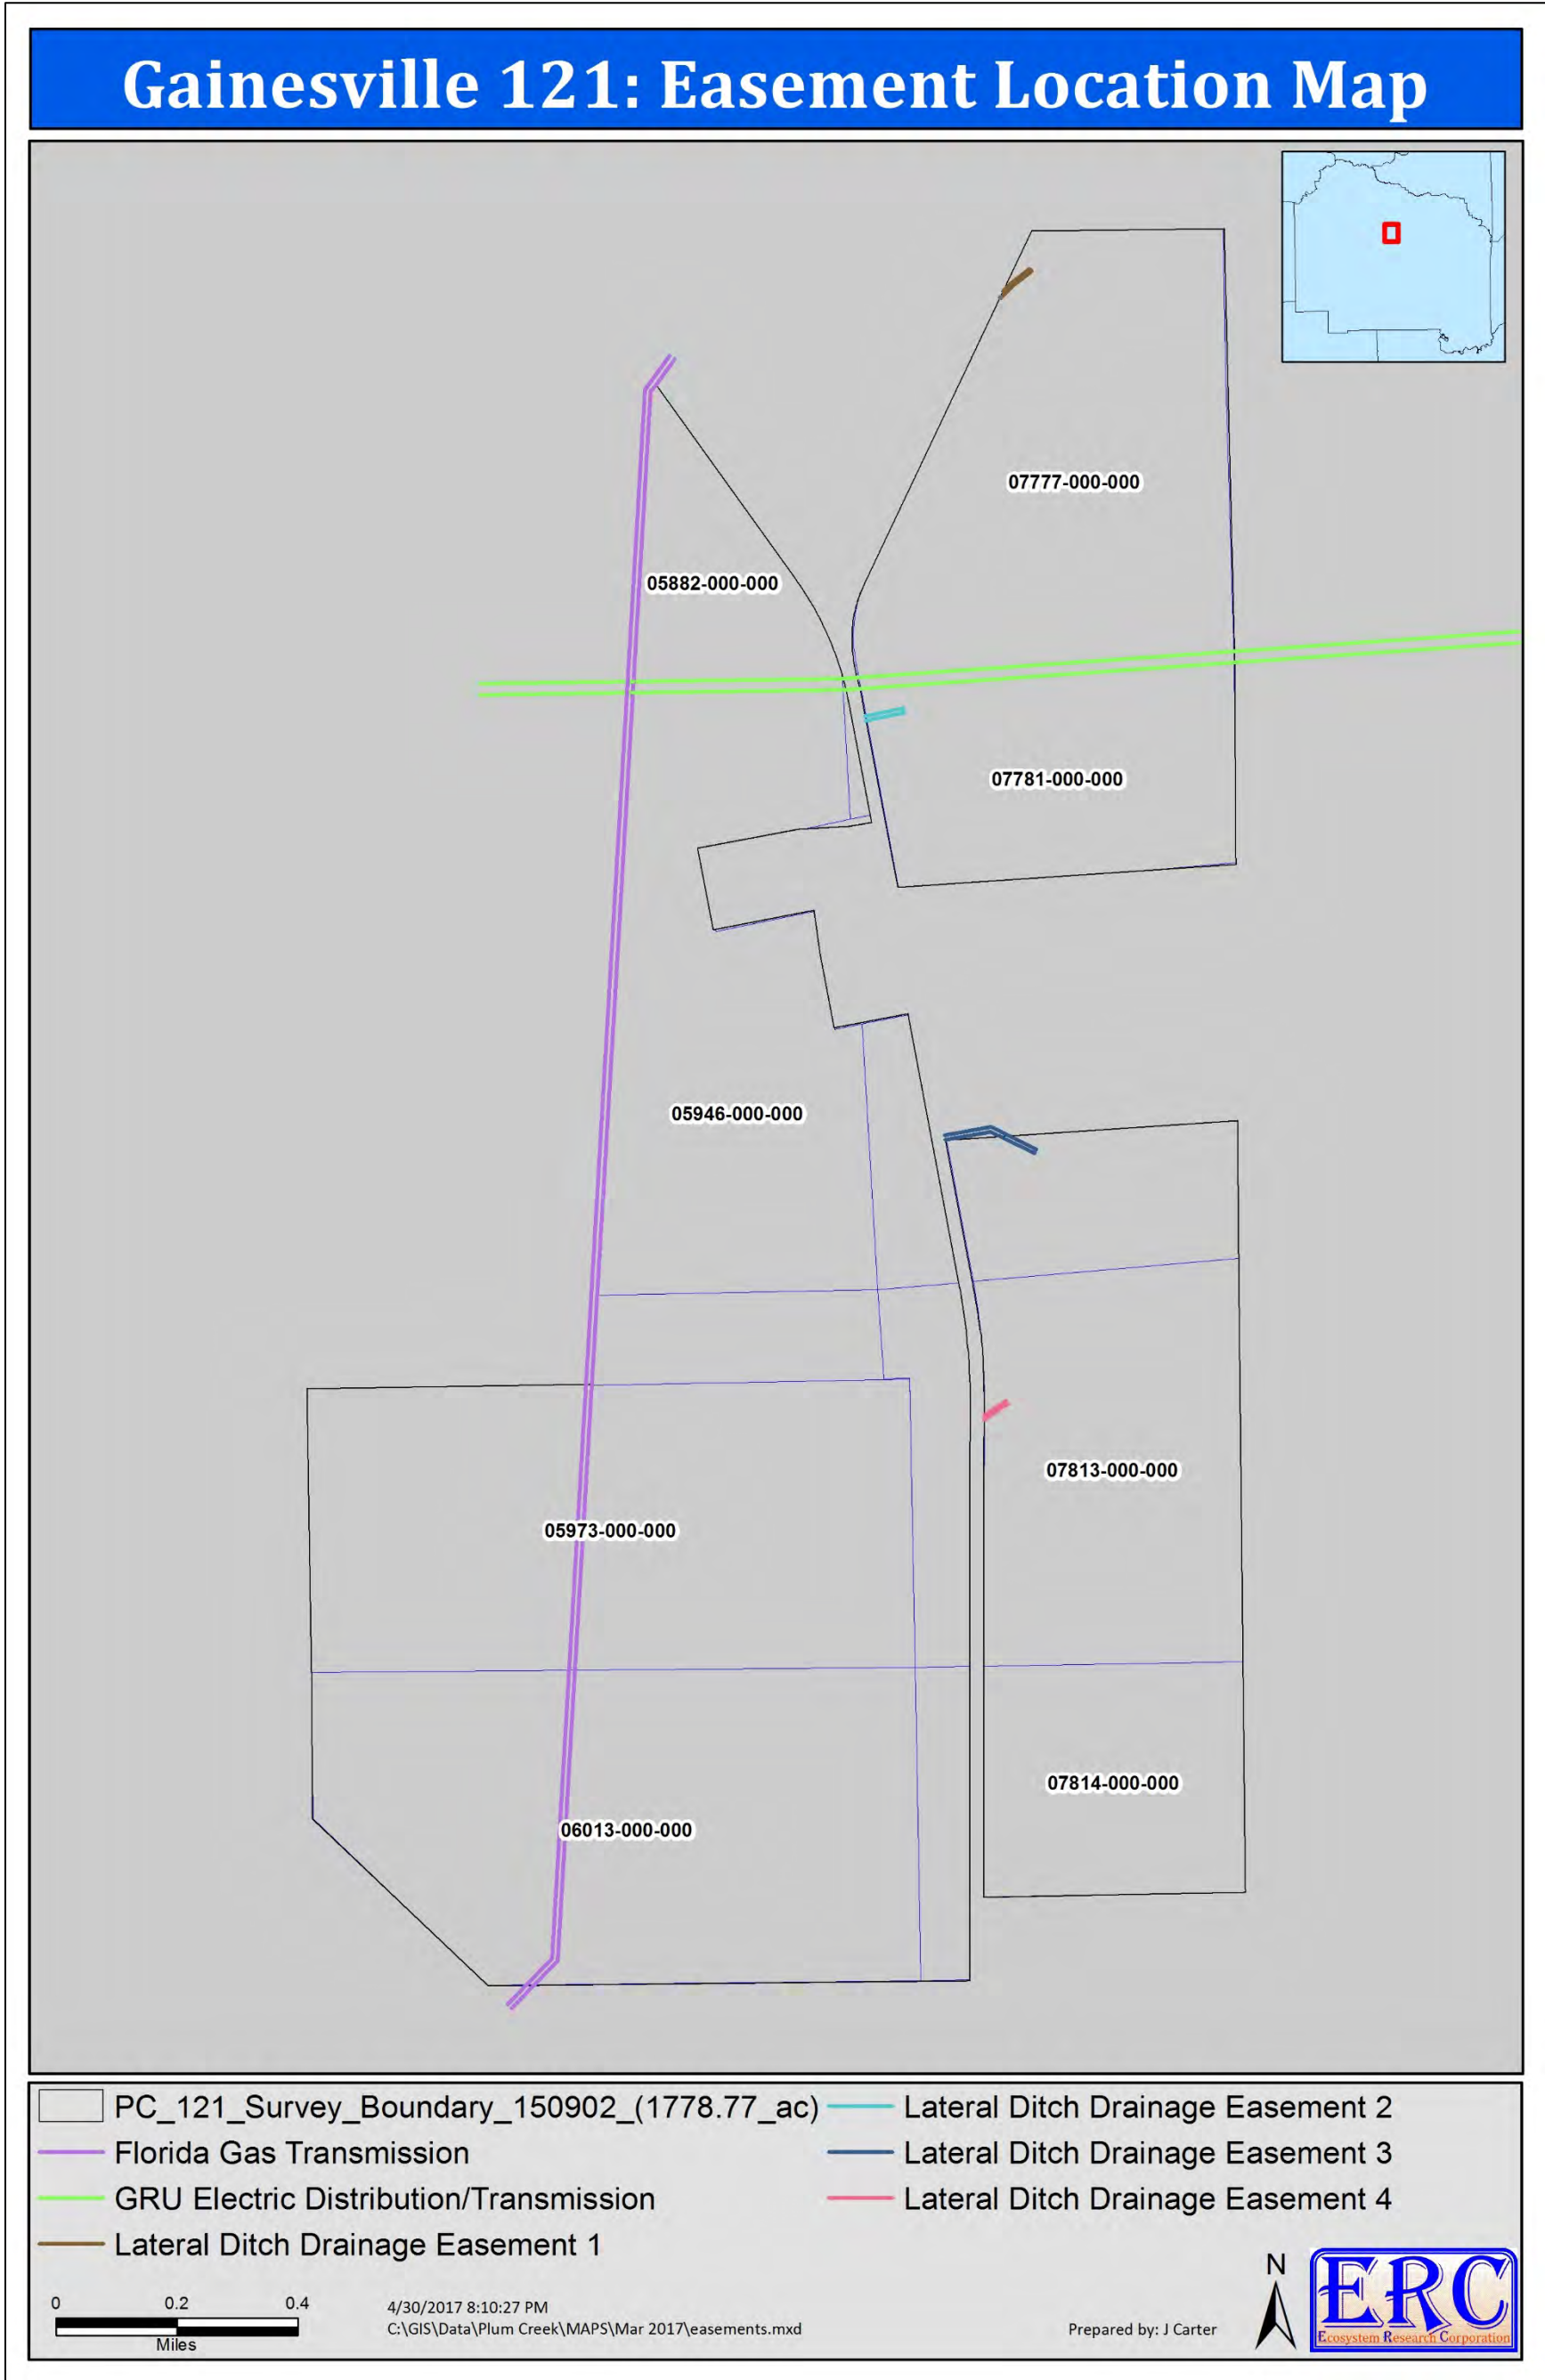
Figure 6. Utility easements located within the Gainesville 121 Project Site.

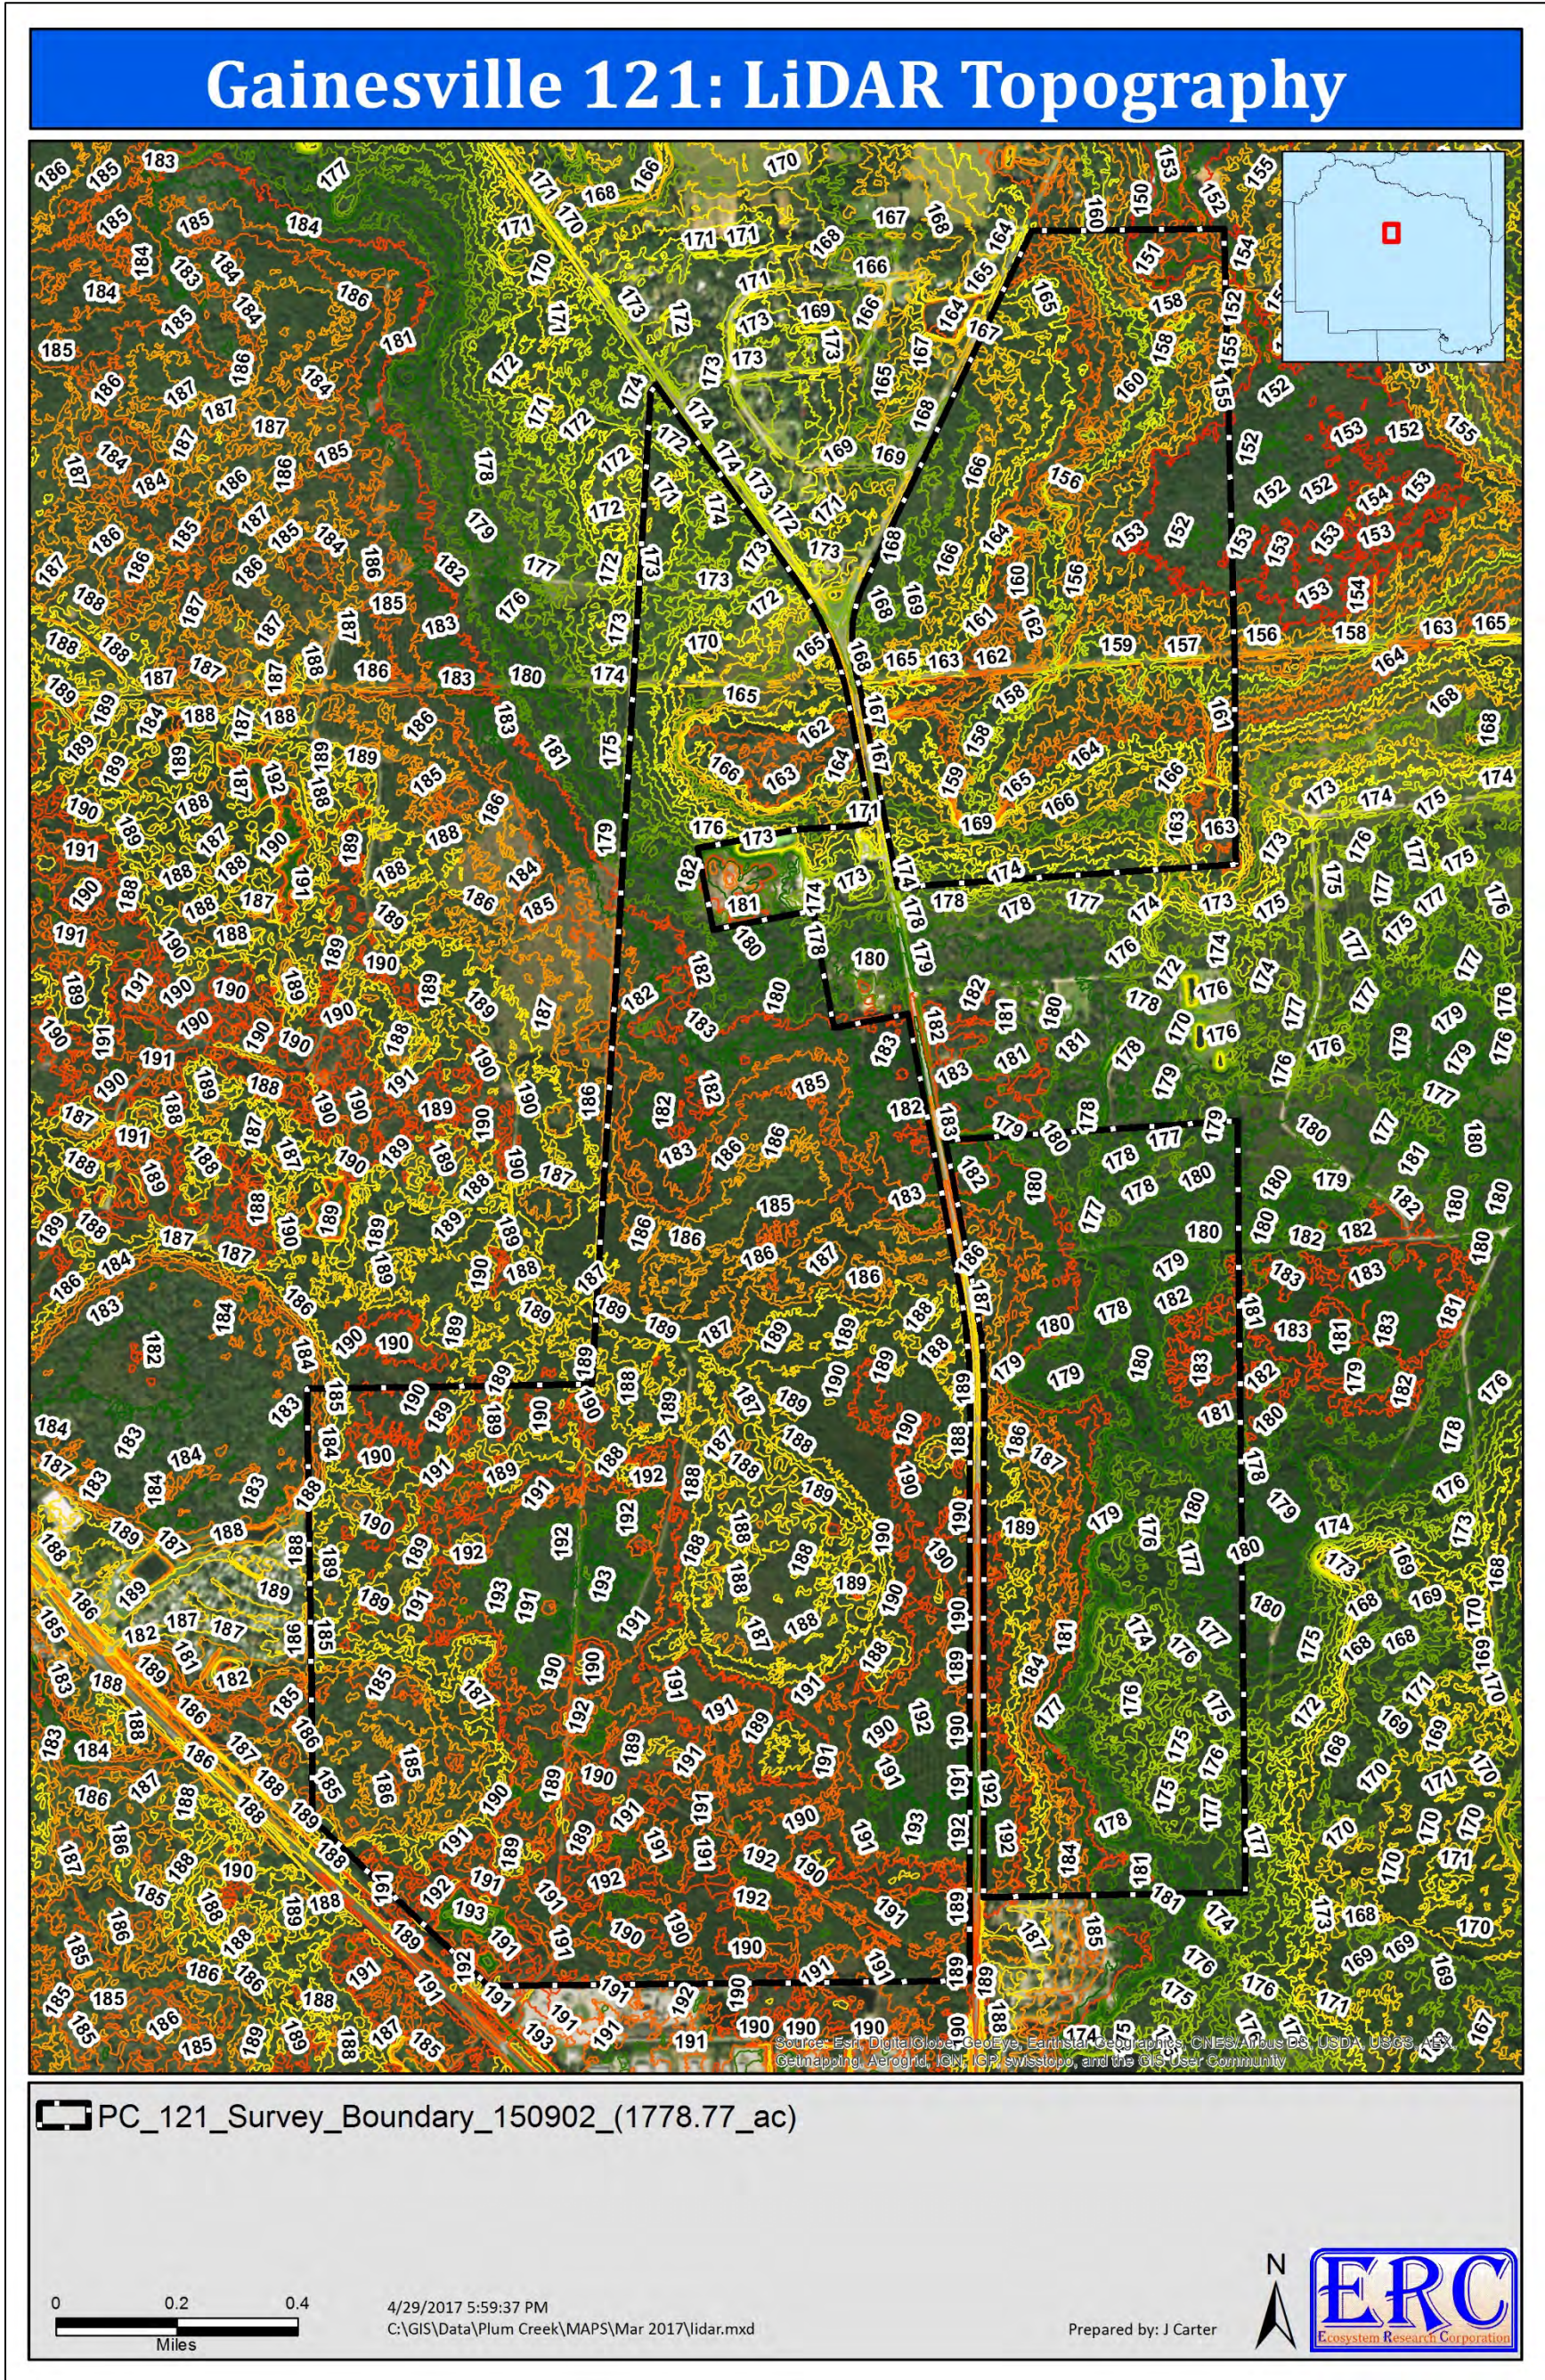
Figure 15. LiDAR topography map of the Gainesville 121 Project Site and surrounding area.

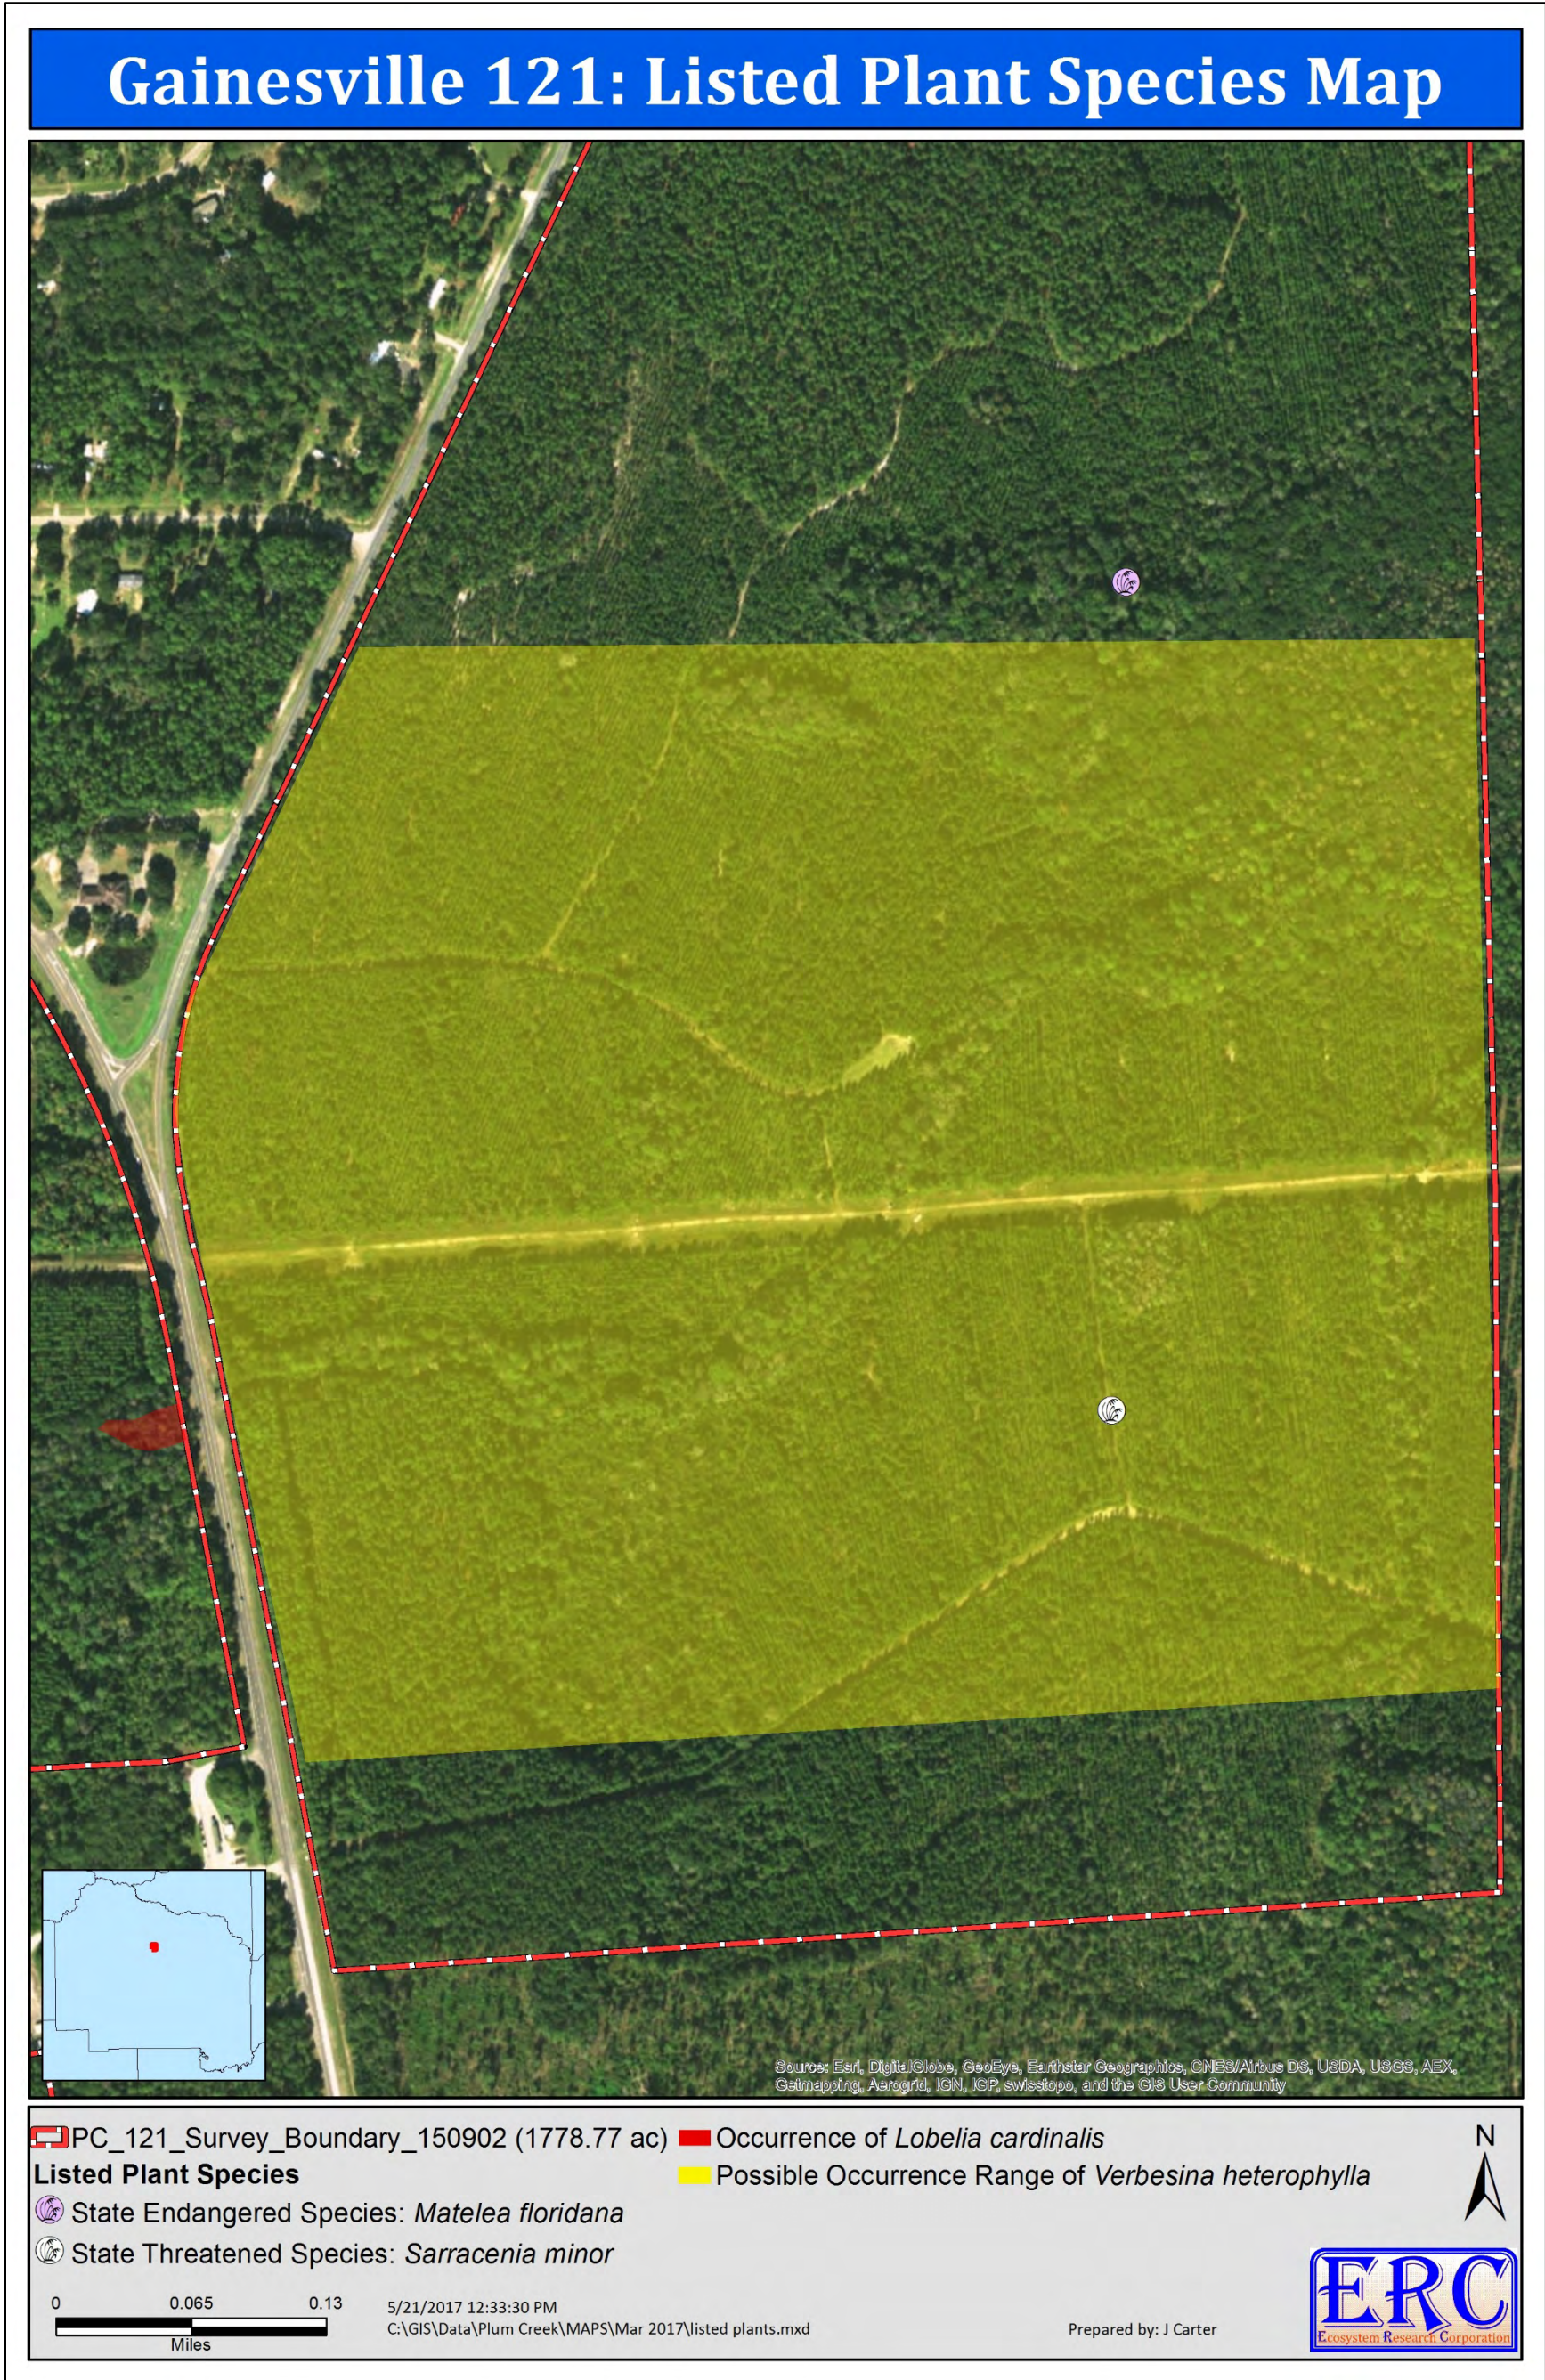
Figure 56. Distribution of listed plant species on the Project Site.

There were four (4) imperiled plant species found on the Project Site as shown on **Figure 56**. All listed plant species observations were recorded in the northeast area of the Project Site. These include Florida spiny pod (*Matelea floridana* [Vail] Woodson; **State Endangered**), cardinalflower (*Lobelia cardinalis* L.; **State Threatened**), and hooded pitcherplant (*Sarracenia minor* Walt.; **State Threatened**). The locations of these species are shown on Figure 56. ERC did identify diverseleaf crownbeard (*Verbesina heterophylla* [Chapm.] A. Gray), a **State Endangered** species, in the general area shown on Figure 56. This plant was collected during a random sampling of plants for identity verification and was an unknown specimen at the time of collection. Therefore, the exact location cannot be verified. The possible occurrence of other listed plant and animal species is discussed within **Section 3.4.2**.

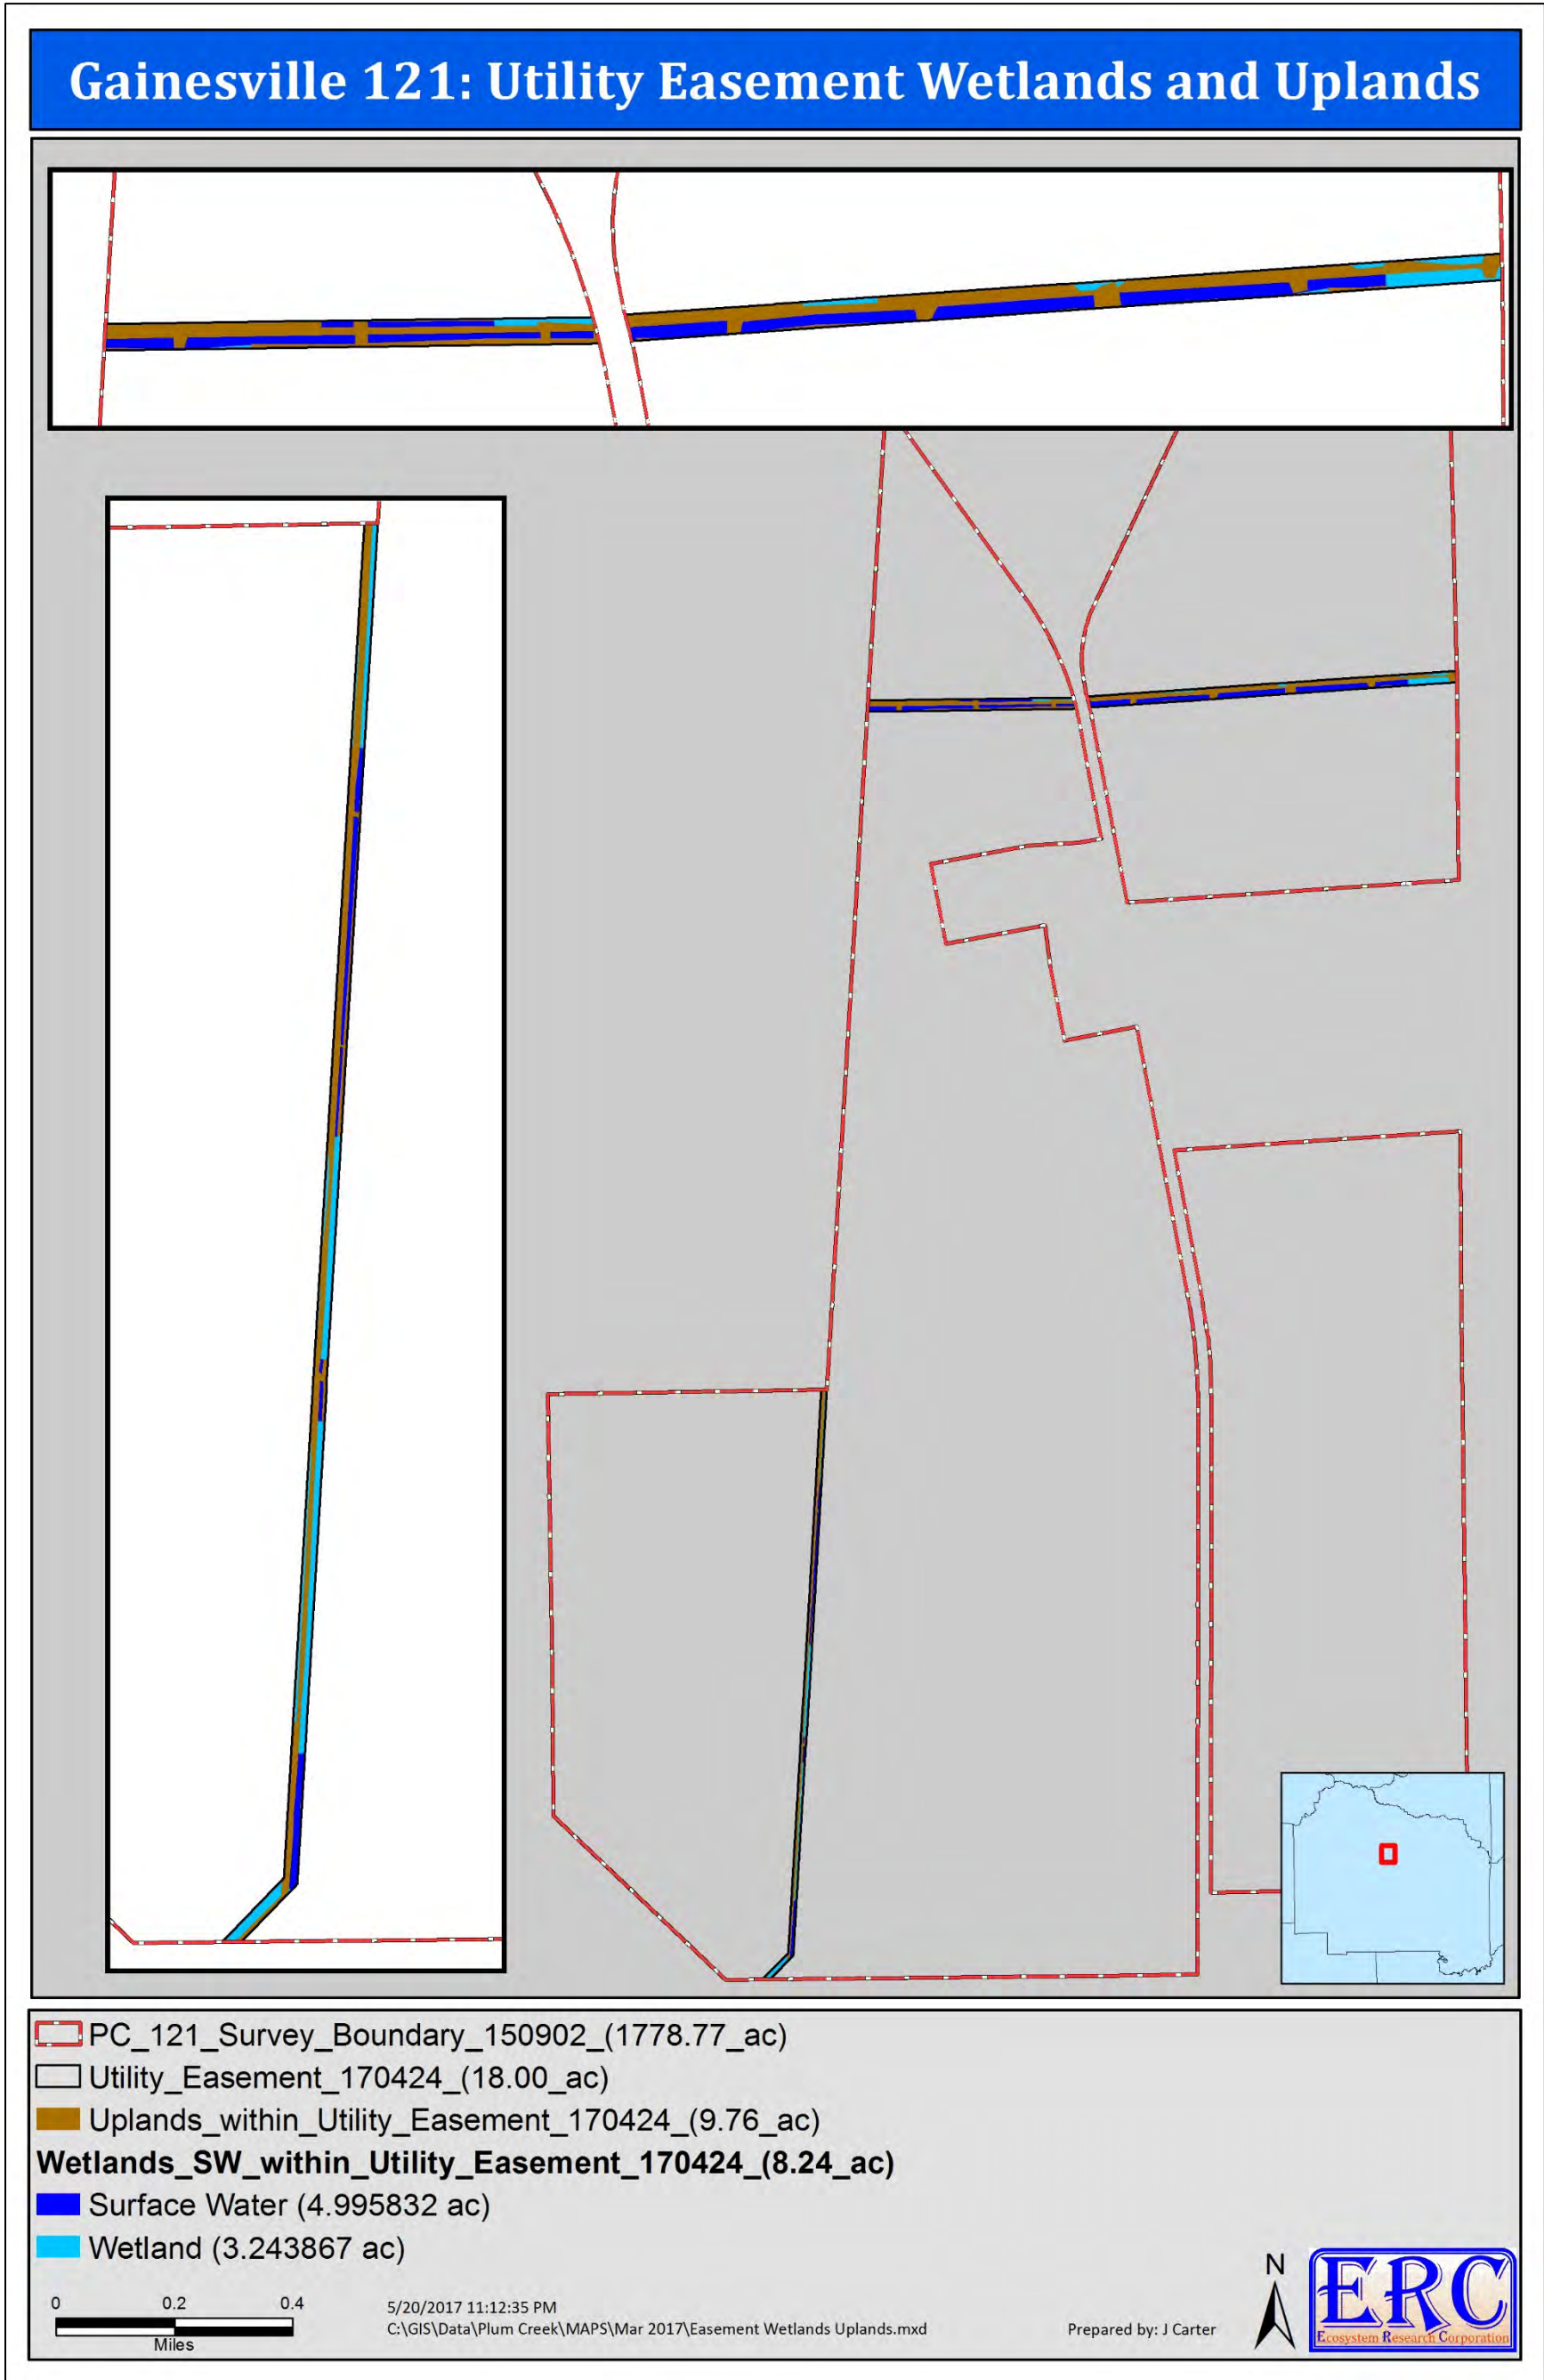
Figure 70. Plant communities occurring within the GRU electric transmission line easement and Florida Natural Gas transmission line easement occurring on the Project Site.

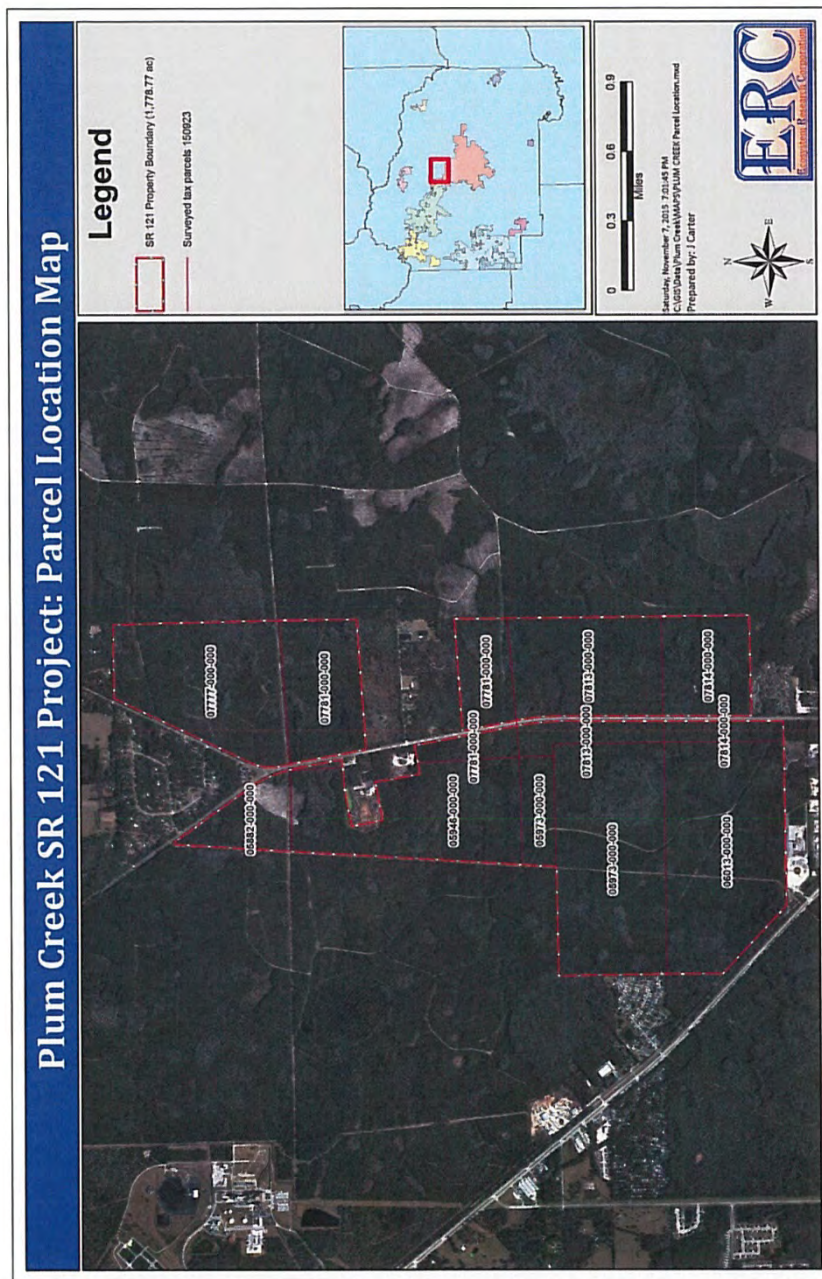
Figure 2. Parcel location map for the Plum Creek SR121 Development project site. The Resource Assessment Area and Planning Parcel are represented by the Project Site boundary.

The Planning Parcel for the project is equivalent to the Development Site boundary and consists of nine (9) Alachua County tax parcels, which total ±1778.77 acres (**Figure 2**). The proposed Development Site and Planning Parcel is contained within the following parcels described with associated acreages, as follows:

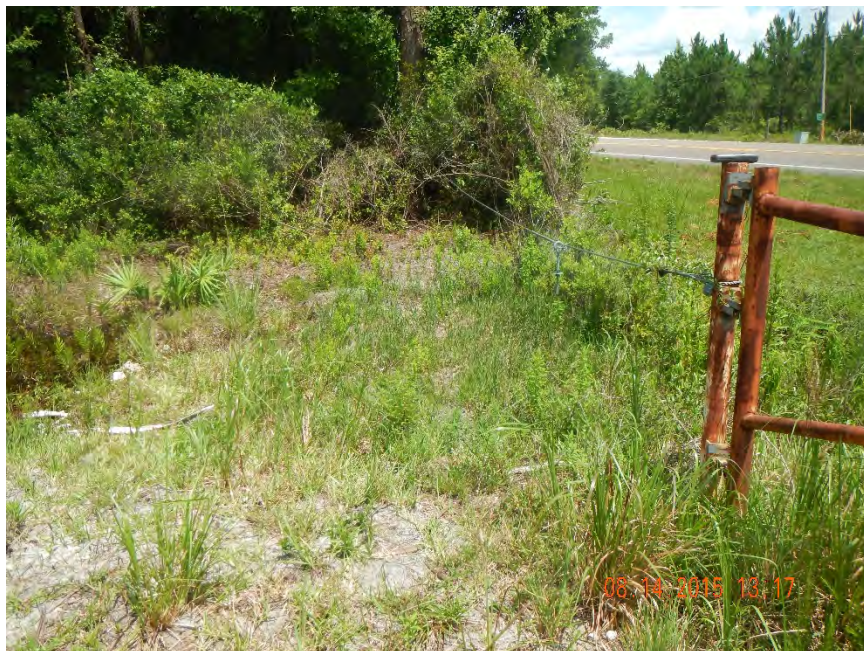
Photo 1. Berm located at GPS location 4 (Frame 7355; 08/14/15).

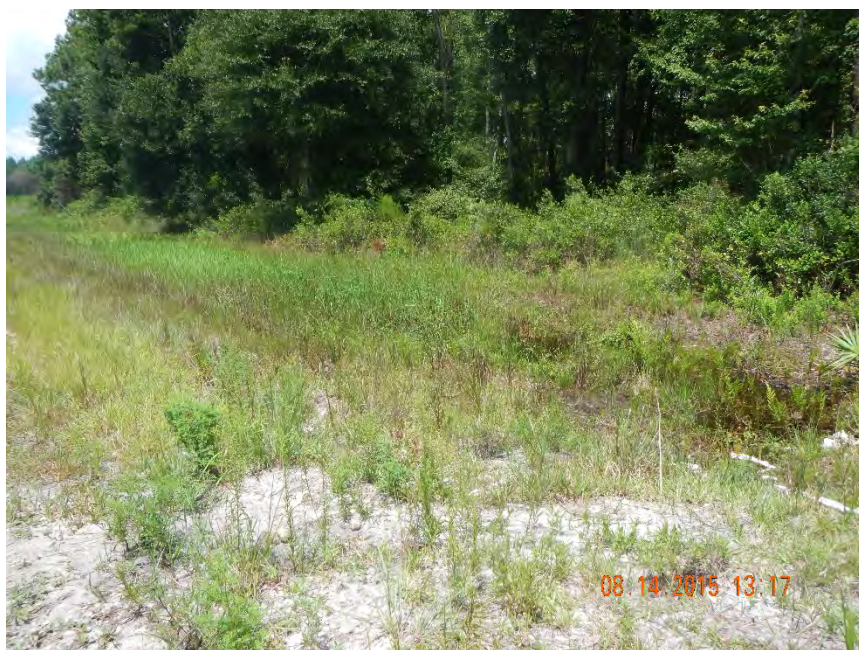
Photo 2. Power line ditch located at GPS location 4 (Frame 7356; 08/14/15).

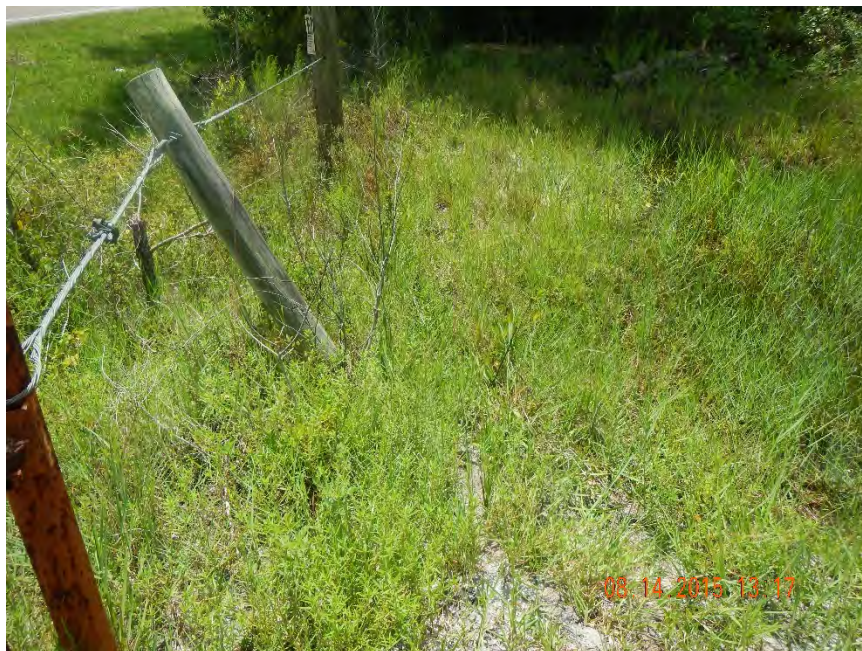
Photo 3. Berm (ditch block) located at GPS location 3 (Frame 7357; 08/14/15).

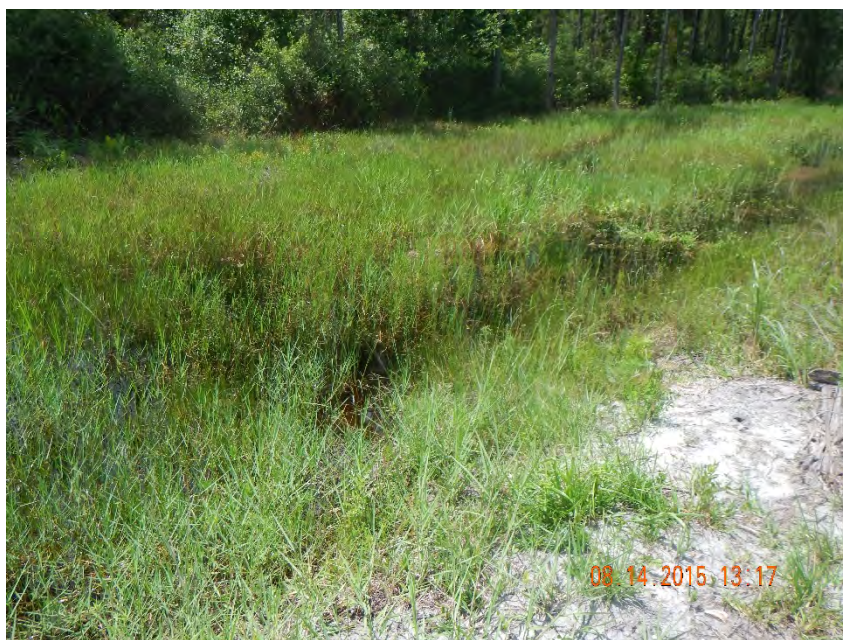
Photo 4. Power line ditch located at GPS location 3 (Frame 7358; 08/14/15).

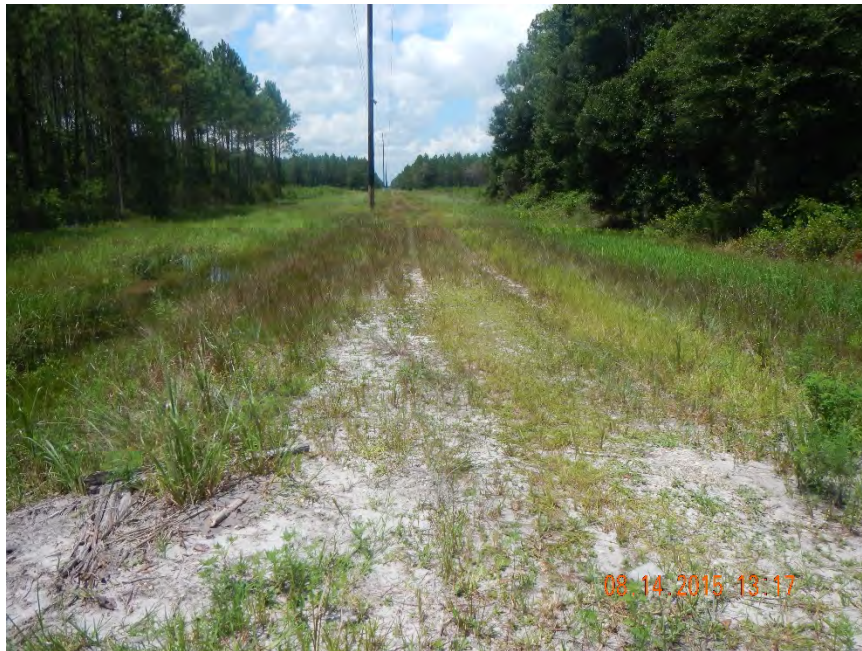
Photo 5. Power line easement as seen looking west from GPS locations 3 and 4 (Frame 7359; 08/14/15).

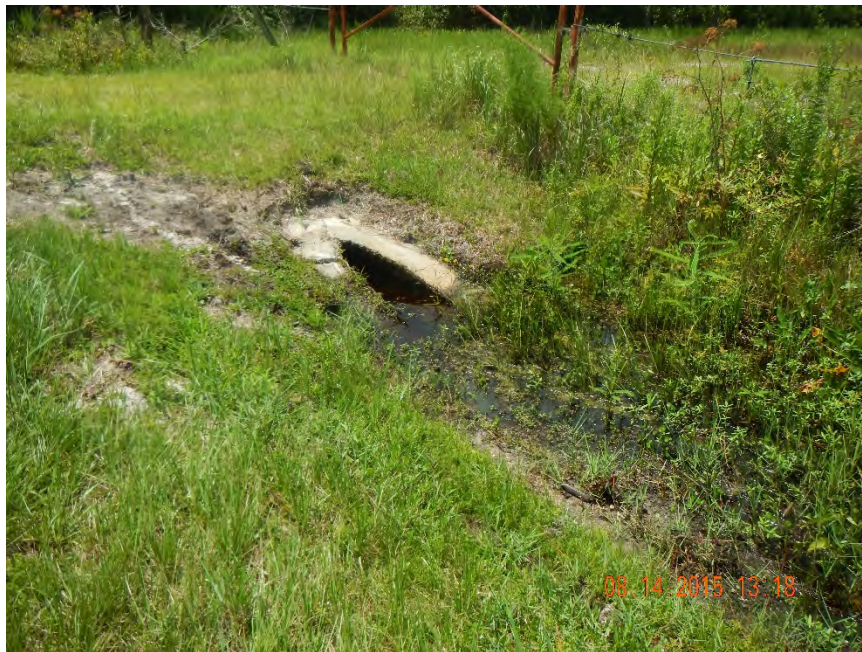
Photo 6. Culvert located on south side of GPS location 2 (Frame 7360; 08/14/15).

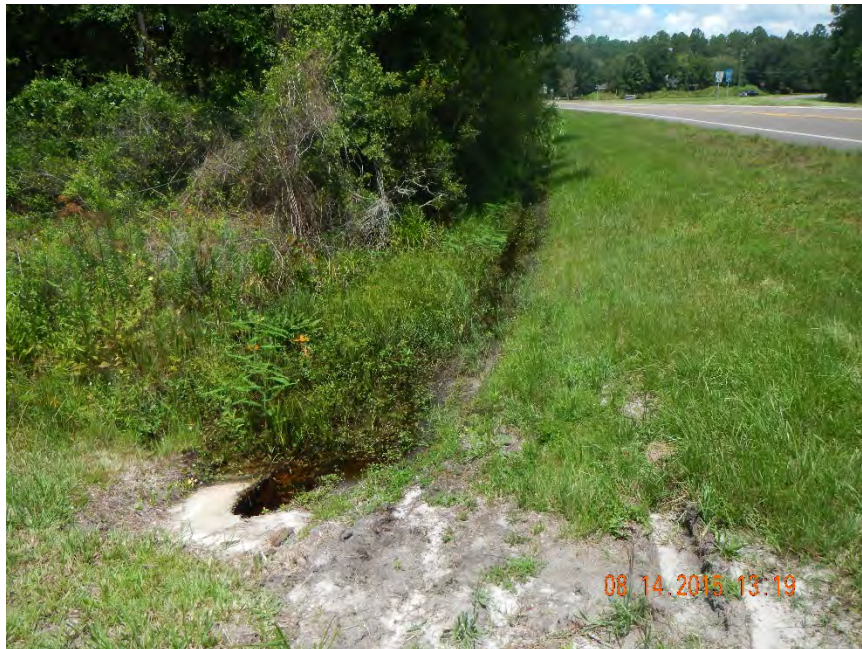
Photo 7. Culvert and ditch located on north side of GPS location 2 (Frame 7361; 08/14/15).

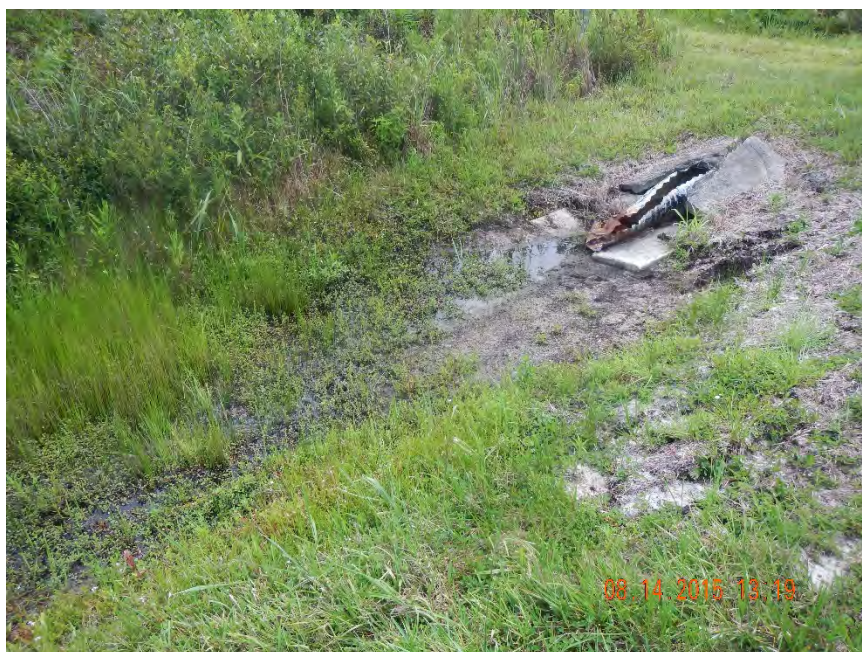
Photo 8. Culvert located on south side of GPS location 1 (Frame 7362; 08/14/15).

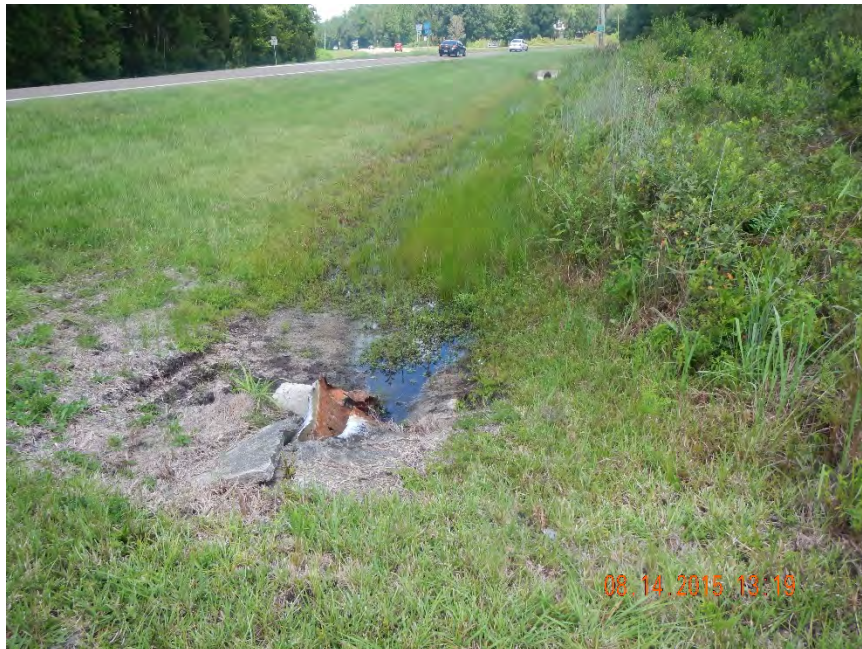
Photo 9. Culvert and ditch located on north side of GPS location 1 (Frame 7363; 08/14/15).

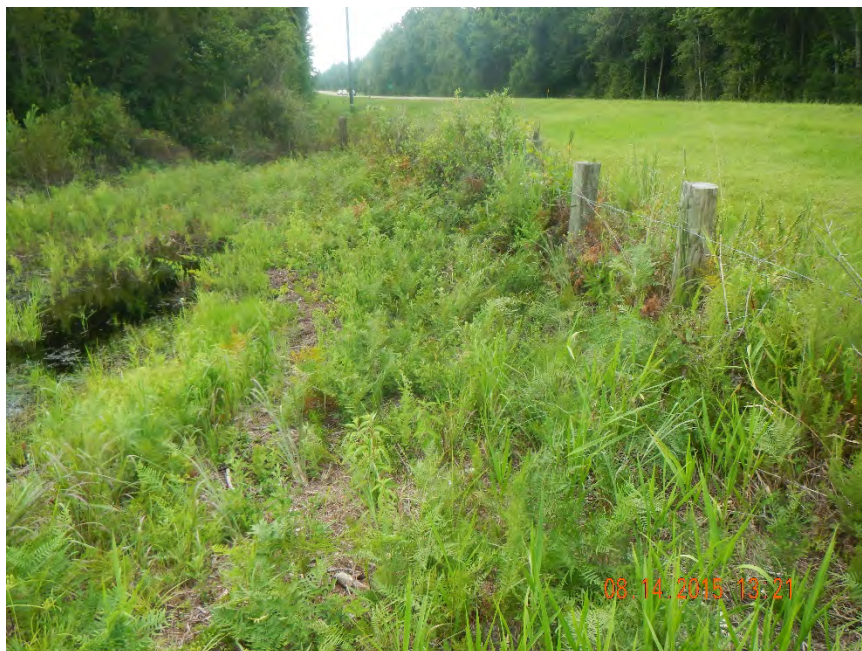
Photo 10. Berm (ditch block) located at GPS location 5 as seen looking south (Frame 7364; 08/14/15).

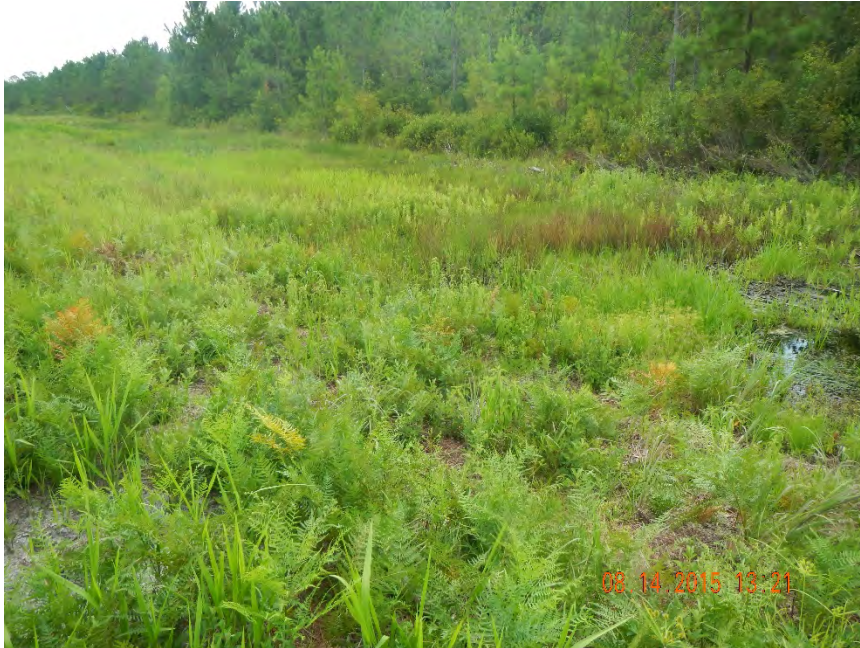
Photo 11. Power line ditch as seen looking east from GPS location 5 (Frame 7365; 08/14/15).
