Natural Area Resource Assessment of the Gainesville 121 Project Site

Provided in support of a current
application for Planned Development

City of Gainesville, Florida

Ecosystem Research Corporation
2906 NW 142 Avenue
Gainesville, FL 32609

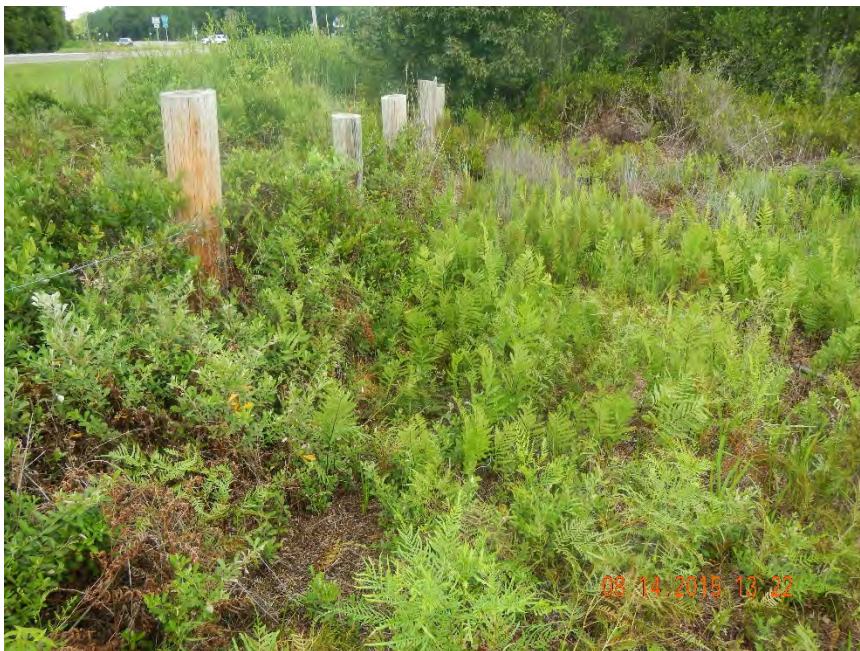
Photo 12. Berm as seen looking north from GPS location 6 (Frame 7366; 08/14/15).

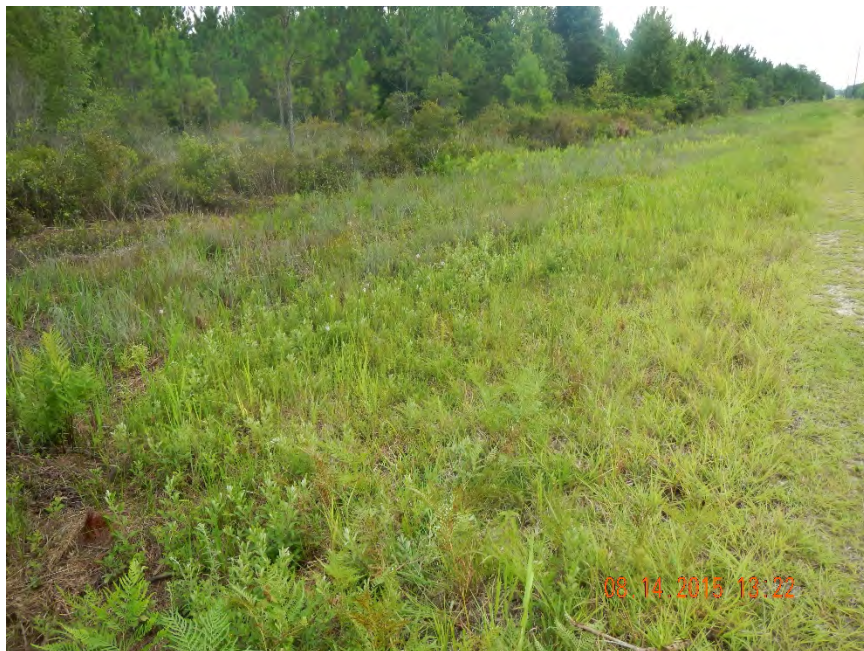
Photo 13. Power line ditch as seen looking east from GPS location 6 (Frame 7367; 08/14/15).

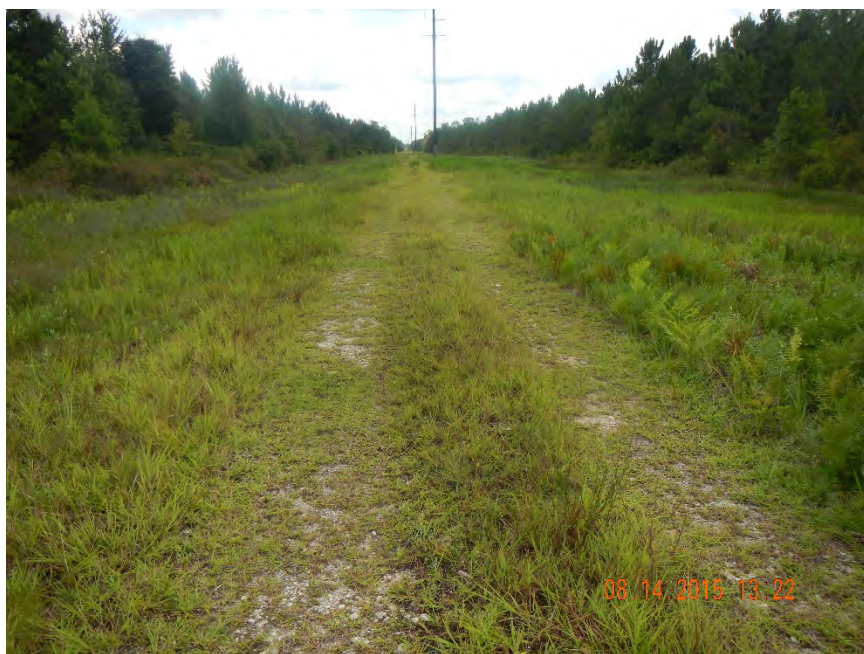
Photo 14. Power line easement as seen looking east from GPS locations 5 and 6 (Frame 7368; 08/14/15).

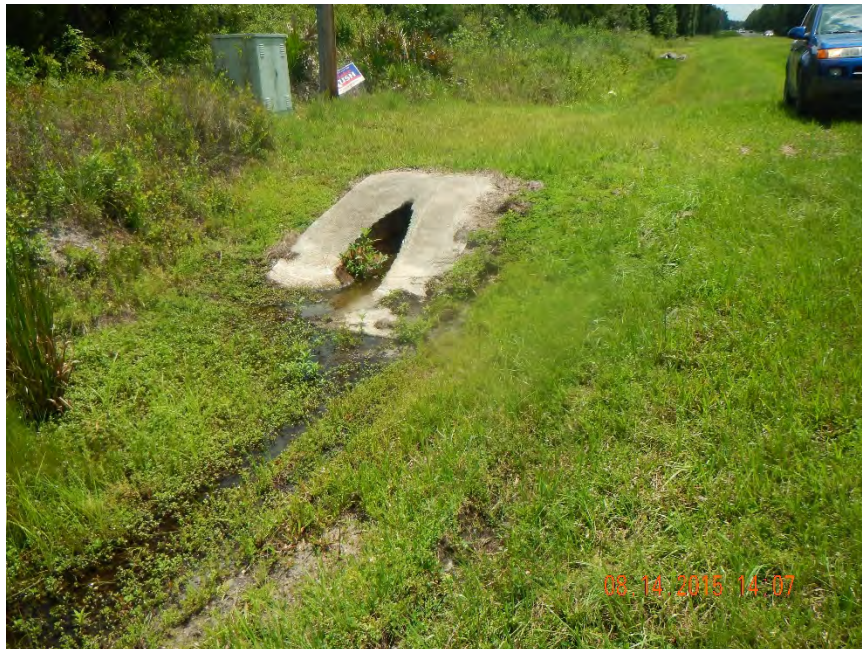
Photo 15. Culvert as seen looking south from GPS location 7 (Frame 7369; 08/14/15).

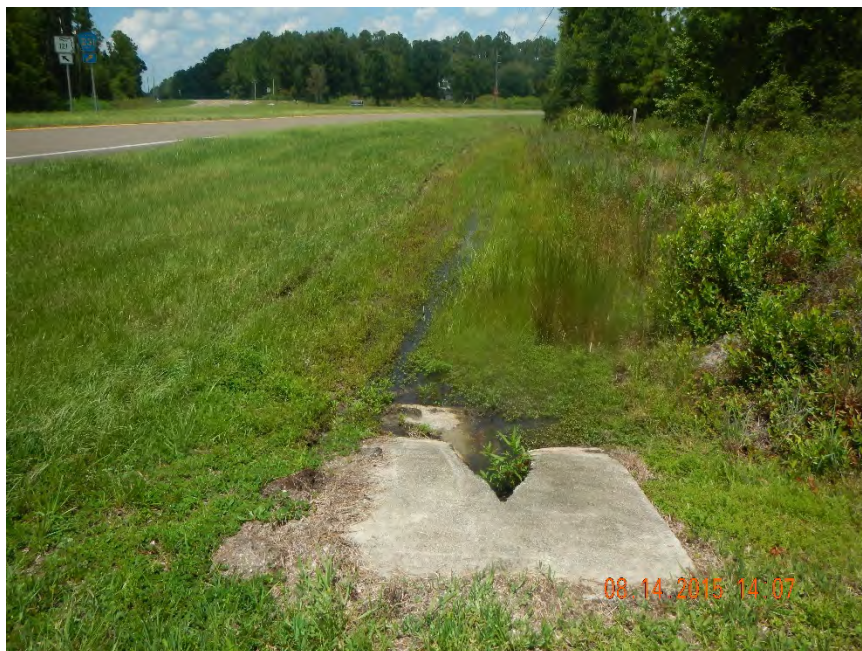
Photo 16. Culvert and ditch as seen looking north from GPS location 7 (Frame 7370; 08/14/15).

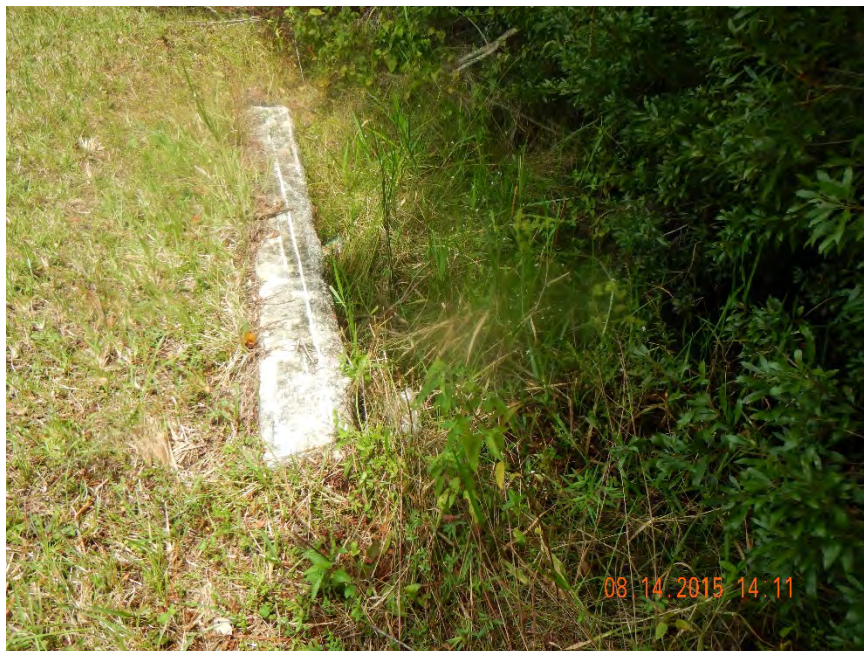
Photo 17. Culvert headwall as seen looking north from GPS location 8 (Frame 7371; 08/14/15).

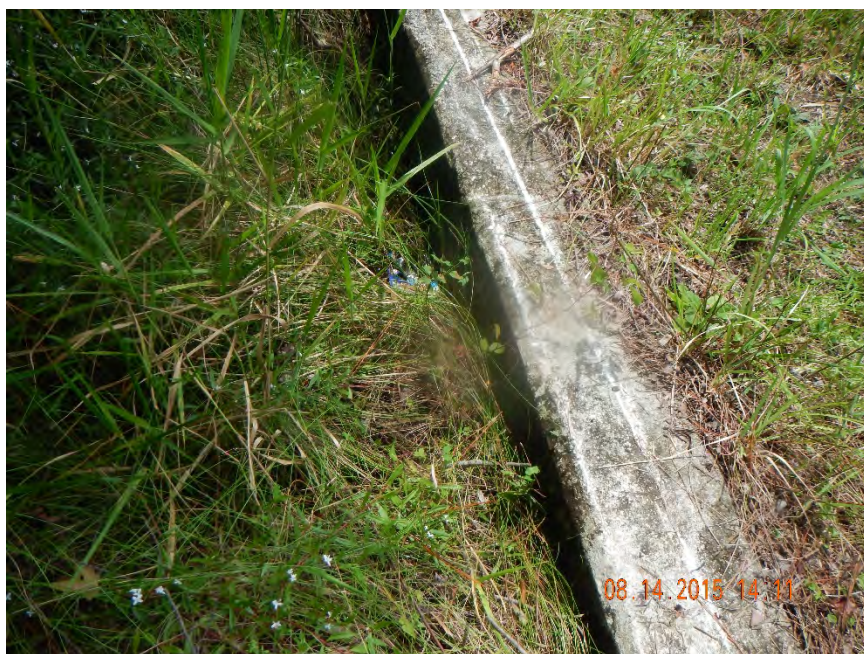
Photo 18. Culvert headwall at GPS location 8 (Frame 7372; 08/14/15).

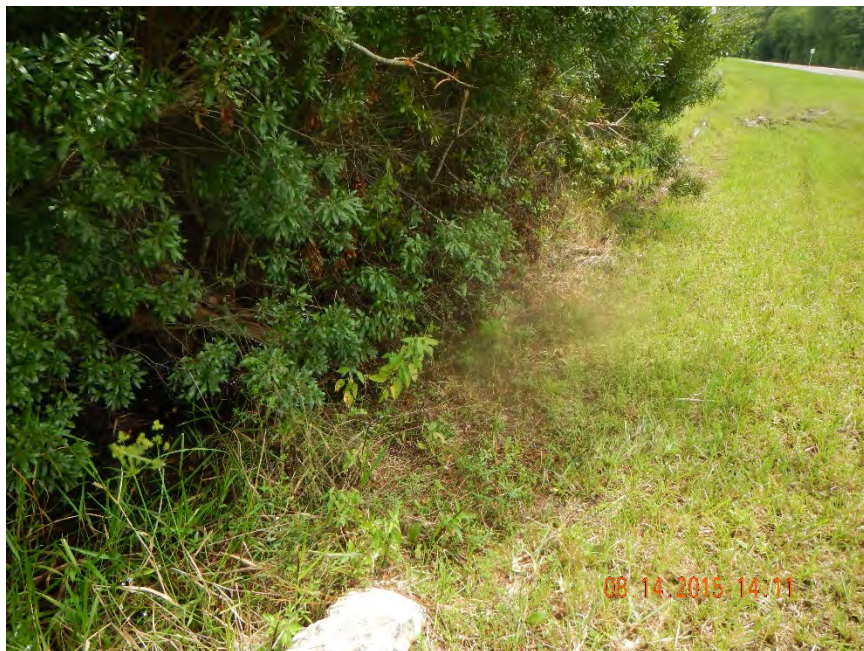
Photo 19. Ditch as seen looking south from GPS location 8 (Frame 7373; 08/14/15).

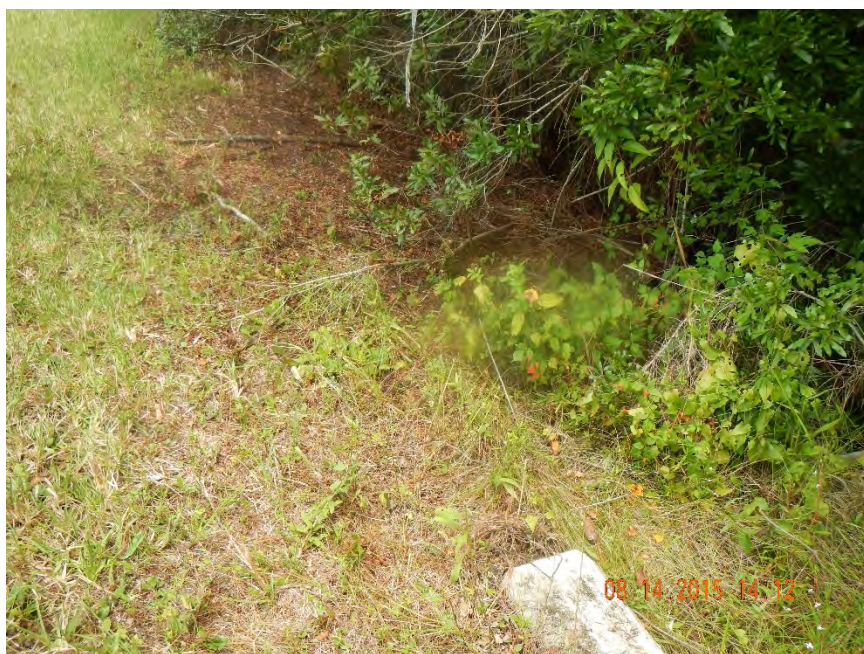
Photo 20. Ditch as seen looking north from GPS location 8 (Frame 7374; 08/14/15).

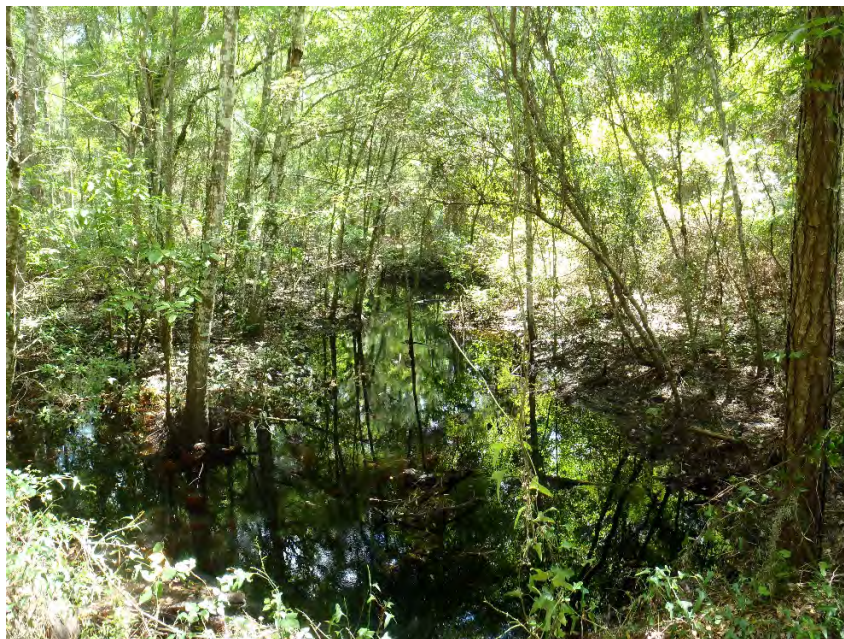
Photo 21. Excavated canal within Wetland: Mixed Oak-Hardwoods-Successional community located south of GPS location 9 (Frames 1486-1487; 08/14/15).

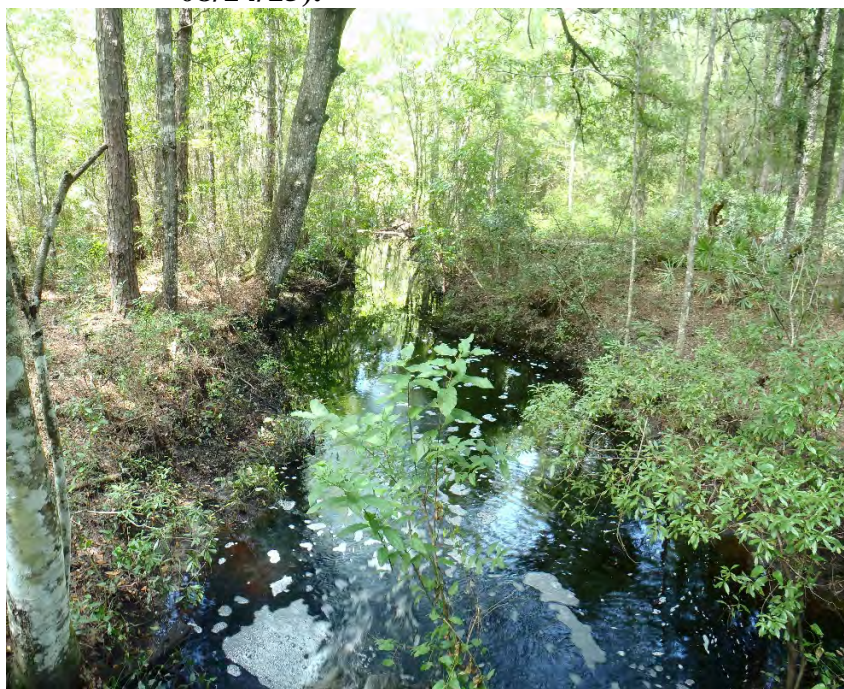
Photo 22. Excavated canal within Wetland: Mixed Oak-Hardwoods-Successional community located north of GPS location 9 (Frames 1488-1489; 08/14/15).

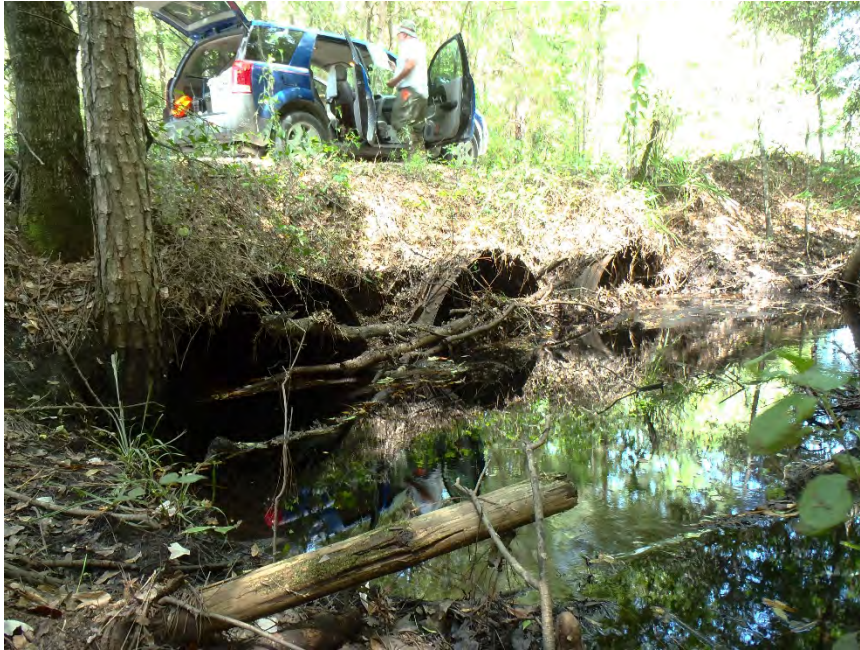
Photo 23. View of three culverts as seen at GPS location 9 (Frame 1490; 08/14/15).

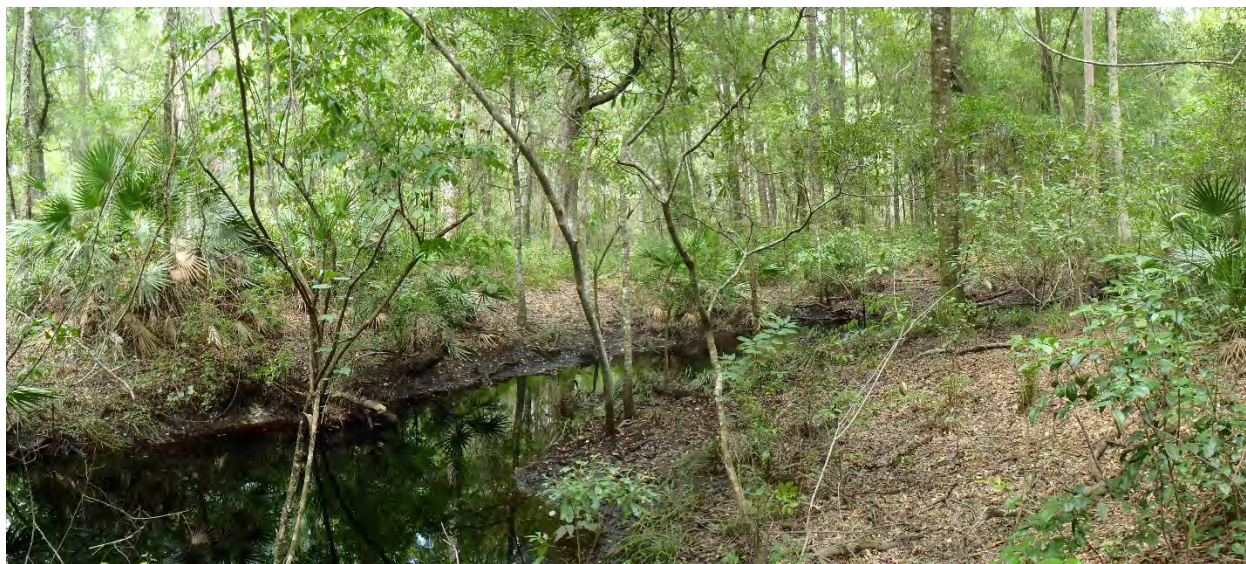
Photo 26. View of Surface Water: Excavated Creek in Wetland as seen looking east from GPS location 23 (Frames 1495-1496; 08/14/15).

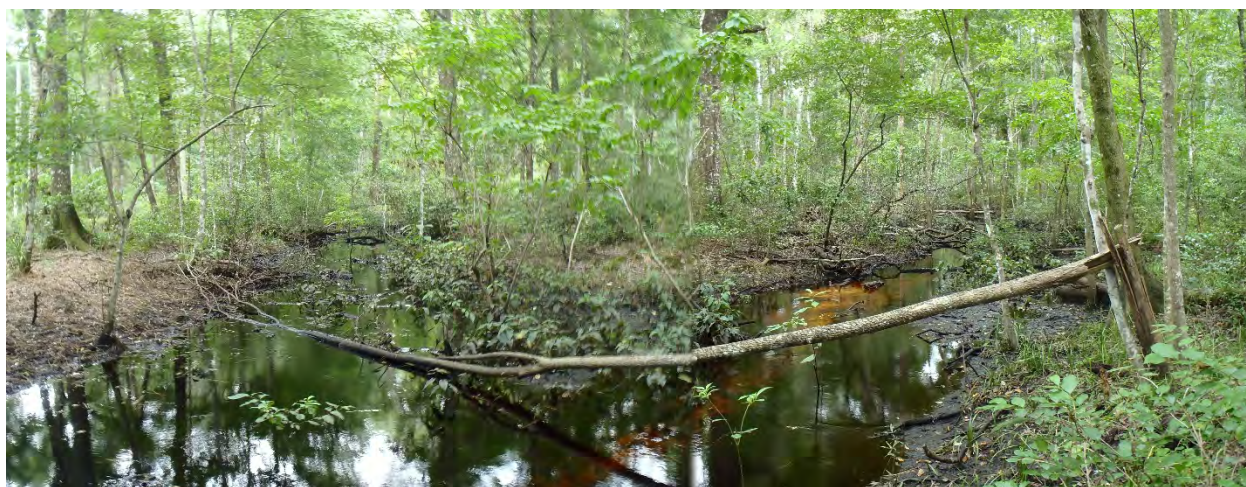
Photo 31. View of Surface Water: Excavated Creek in Wetland as seen looking east from GPS location 51 (Frames 1504-1505; 08/14/15).

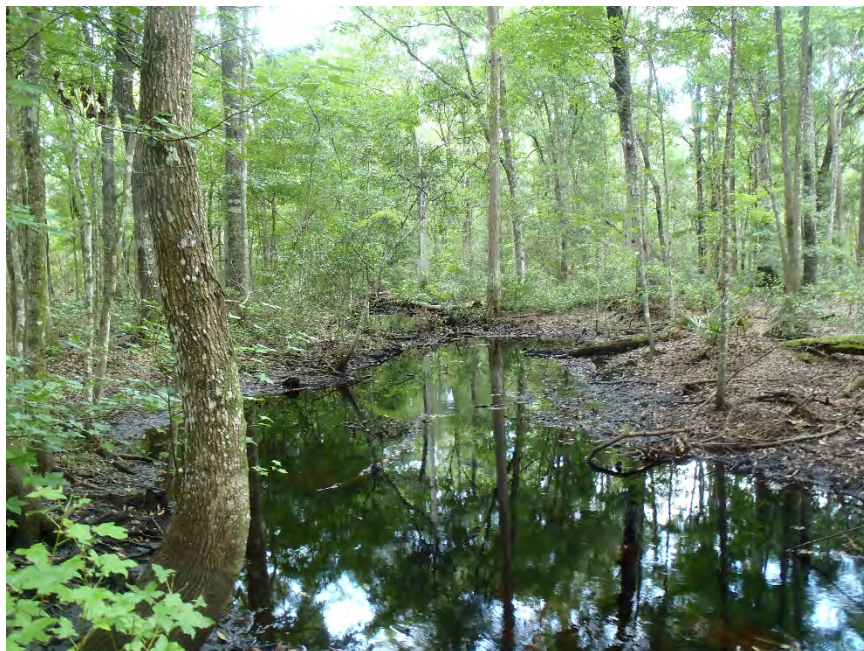
Photo 32. View of Surface Water: Excavated Creek in Wetland as seen looking north from GPS location 51 (Frame 1506; 08/14/15).

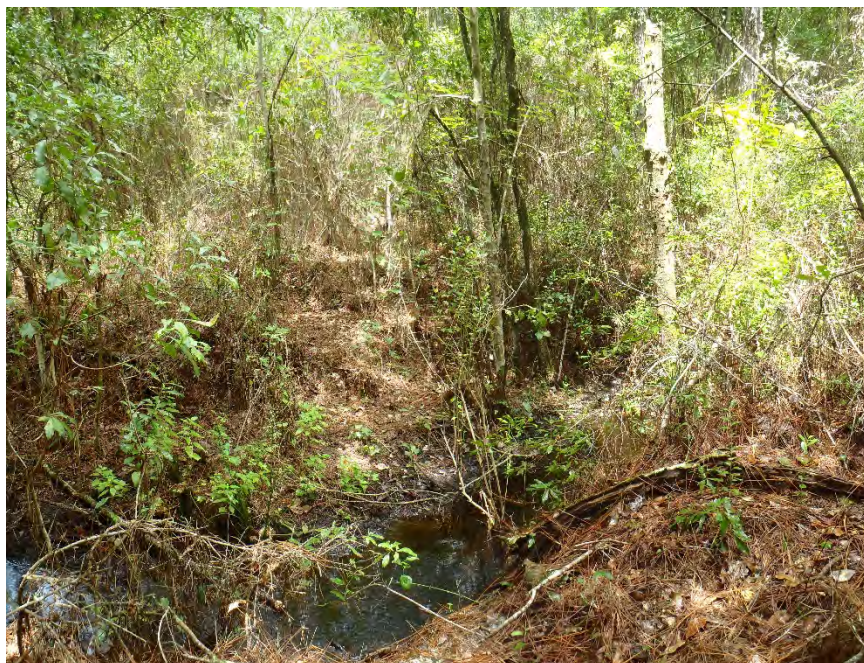
Photo 37. View of Surface Water: Excavated Creek in Wetland as seen looking north from GPS location 168 (Frames 1515-1516; 08/17/15).

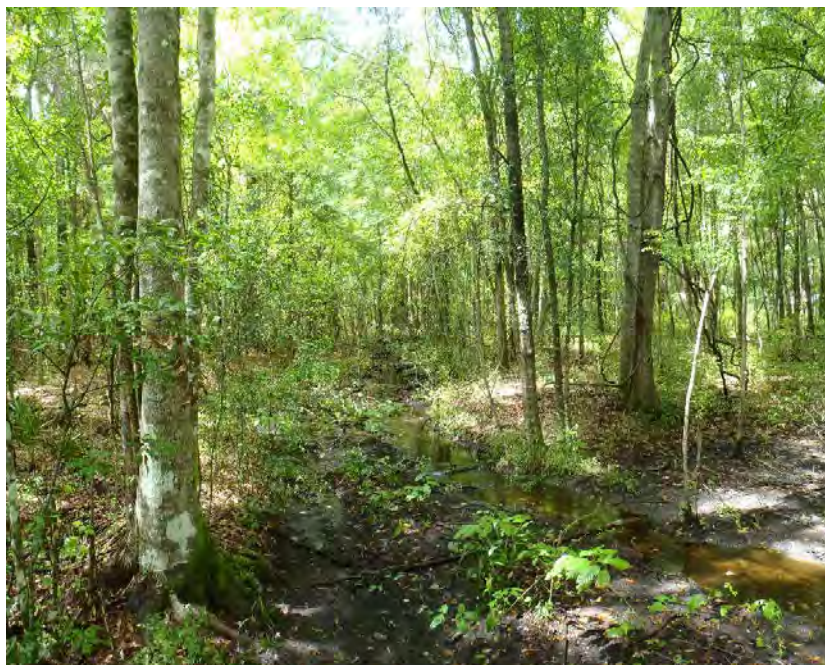
Photo 41. View of Surface Water: Excavated Creek in Wetland as seen looking northwest from GPS location 198 (Frames 1523-1524; 08/17/15).

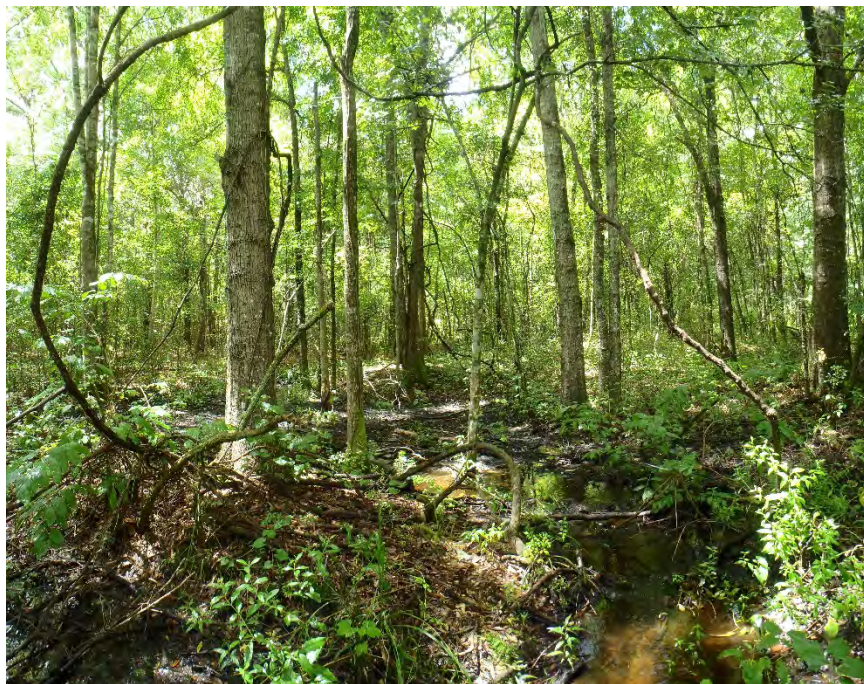
Photo 42. View of Surface Water: Excavated Creek in Wetland as seen looking west from GPS location 200 (Frames 1525-1526; 08/17/15).

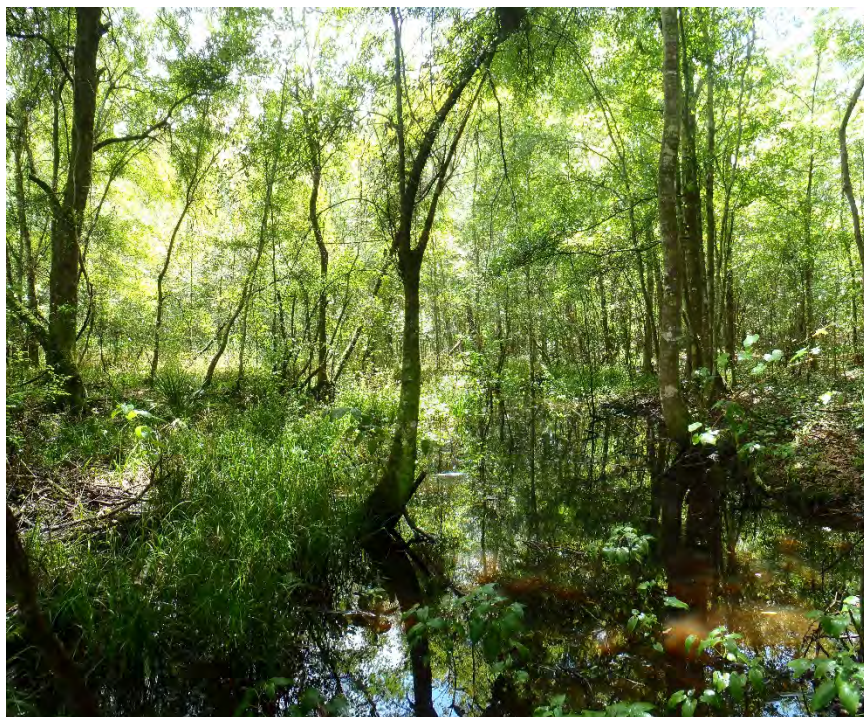
Photo 43. View of Surface Water: Excavated Creek in Wetland as seen looking south from GPS location 200 (Frames 1527-1528; 08/17/15).

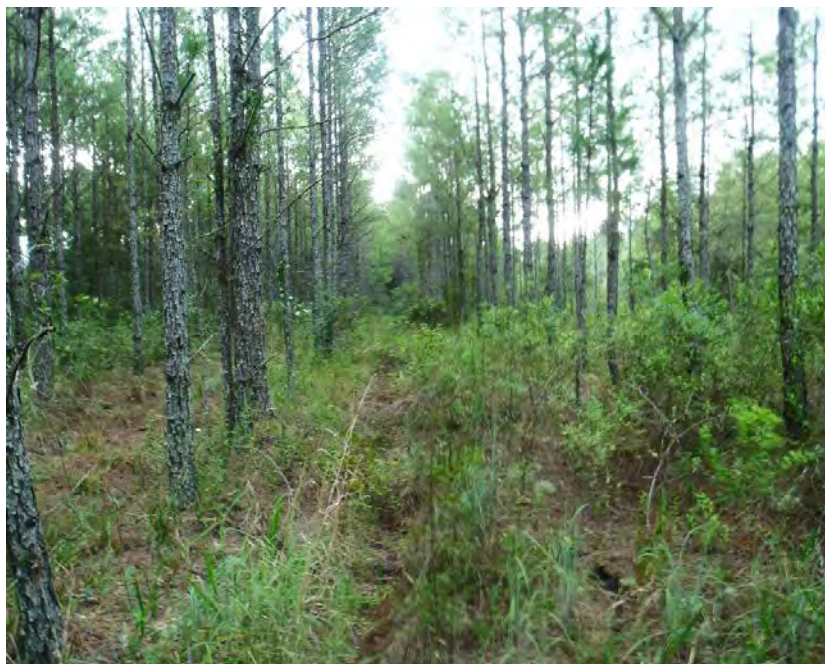
Photo 47. View of Wetland: Mixed Shrubs & Vines, Undetermined Boundary, as seen looking east from GPS location 263 (Frames 1536-1537; 08/17/15).

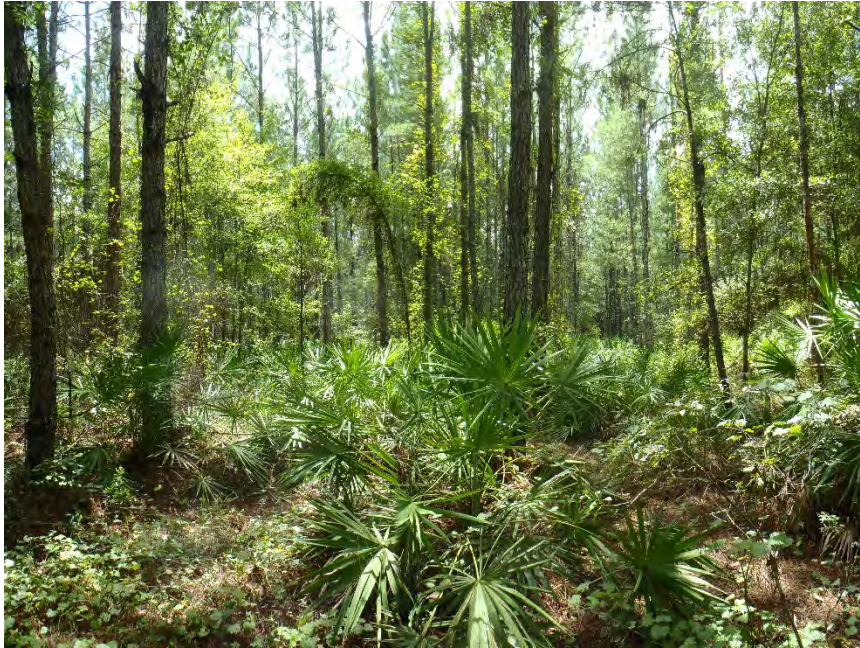
Photo 48. View of Mesic: Planted Pine-Mesic Pine Flatwoods as seen looking south from GPS location 282 (Frames 1530-1532; 08/17/15).

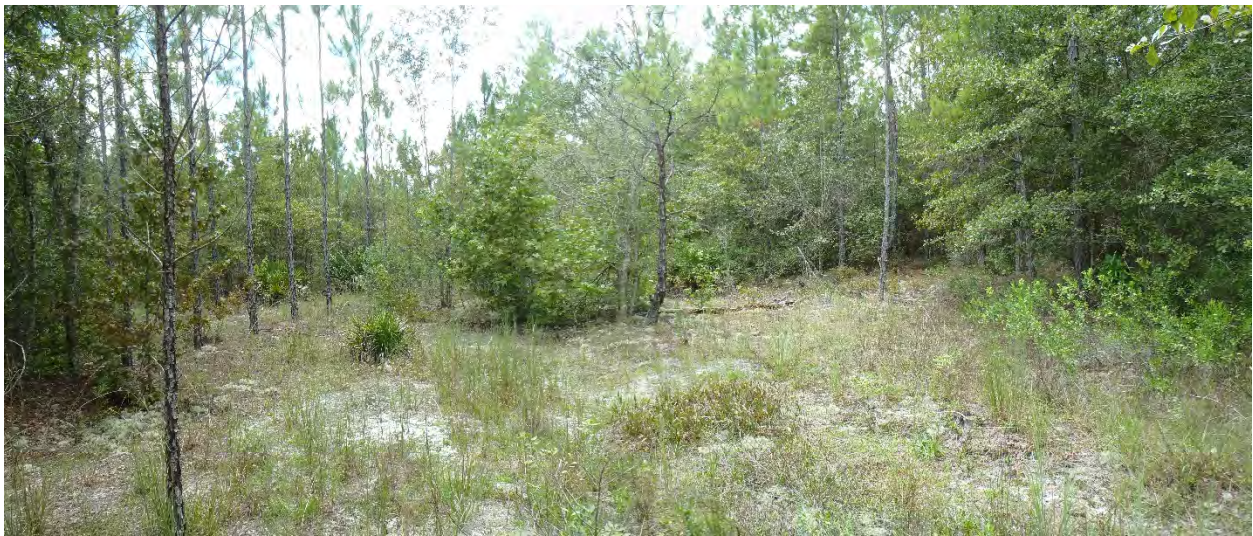
Photo 49. View of Mesic: Mixed Shrubs & Vines community as seen looking southwest from GPS location 300 (Frames 1542-1543; 08/18/15).

Photo 43.	View of Surface Water: Excavated Creek in Wetland as seen looking south from GPS location 200 (Frames 1527-1528; 08/17/15).	274
Photo 44.	View of Mixed Hardwood Swamp as seen looking east from GPS location 201 (Frames 1529-1530; 08/17/15).	275
Photo 45.	View of Mesic: Planted Pine-Mesic Pine Flatwoods as seen looking east from GPS location 220 (Frames 1531-1533; 08/17/15).....	275
Photo 46.	View of Surface Water: Excavated Creek in Wetland as seen looking north from GPS location 237 (Frames 1534-1535; 08/17/15).	276
Photo 47.	View of Wetland: Mixed Shrubs & Vines, Undetermined Boundary, as seen looking east from GPS location 263 (Frames 1536-1537; 08/17/15).....	276
Photo 48.	View of Mesic: Planted Pine-Mesic Pine Flatwoods as seen looking south from GPS location 282 (Frames 1530-1532; 08/17/15).	277
Photo 49.	View of Mesic: Mixed Shrubs & Vines community as seen looking southwest from GPS location 300 (Frames 1542-1543; 08/18/15).....	277

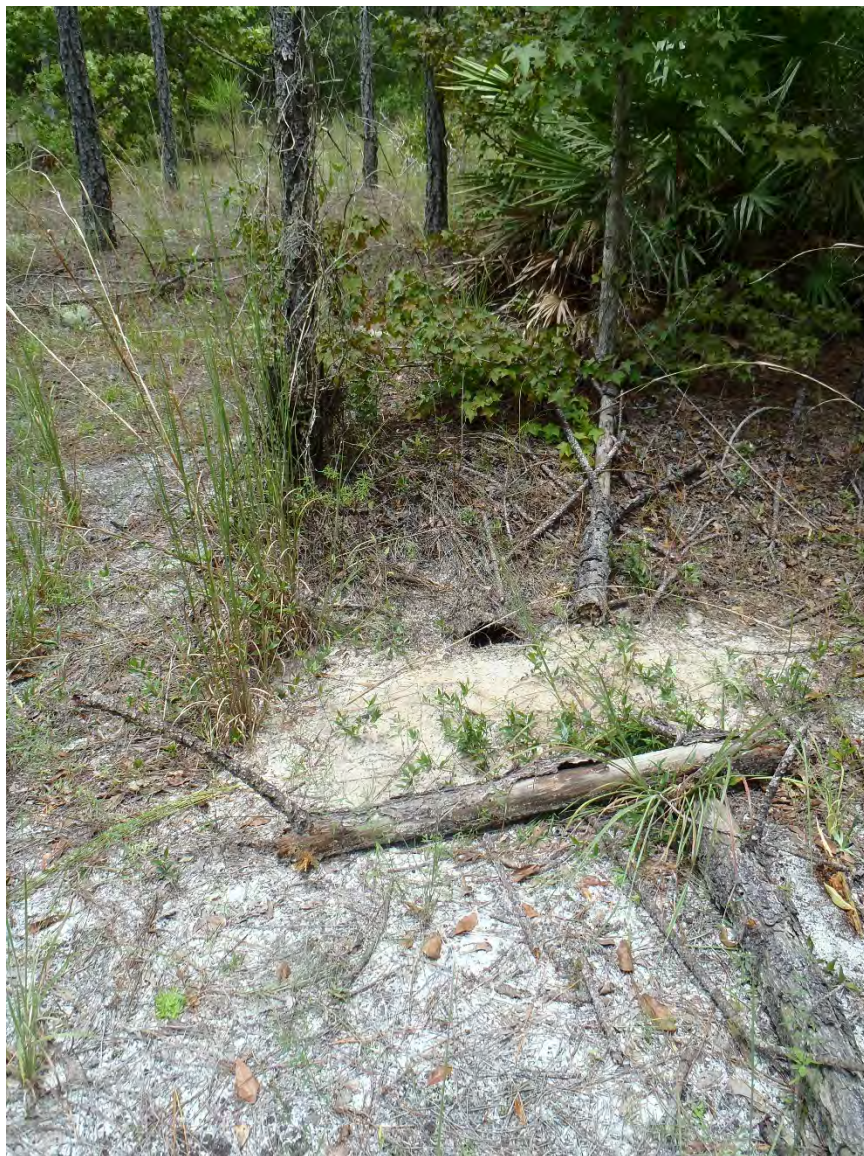
Photo 50. View of gopher tortoise burrow (Inactive, Juvenile) located at GPS location 308 (Frame 1540; 08/18/15).

Photo 50.	View of gopher tortoise burrow (Inactive, Juvenile) located at GPS location 308 (Frame 1540; 08/18/15).	278
Photo 51.	View of gopher tortoise burrow (Potentially Occupied) located at GPS location 323 (Frame 1541; 08/18/15).	279
Photo 52.	View of Planted Pine-Mesic Pine Flatwoods as seen looking northwest from GPS location 327 (Frames 1544-1545; 08/18/15).....	280

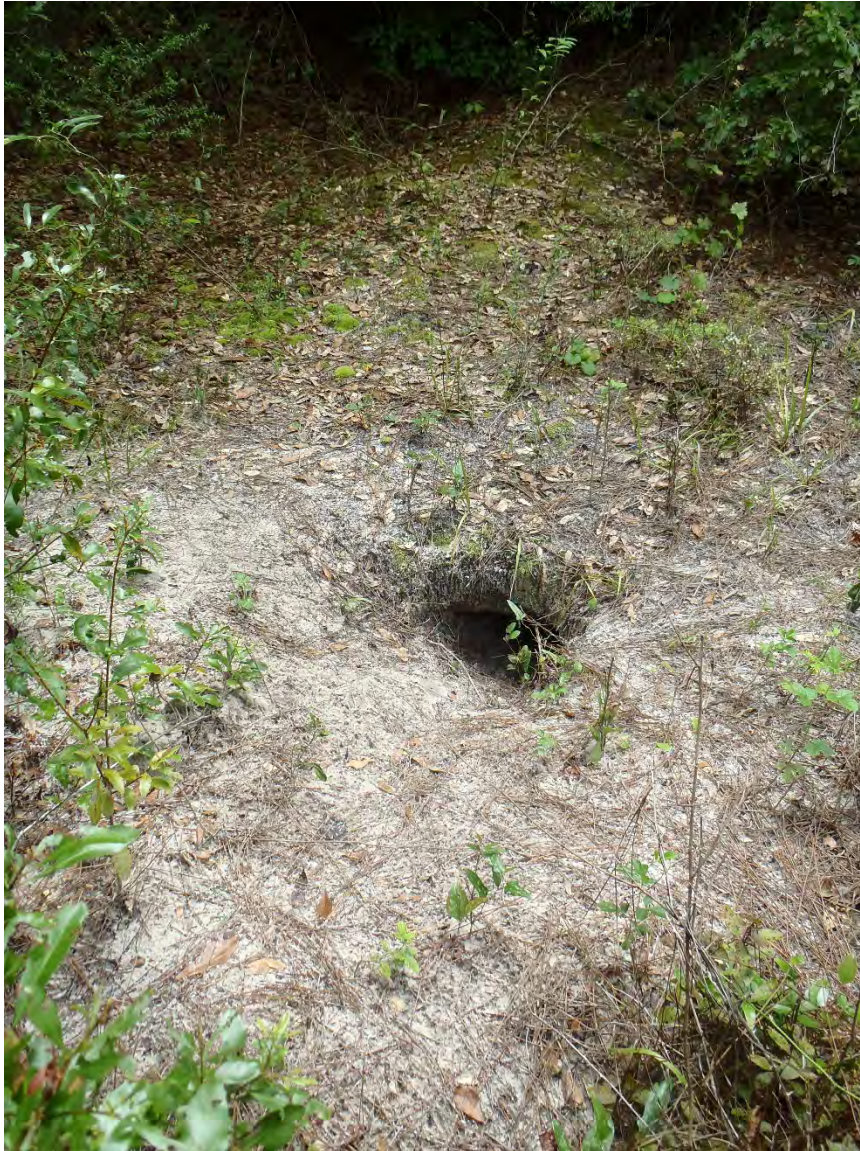
Photo 51. View of gopher tortoise burrow (Potentially Occupied) located at GPS location 323 (Frame 1541; 08/18/15).

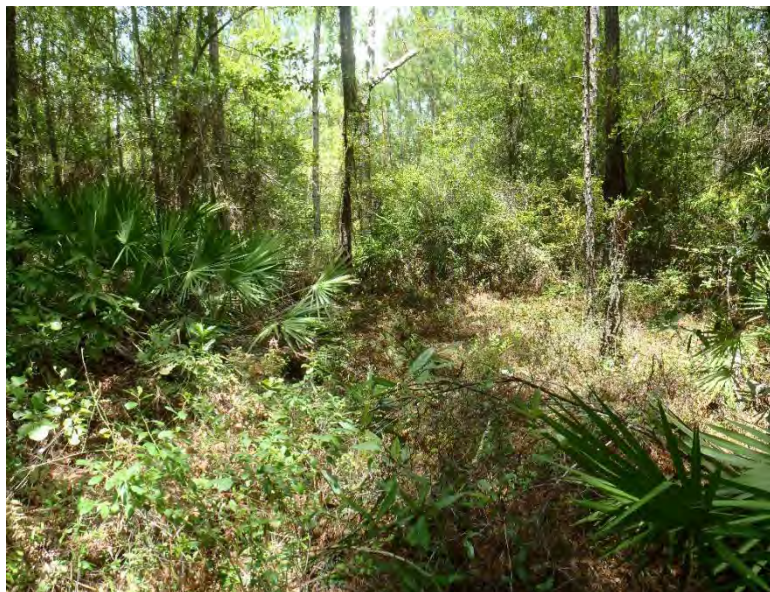
Photo 52. View of Planted Pine-Mesic Pine Flatwoods as seen looking northwest from GPS location 327 (Frames 1544-1545; 08/18/15).

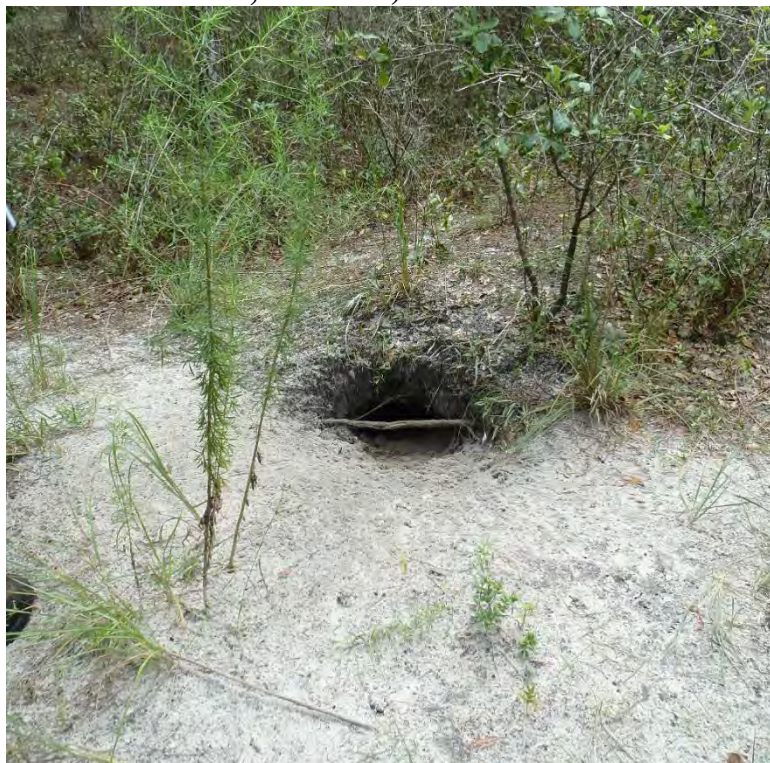
Photo 53. View of gopher tortoise burrow (Active) located at GPS location 336 (Frame 1546; 08/18/15).

Photo 53. View of gopher tortoise burrow (Active) located at GPS location 336 (Frame 1546; 08/18/15).....	280
Photo 54. View of gopher tortoise burrow (Active) located at GPS location 346 (Frame 1547; 08/18/15).....	281
Photo 55. View of gopher tortoise burrow (Active) located at GPS location 351 (Frame 1548; 08/18/15).....	282
Photo 56. View of gopher tortoise burrow (Active) located at GPS location 352 (Frame 1549; 08/18/15).....	283
Photo 57. View of gopher tortoise burrow (Active, Juvenile) located at GPS location 353 (Frame 1550; 08/18/15).....	284
Photo 58. View of Planted Pine-Mesic Pine Flatwoods as seen looking west-northwest from GPS location 364 (Frames 1551-1552; 08/18/15).....	285
Photo 59. View of gopher tortoise burrow (Active, Juvenile) located at GPS location 367 (Frame 1553; 08/18/15).....	285
Photo 60. View of Planted Pine-Mesic Pine Flatwoods as seen looking west from GPS location 372 (Frames 1554-1555; 08/18/15).....	286

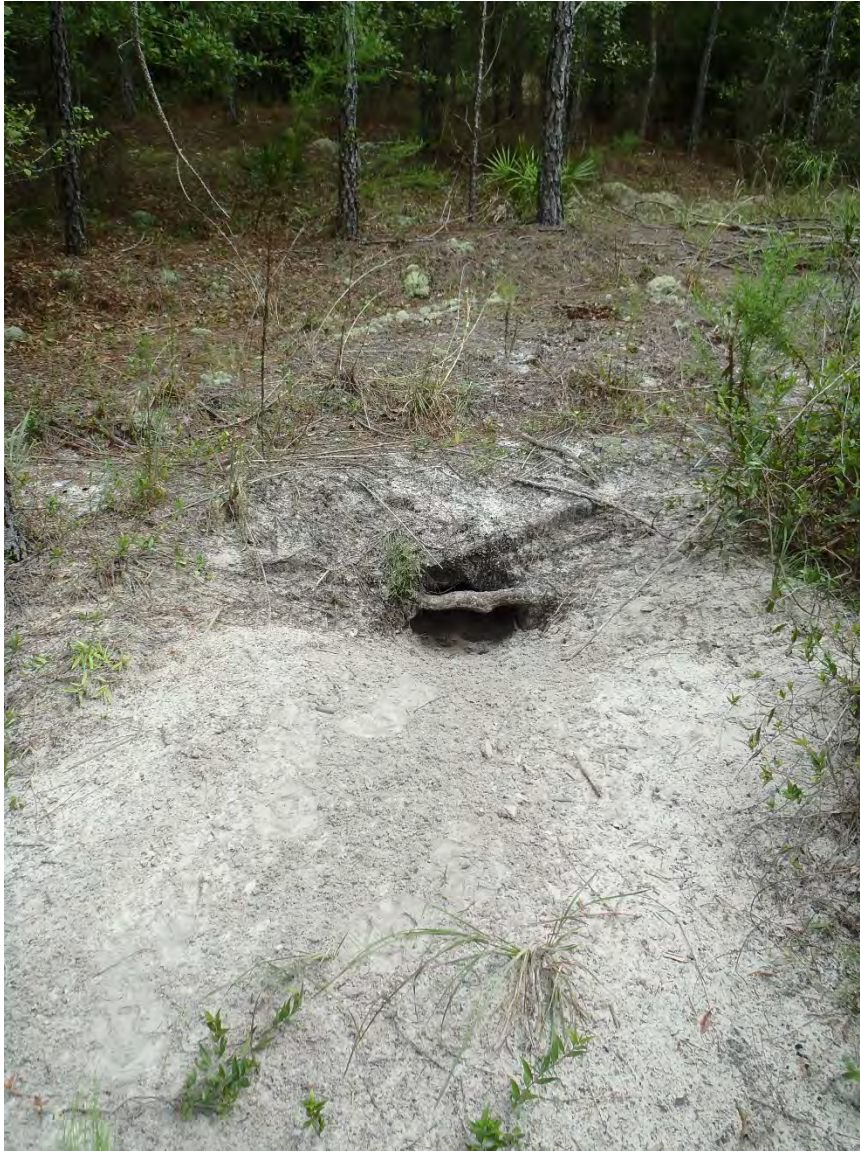
Photo 54. View of gopher tortoise burrow (Active) located at GPS location 346 (Frame 1547; 08/18/15).

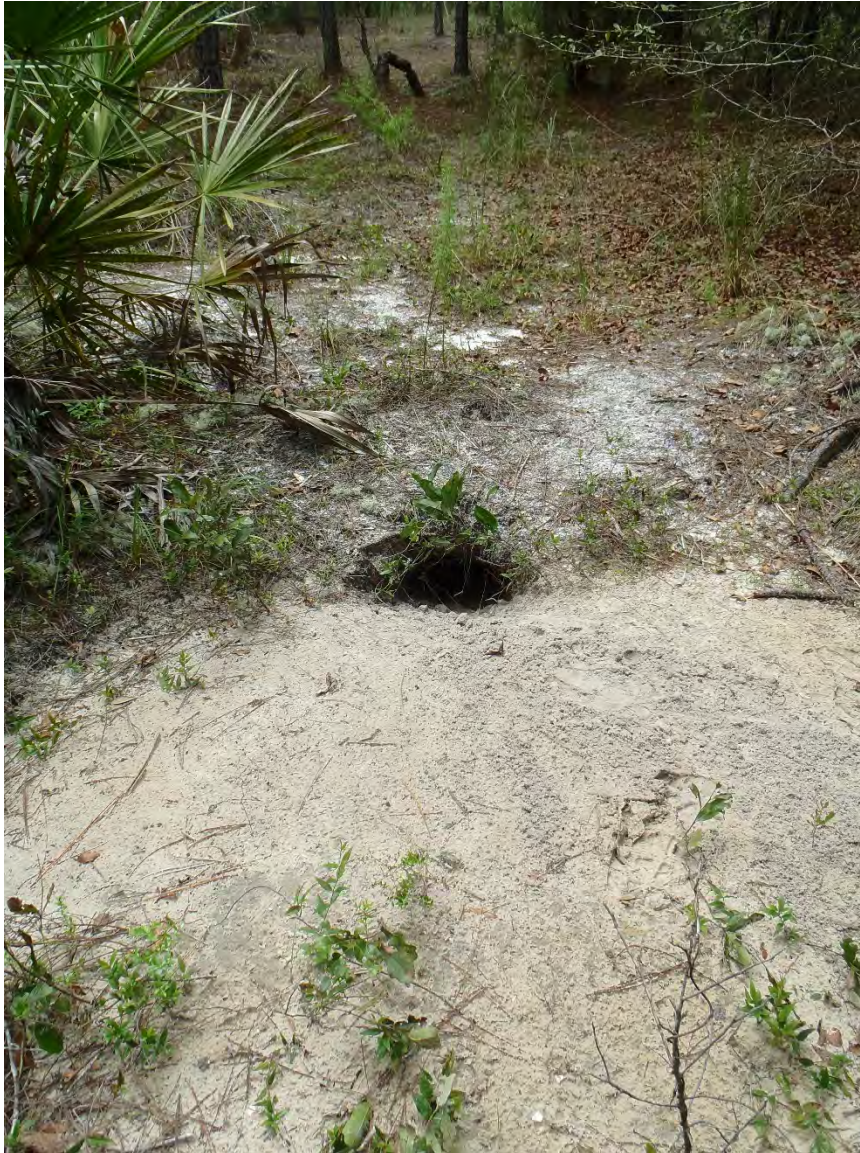
Photo 55. View of gopher tortoise burrow (Active) located at GPS location 351 (Frame 1548; 08/18/15).

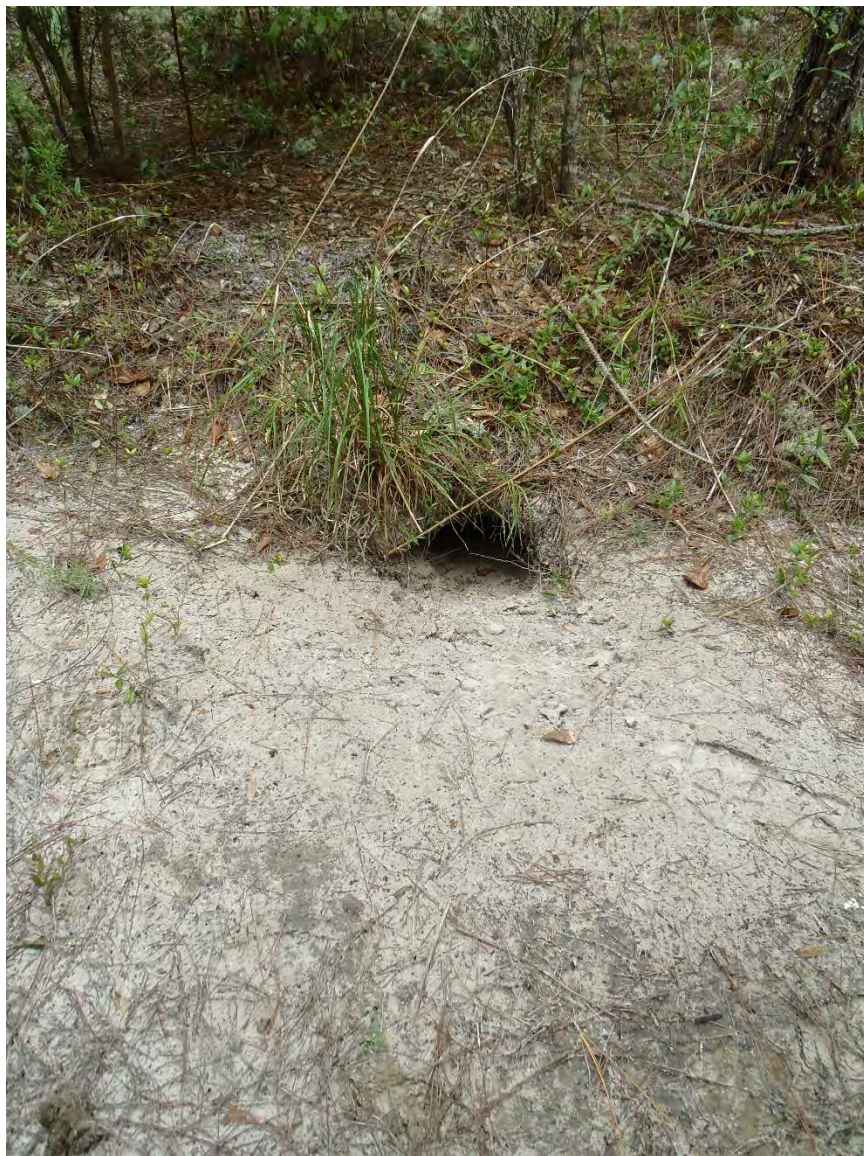
Photo 56. View of gopher tortoise burrow (Active) located at GPS location 352 (Frame 1549; 08/18/15).

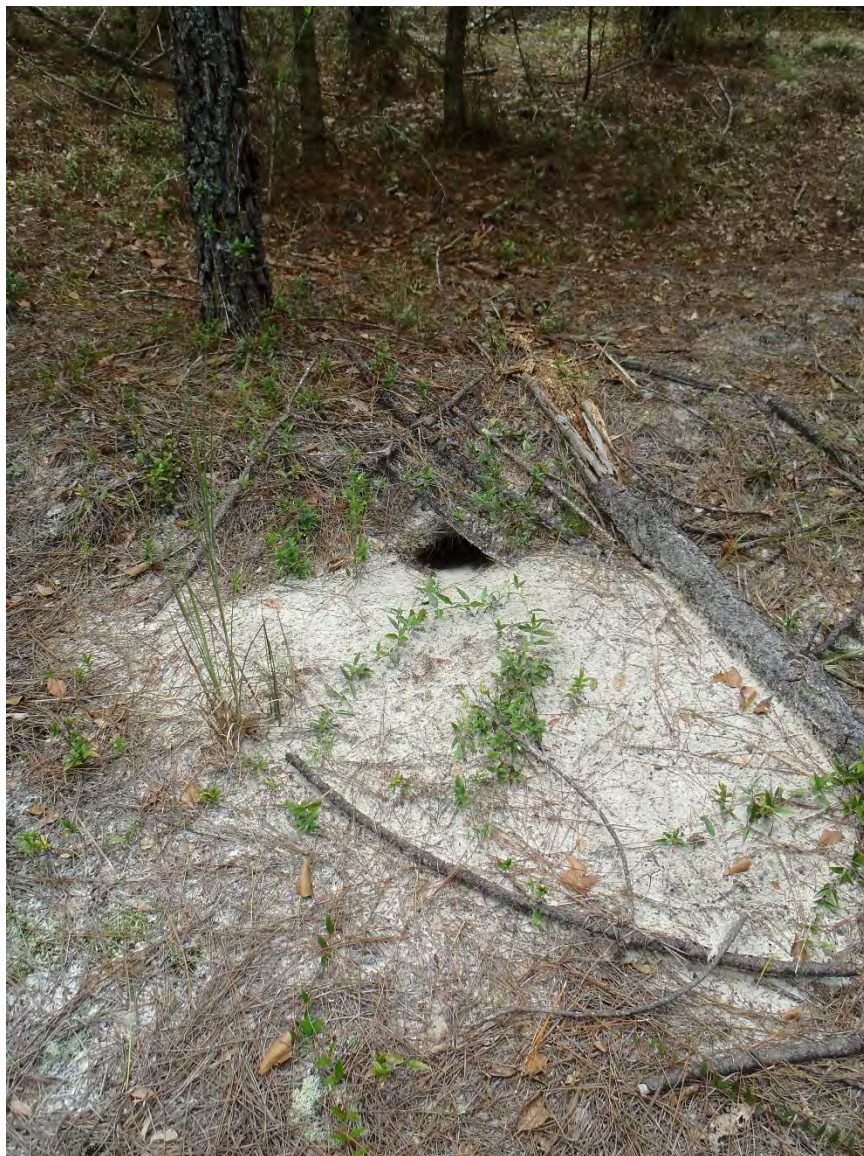
Photo 57. View of gopher tortoise burrow (Active, Juvenile) located at GPS location 353 (Frame 1550; 08/18/15).

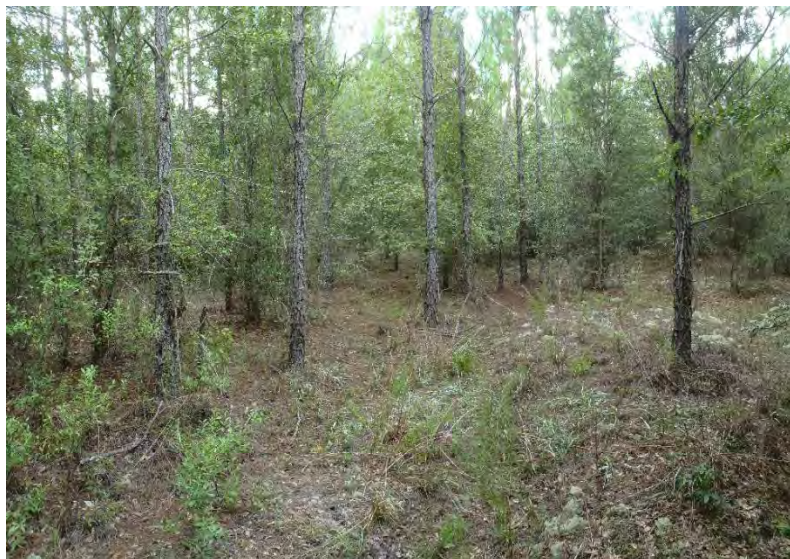
Photo 58. View of Planted Pine-Mesic Pine Flatwoods as seen looking west-northwest from GPS location 364 (Frames 1551-1552; 08/18/15).

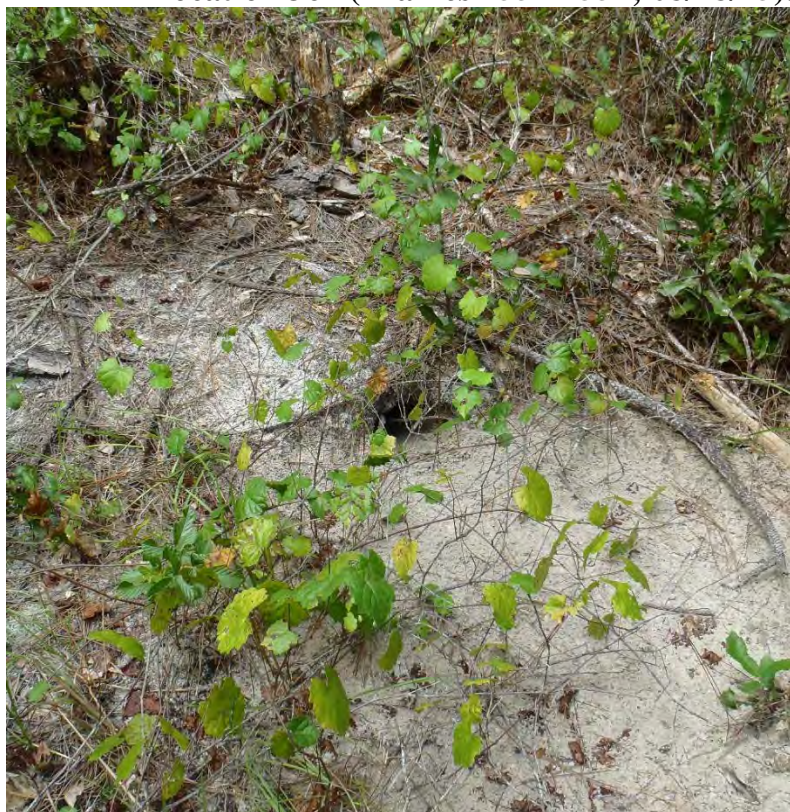
Photo 59. View of gopher tortoise burrow (Active, Juvenile) located at GPS location 367 (Frame 1553; 08/18/15).

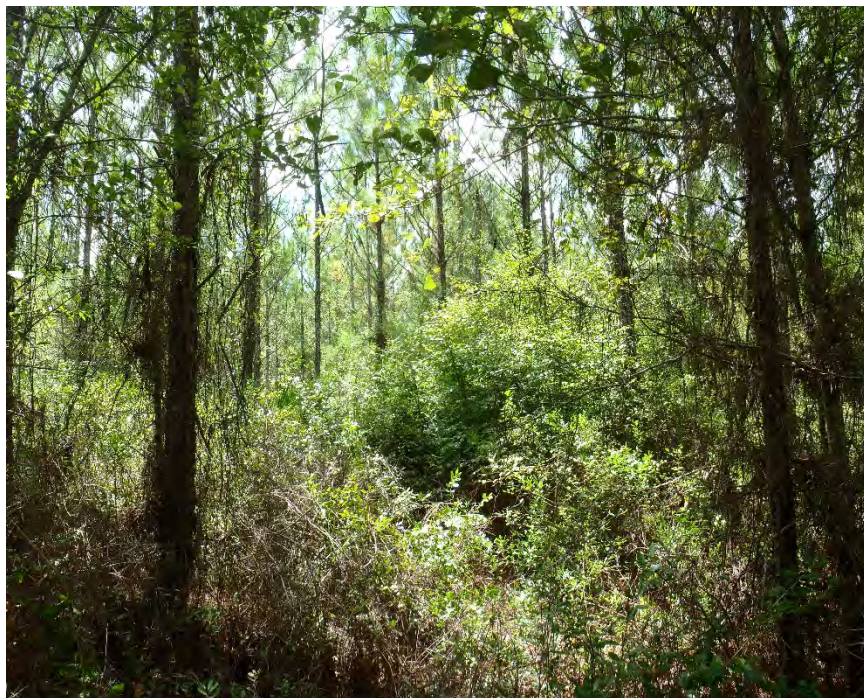
Photo 60. View of Planted Pine-Mesic Pine Flatwoods as seen looking west from GPS location 372 (Frames 1554-1555; 08/18/15).
