Natural Area Resource Assessment of the Gainesville 121 Project Site

Provided in support of a current
application for Planned Development

City of Gainesville, Florida

Ecosystem Research Corporation
2906 NW 142 Avenue
Gainesville, FL 32609

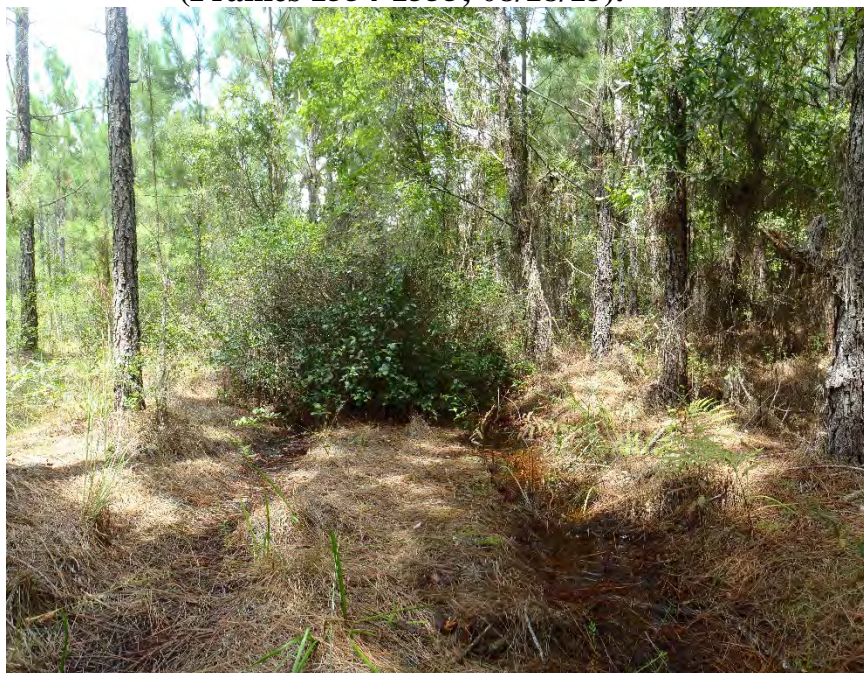
Photo 61. View of Hydric: Planted Pine Flatwoods as seen looking northeast from GPS location 377 (Frames 1556-1557; 08/18/15).

Photo 61. View of Hydric: Planted Pine Flatwoods as seen looking northeast from GPS location 377 (Frames 1556-1557; 08/18/15).....	286
Photo 62. View of Wetland: Mixed Hardwoods-Seepage Slope community as seen looking east from GPS location 404 (Frames 1558-1559; 08/18/15).....	287
Photo 63. View of Wetland: Mixed Hardwoods-Seepage Slope community as seen looking south from GPS location 404 (Frames 1560-1561; 08/18/15).....	287
Photo 64. View of Planted Pine-Mesic Pine Flatwoods as seen looking east from GPS location 414 (Frames 1562-1563; 08/18/15).....	288
Photo 65. View of Planted Pine-Mesic Pine Flatwoods as seen looking west from GPS location 414 (Frames 1564-1565; 08/18/15).....	288
Photo 66. View of roadway and habitat as seen looking east from GPS location 9 (Frames 1566-1567; 08/18/15).....	289
Photo 67. View of Wetland: Planted Pine-Marsh as seen looking northwest from GPS location 470 (Frames 1568-1569; 08/18/15).....	289

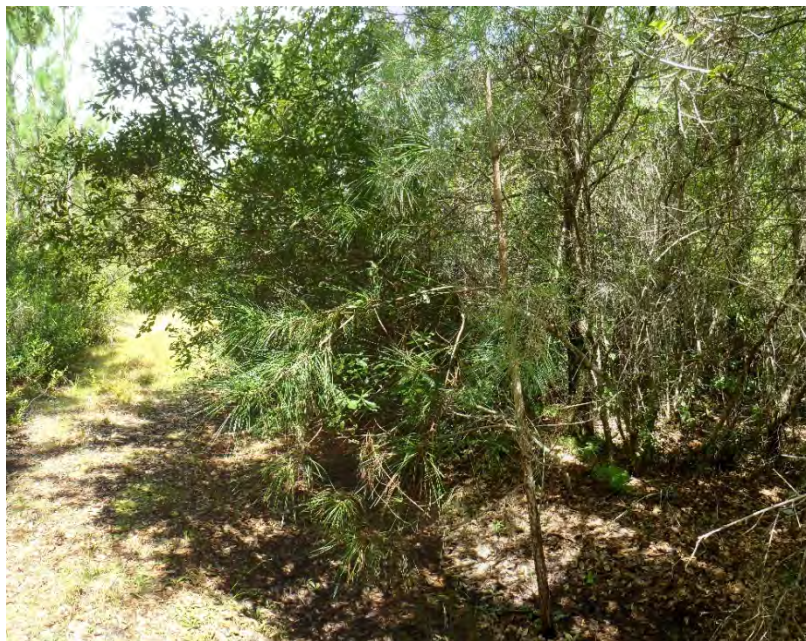
Photo 62. View of Wetland: Mixed Hardwoods-Seepage Slope community as seen looking east from GPS location 404 (Frames 1558-1559; 08/18/15).

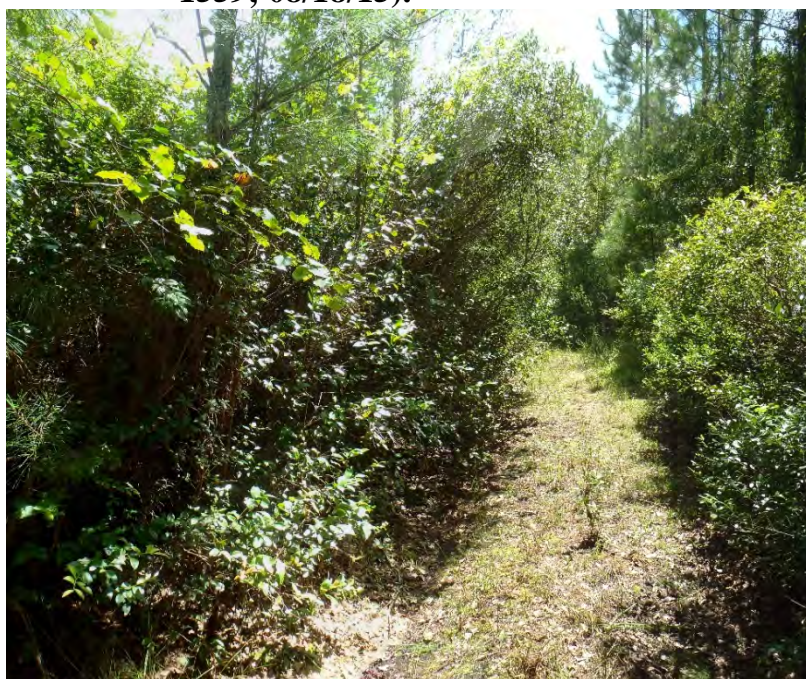
Photo 63. View of Wetland: Mixed Hardwoods-Seepage Slope community as seen looking south from GPS location 404 (Frames 1560-1561; 08/18/15).

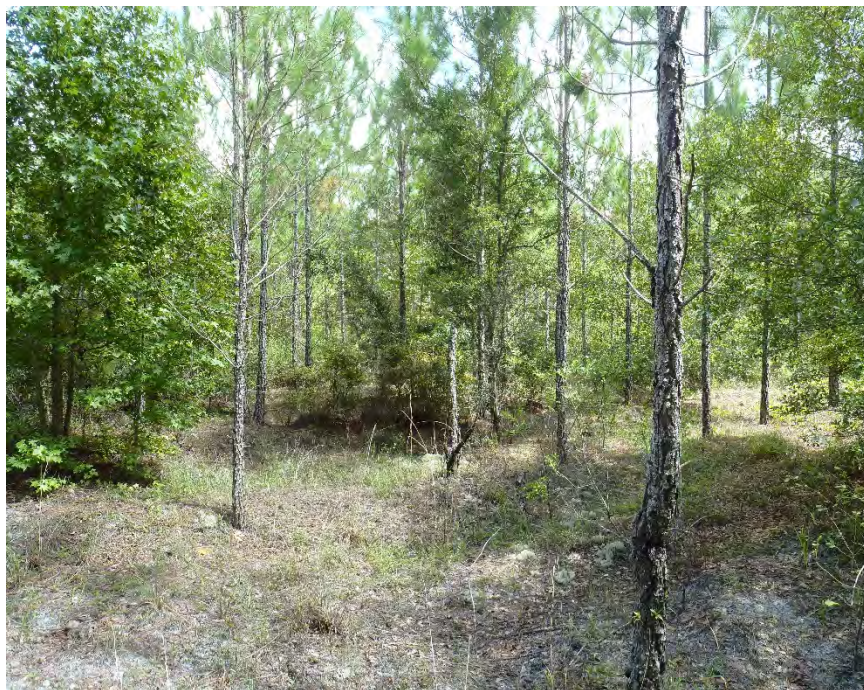
Photo 64. View of Planted Pine-Mesic Pine Flatwoods as seen looking east from GPS location 414 (Frames 1562-1563; 08/18/15).

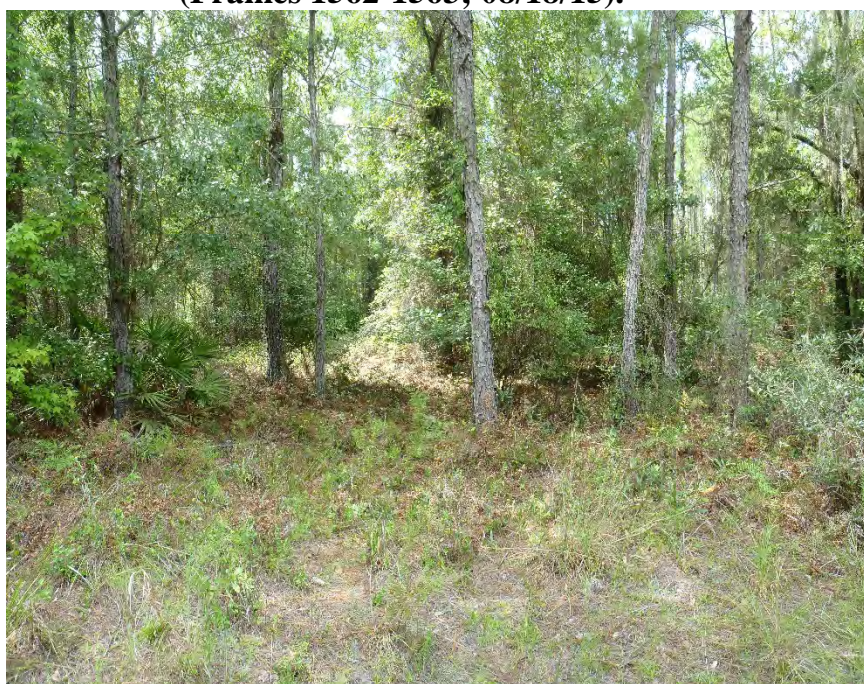
Photo 65. View of Planted Pine-Mesic Pine Flatwoods as seen looking west from GPS location 414 (Frames 1564-1565; 08/18/15).

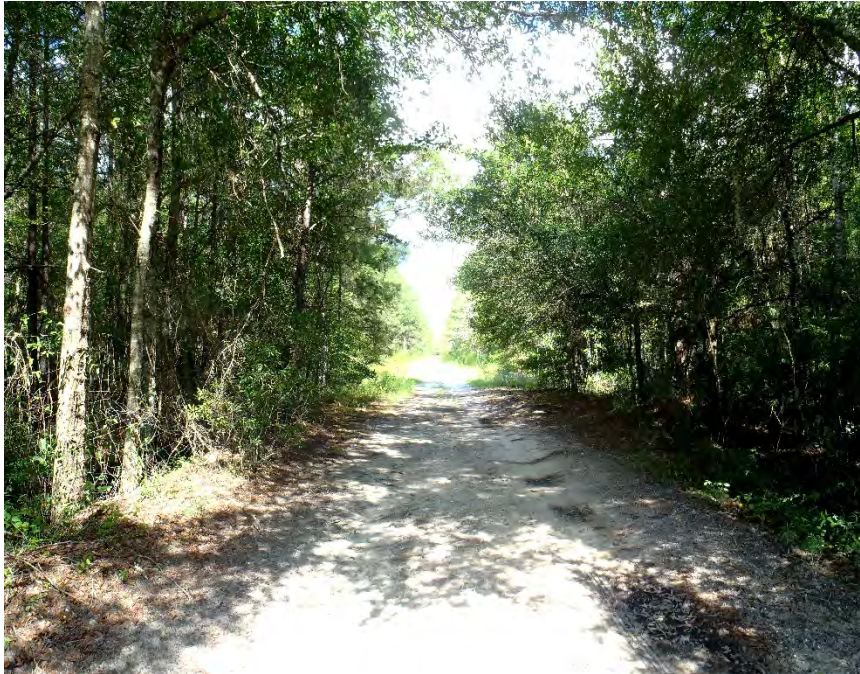
Photo 66. View of roadway and habitat as seen looking east from GPS location 9 (Frames 1566-1567; 08/18/15).

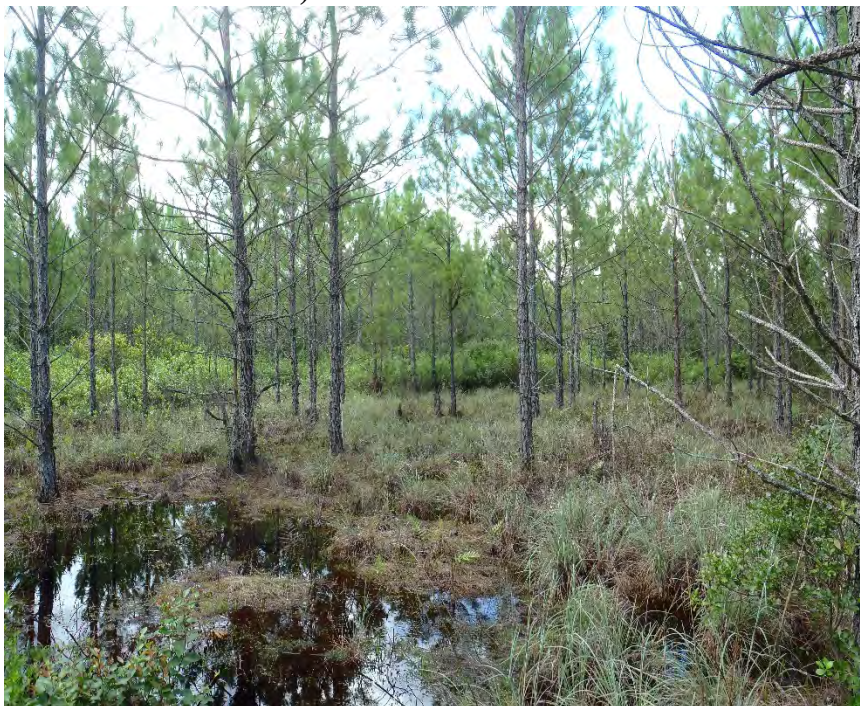
Photo 67. View of Wetland: Planted Pine-Marsh as seen looking northwest from GPS location 470 (Frames 1568-1569; 08/18/15).

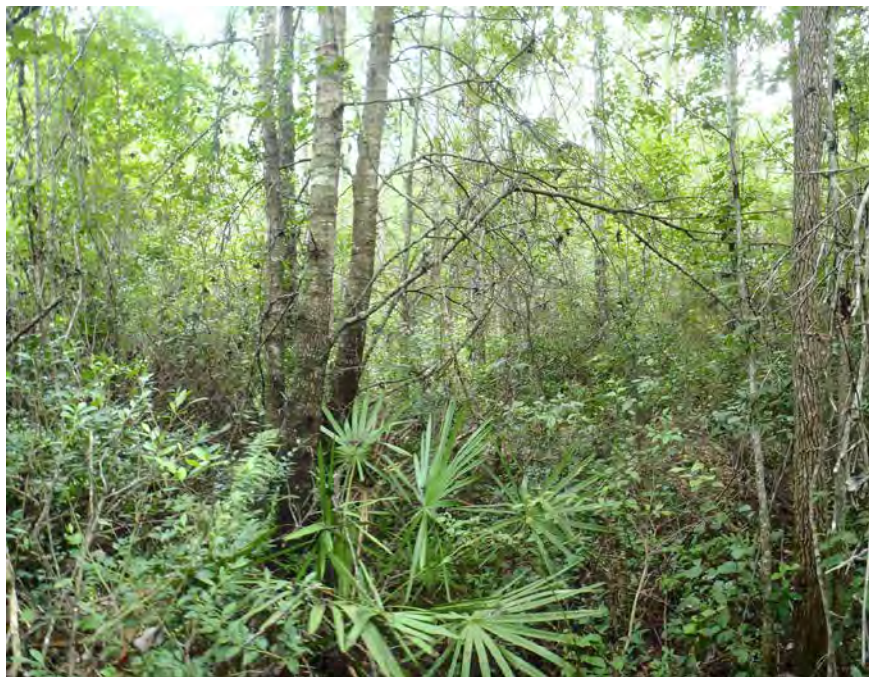
Photo 68. View of Wetland: Mixed Hardwoods-Seepage Slope as seen looking southeast from GPS location 501 (Frames 1570-1571; 08/18/15).

Photo 68. View of Wetland: Mixed Hardwoods-Seepage Slope as seen looking southeast from GPS location 501 (Frames 1570-1571; 08/18/15).....	290
Photo 69. View of Wetland: Hydric Hammock as seen looking south from GPS location 511 (Frames 1572-1573; 08/18/15).....	290

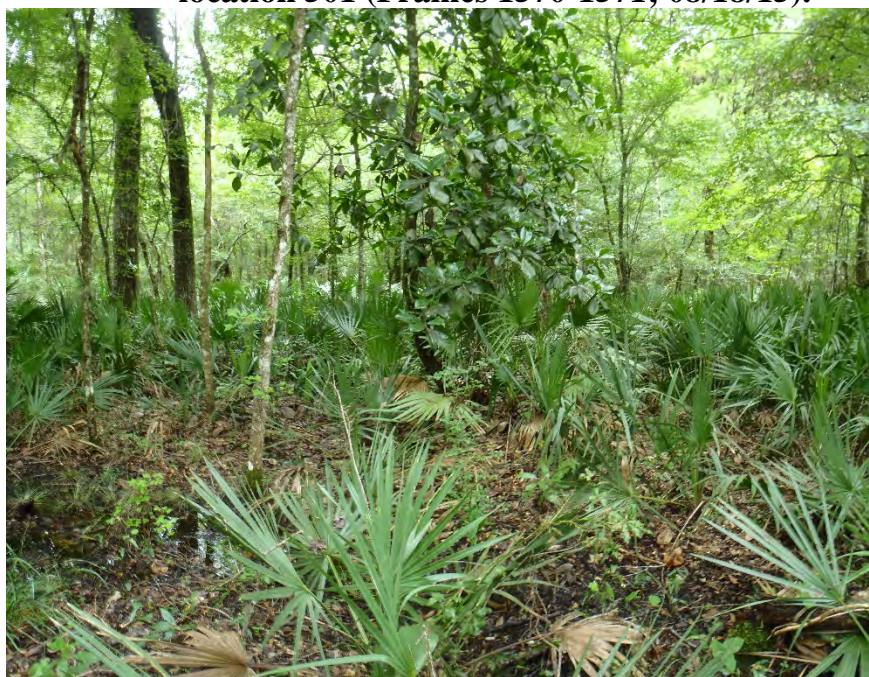
Photo 69. View of Wetland: Hydric Hammock as seen looking south from GPS location 511 (Frames 1572-1573; 08/18/15).

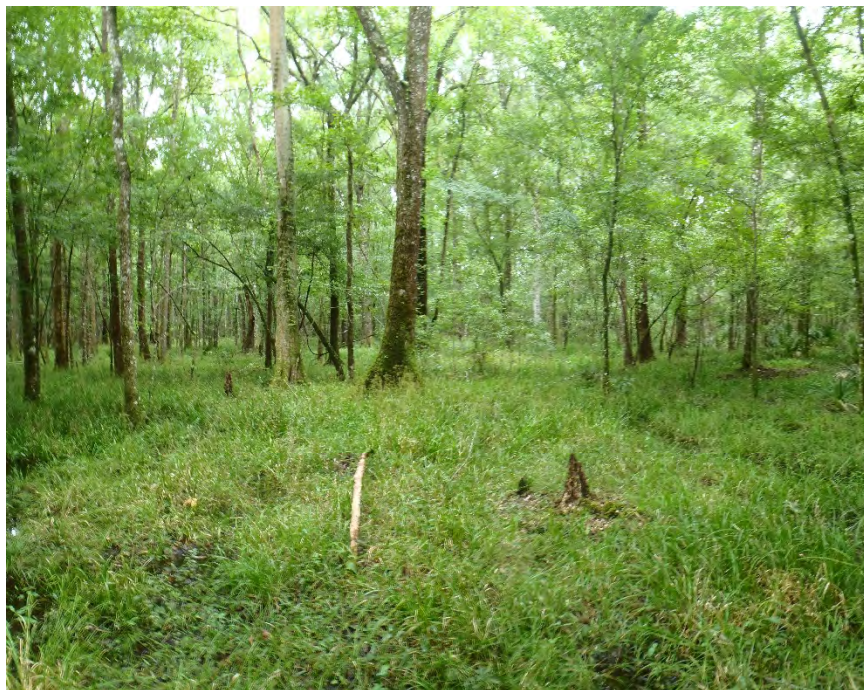
Photo 70. View of Wetland: Hydric Hammock as seen looking south from GPS location 517 (Frames 1574-1575; 08/18/15).

Photo 70.	View of Wetland: Hydric Hammock as seen looking south from GPS location 517 (Frames 1574-1575; 08/18/15).	291
Photo 71.	View of Wetland: Hydric Hammock as seen looking west from GPS location 517 (Frames 1576-1677; 08/18/15).	291
Photo 72.	View of Wetland: Mixed Hardwood Swamp as seen looking southwest from GPS location 522 (Frames 1578-1579; 08/18/15).	292
Photo 73.	View of Surface Water: Excavated Creek in Wetland as seen looking west from GPS location 555 (Frame 1580; 08/18/15).	292
Photo 74.	View of wetland flagging over stream as seen looking west from GPS location 561 (Frame 1581; 08/18/15).	293
Photo 75.	View of Hydric: Planted Pine Flatwoods as seen looking north from GPS location 565 (Frames 1582-1583; 08/18/15).	294
Photo 76.	View of Wetland: Planted Pine-Marsh as seen at GPS location 569 (Frame 1584-1585; 08/18/15).	294
Photo 77.	View of Wetland: Mixed Hardwood Swamp as seen looking northeast from GPS location 582 (Frames 1586-1587; 08/18/15).	295

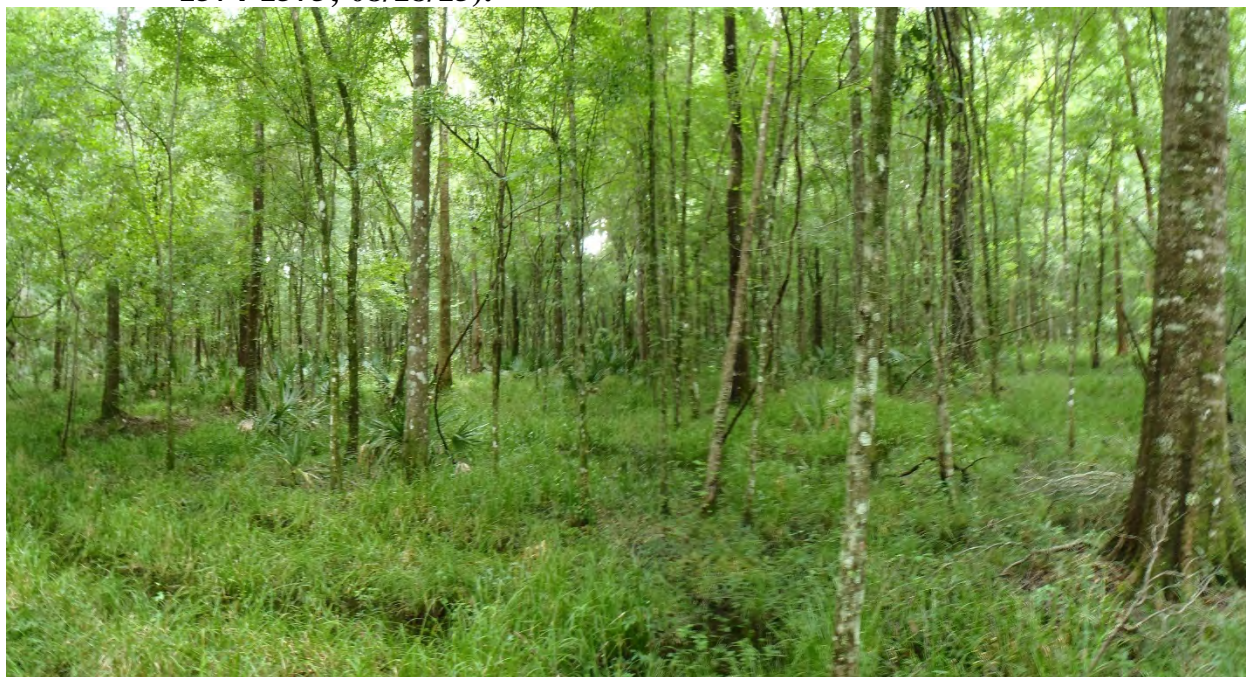
Photo 71. View of Wetland: Hydric Hammock as seen looking west from GPS location 517 (Frames 1576-1677; 08/18/15).

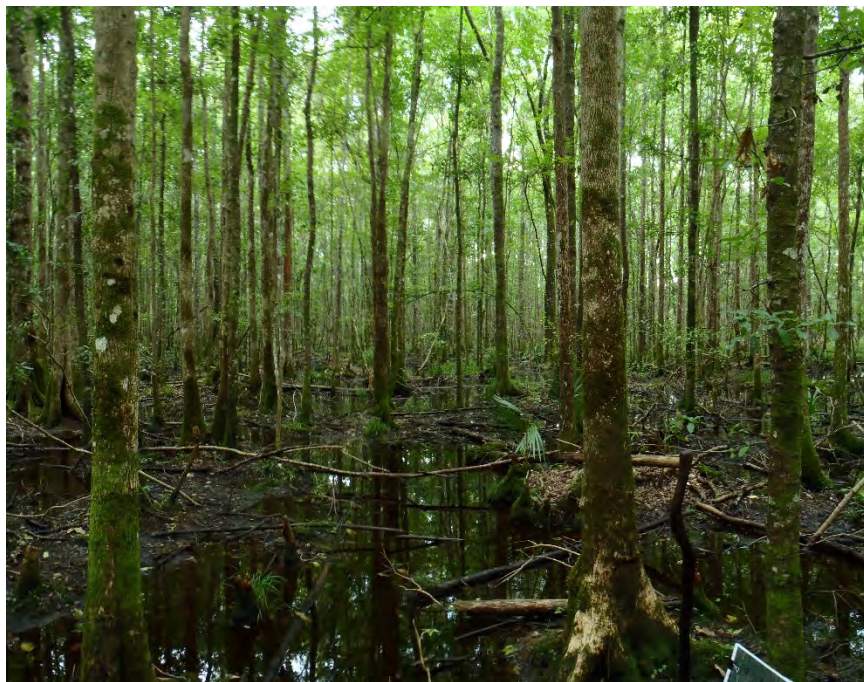
Photo 72. View of Wetland: Mixed Hardwood Swamp as seen looking southwest from GPS location 522 (Frames 1578-1579; 08/18/15).

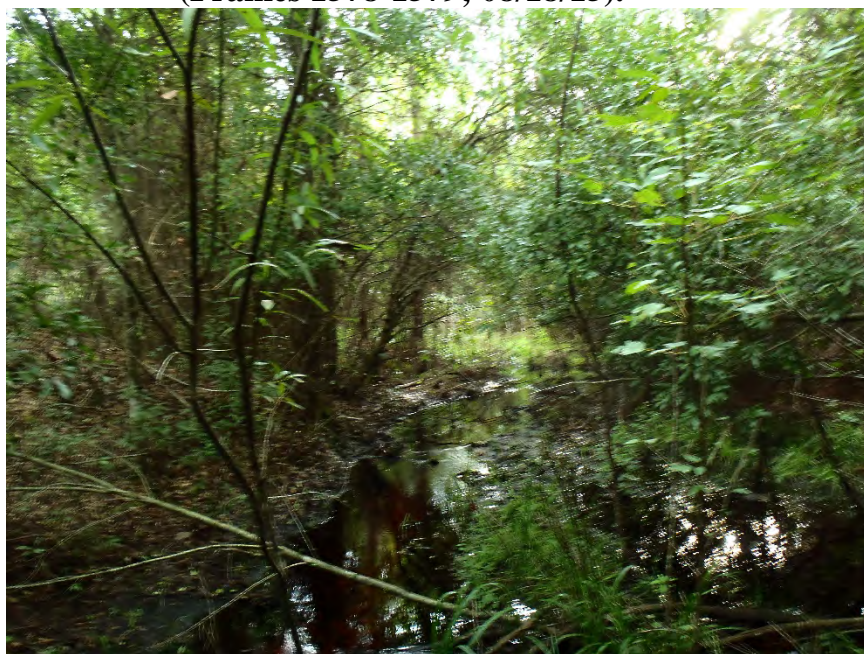
Photo 73. View of Surface Water: Excavated Creek in Wetland as seen looking west from GPS location 555 (Frame 1580; 08/18/15).

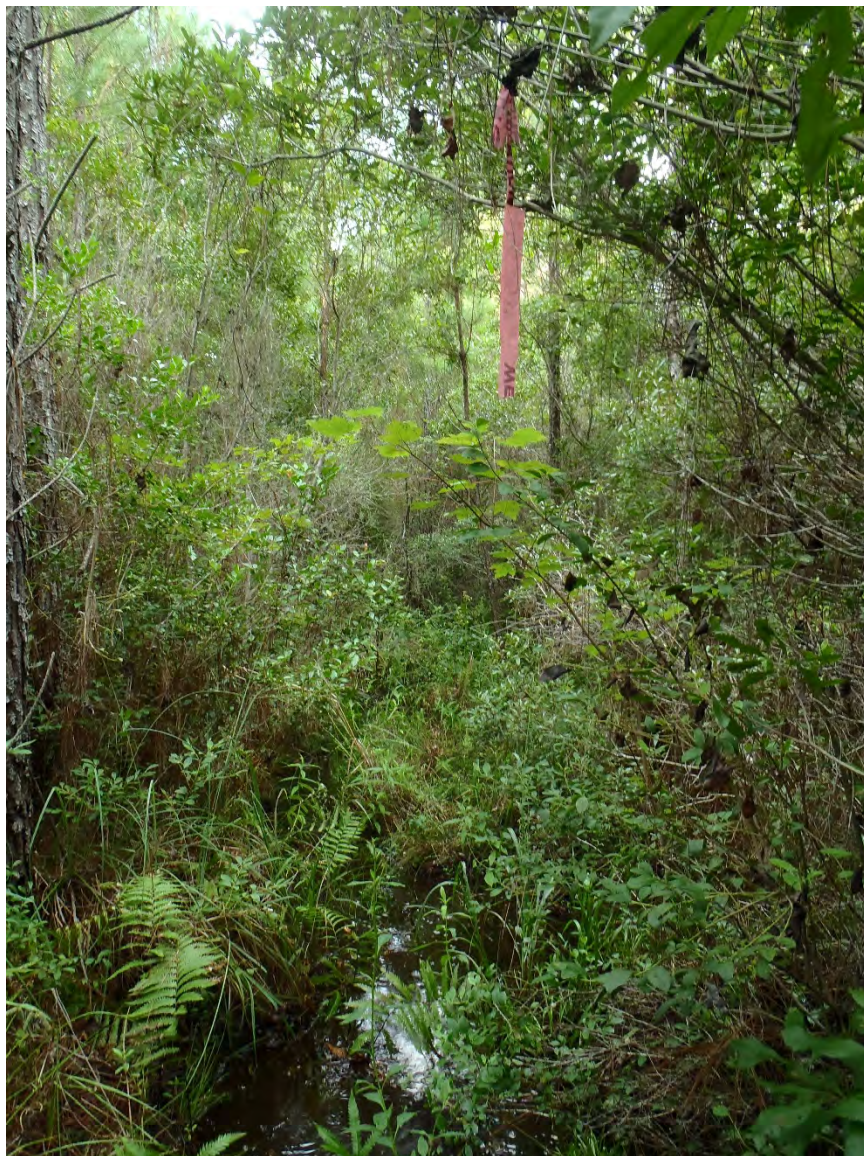
Photo 74. View of wetland flagging over stream as seen looking west from GPS location 561 (Frame 1581; 08/18/15).

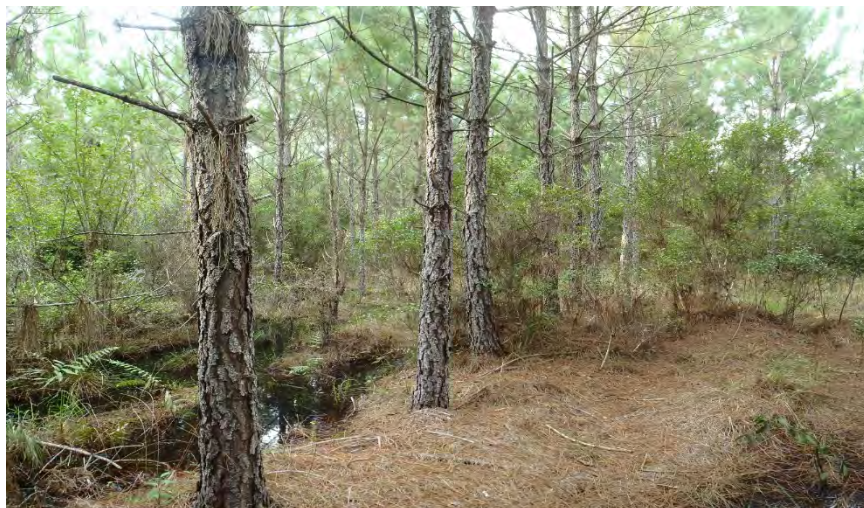
Photo 75. View of Hydric: Planted Pine Flatwoods as seen looking north from GPS location 565 (Frames 1582-1583; 08/18/15).

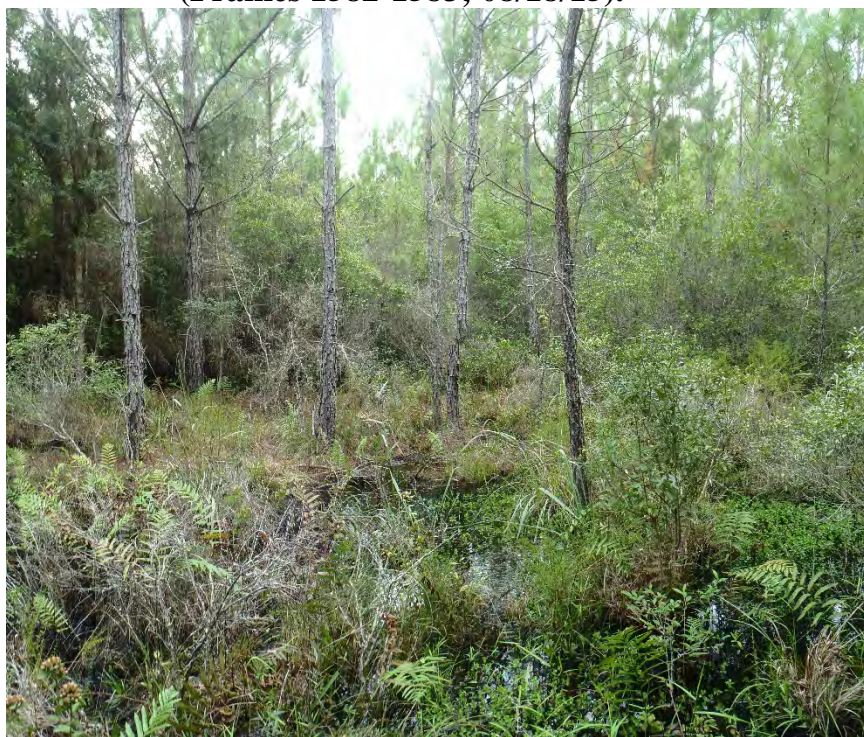
Photo 76. View of Wetland: Planted Pine-Marsh as seen at GPS location 569 (Frame 1584-1585; 08/18/15).

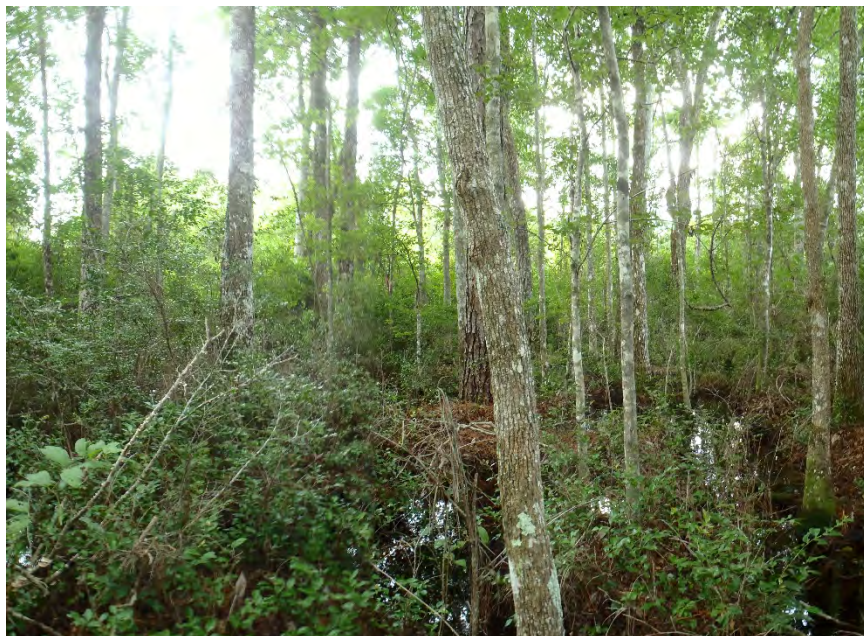
Photo 77. View of Wetland: Mixed Hardwood Swamp as seen looking northeast from GPS location 582 (Frames 1586-1587; 08/18/15).

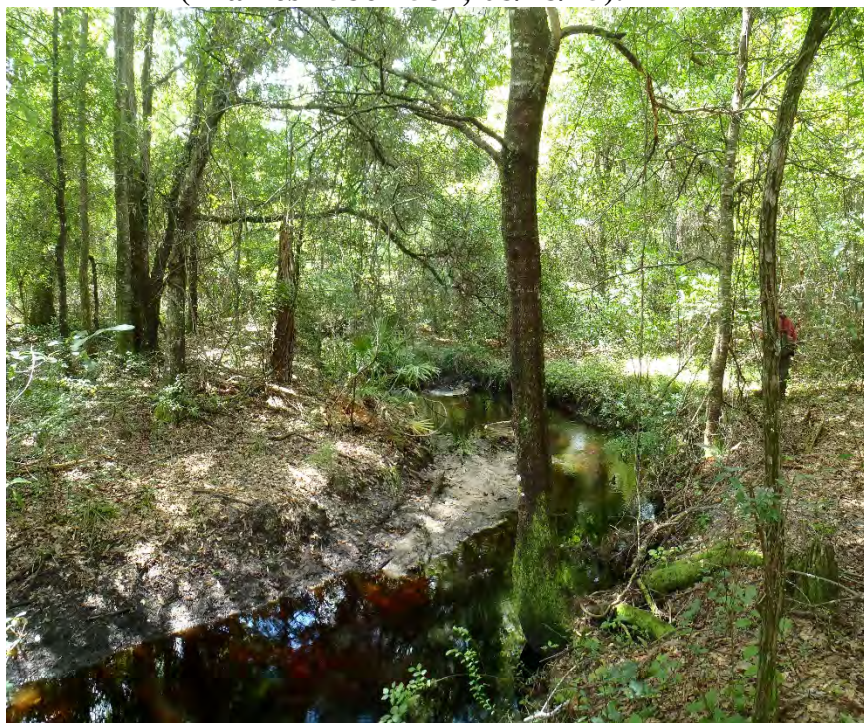
Photo 78. View of Surface Water: Excavated Creek in Wetland as seen looking south from GPS location 622 (Frames 1650-1651; 08/21/15).

Photo 78.	View of Surface Water: Excavated Creek in Wetland as seen looking south from GPS location 622 (Frames 1650-1651; 08/21/15).	295
Photo 79.	View of Wetland: Mixed Hardwoods-Seepage Slope as seen looking west from GPS location 624 (Frames 1652-1653; 08/21/15).	296
Photo 80.	View of Wetland: Mixed Oak-Hardwoods-Successional community as seen looking east from GPS location 625 (Frames 1659-1660; 08/21/15).	296
Photo 81.	View of old cat-faced stump located at GPS location 646 (Frame 1656; 08/21/15).	297
Photo 82.	View of old cat-faced stump located at GPS location 646 (Frame 7396; 08/21/15).	298
Photo 83.	View of old cat-faced stump located at GPS location 646 (Frame 7397; 08/21/15).	298
Photo 84.	View of old cat-faced stump located at GPS location 646 (Frame 7398; 08/21/15).	299
Photo 85.	View of Wetland: Natural Flow-way as seen looking east from GPS location 653 (Frames 1657-1658; 08/21/15).	299

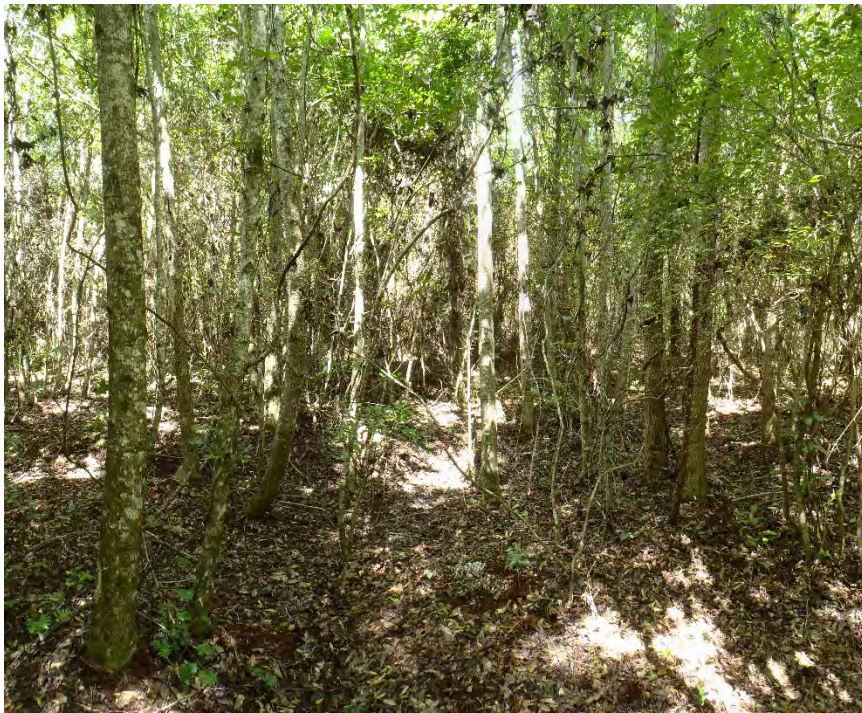
Photo 79. View of Wetland: Mixed Hardwoods-Seepage Slope as seen looking west from GPS location 624 (Frames 1652-1653; 08/21/15).

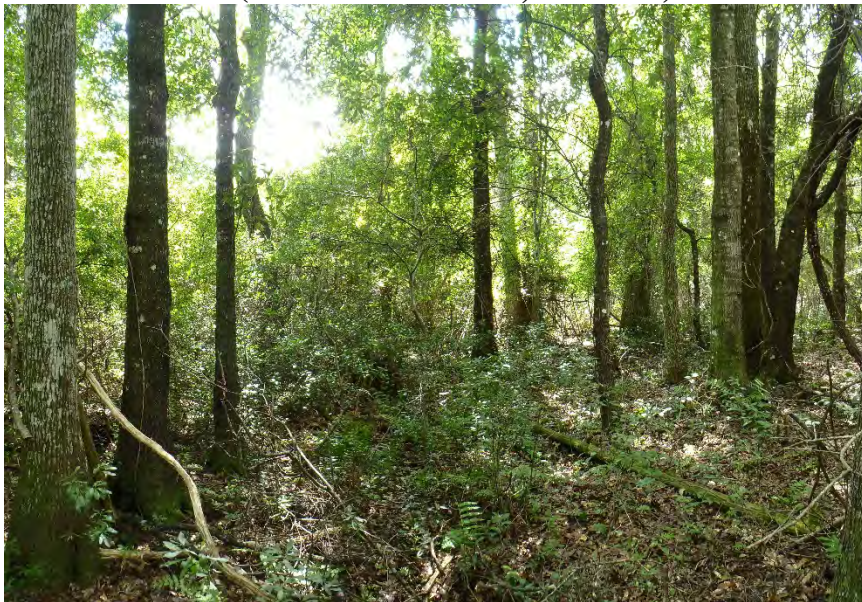
Photo 80. View of Wetland: Mixed Oak-Hardwoods-Successional community as seen looking east from GPS location 625 (Frames 1659-1660; 08/21/15).

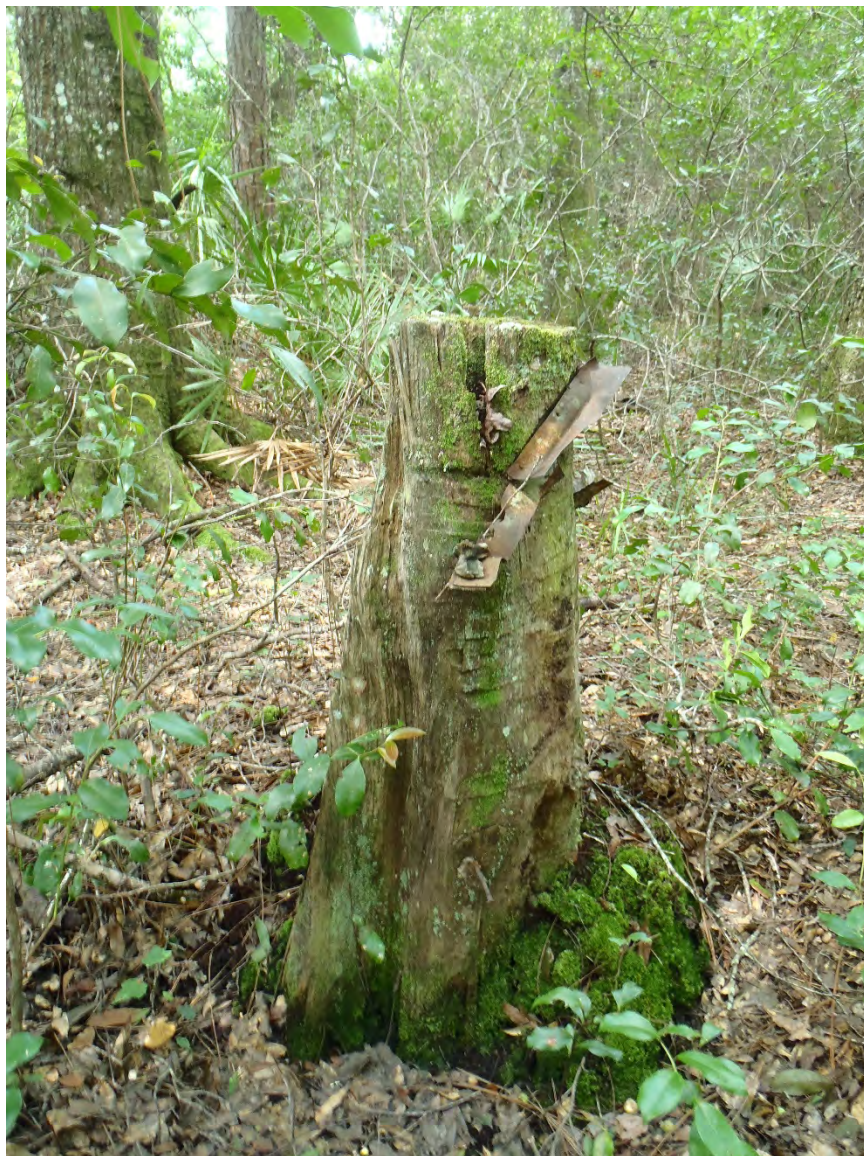
Photo 81. View of old cat-faced stump located at GPS location 646 (Frame 1656; 08/21/15).

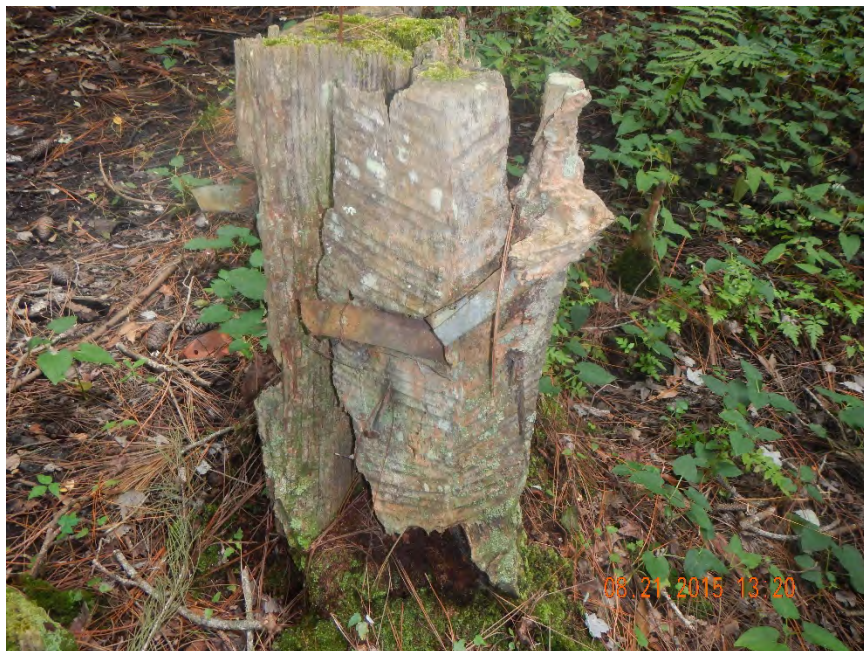
Photo 82. View of old cat-faced stump located at GPS location 646 (Frame 7396; 08/21/15).

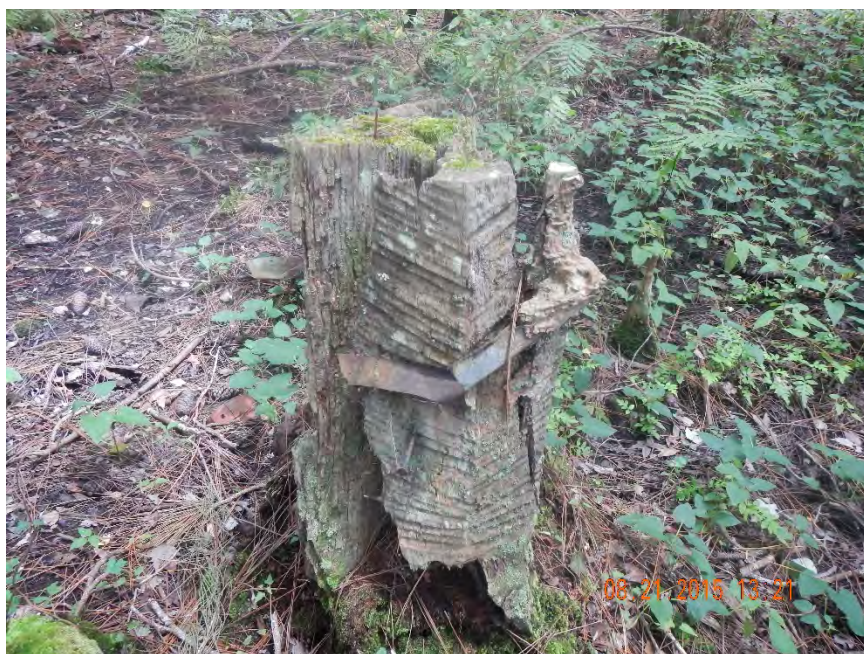
Photo 83. View of old cat-faced stump located at GPS location 646 (Frame 7397; 08/21/15).

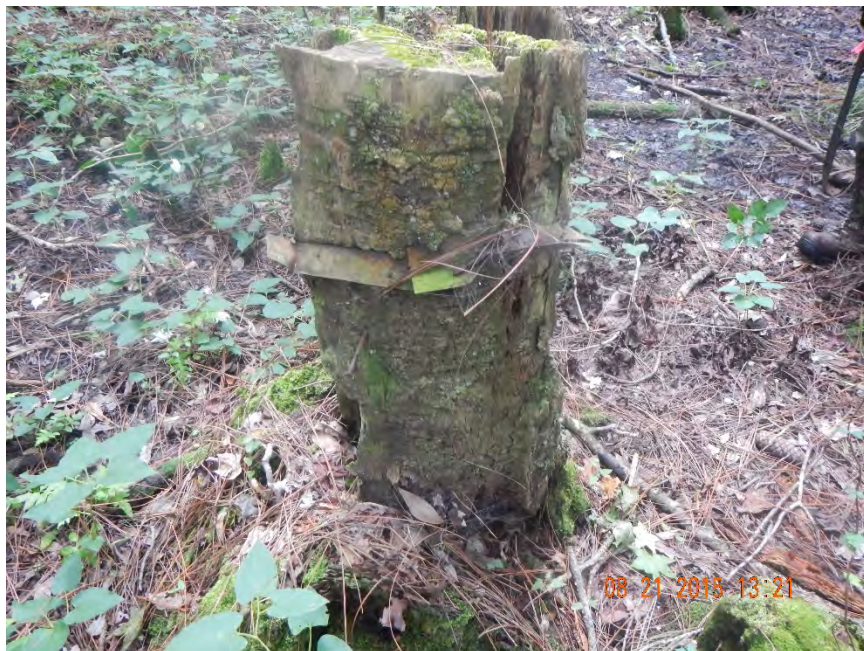
Photo 84. View of old cat-faced stump located at GPS location 646 (Frame 7398; 08/21/15).

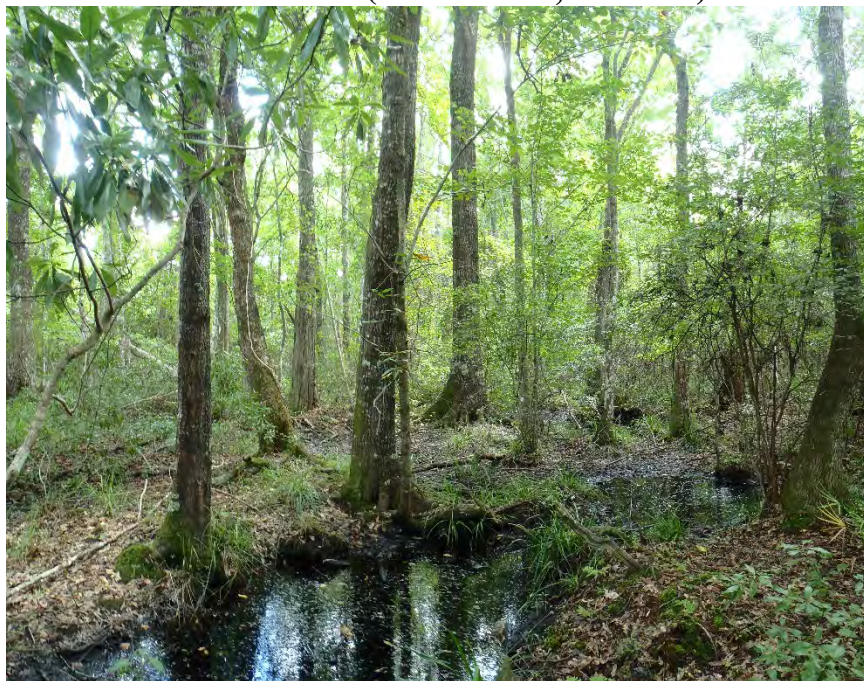
Photo 85. View of Wetland: Natural Flow-way as seen looking east from GPS location 653 (Frames 1657-1658; 08/21/15).

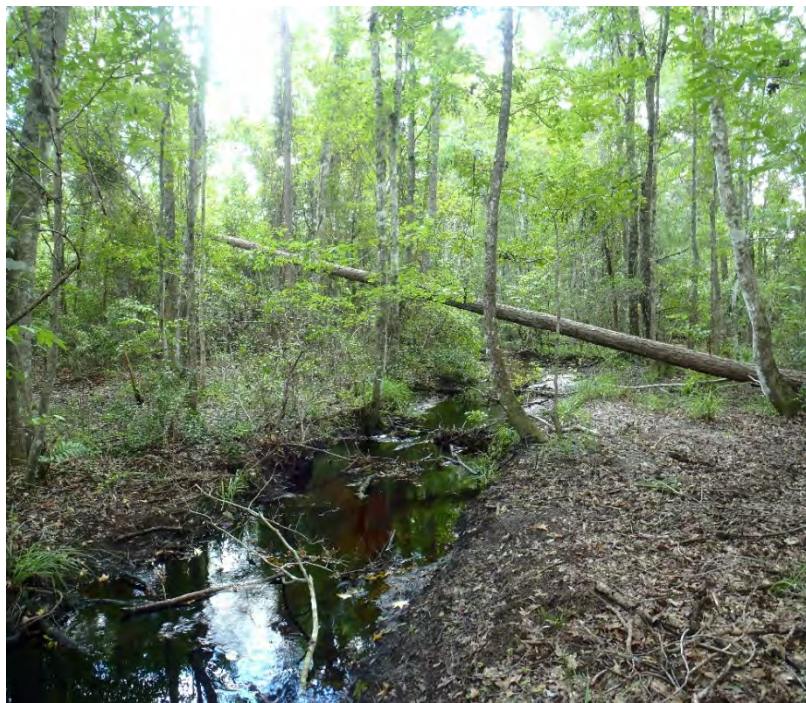
Photo 86. View of Surface Water: Excavated Creek in Wetland as seen looking east from GPS location 655 (Frames 1659-1660; 08/21/15).

Photo 86.	View of Surface Water: Excavated Creek in Wetland as seen looking east from GPS location 655 (Frames 1659-1660; 08/21/15).	300
Photo 87.	View of Surface Water: Excavated Creek in Wetland as seen looking west from GPS location 655 (Frames 1661-1662; 08/21/15).	300

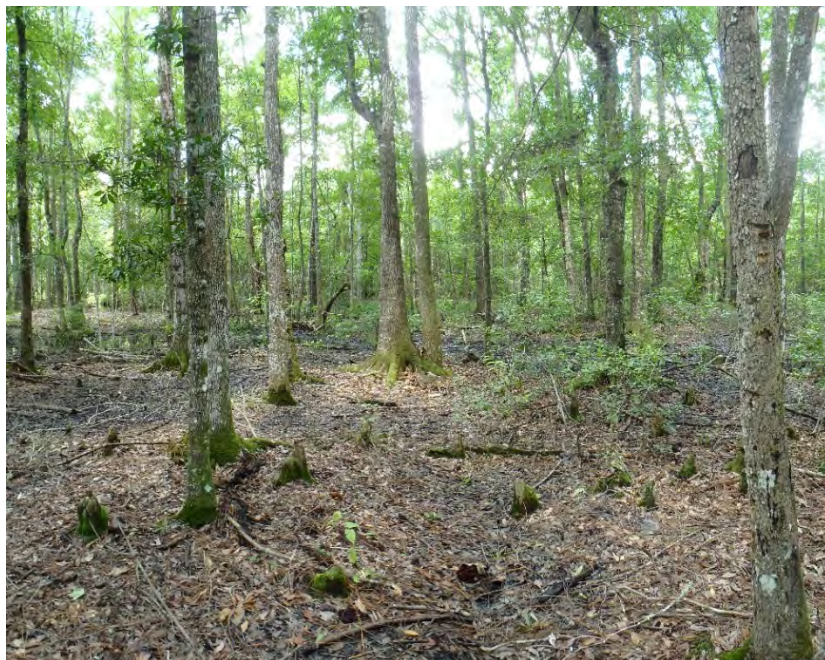
Photo 87. View of Surface Water: Excavated Creek in Wetland as seen looking west from GPS location 655 (Frames 1661-1662; 08/21/15).

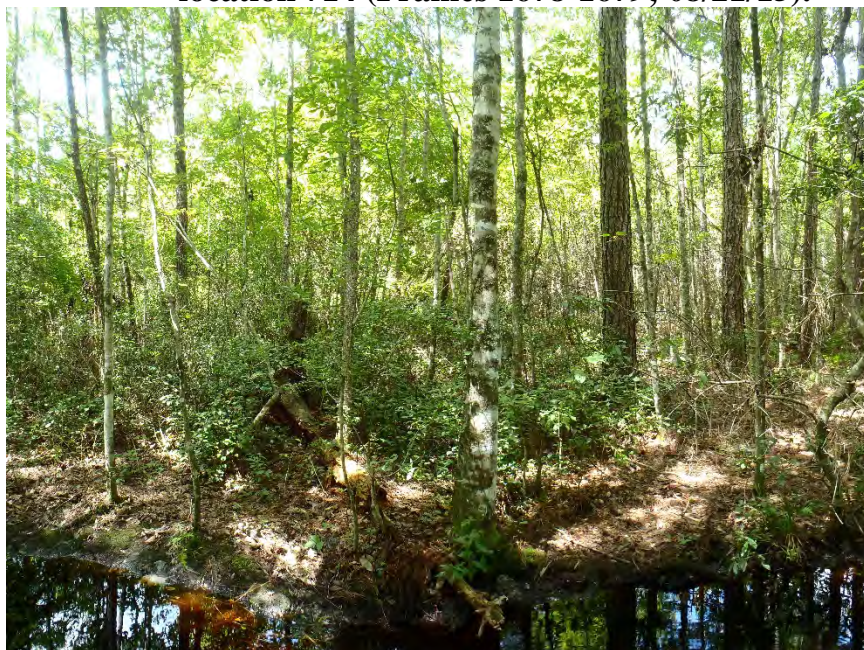
Photo 95. View of Surface Water: Excavated Creek in Wetland as seen looking northeast from GPS location 714 (Frames 1678-1679; 08/21/15).

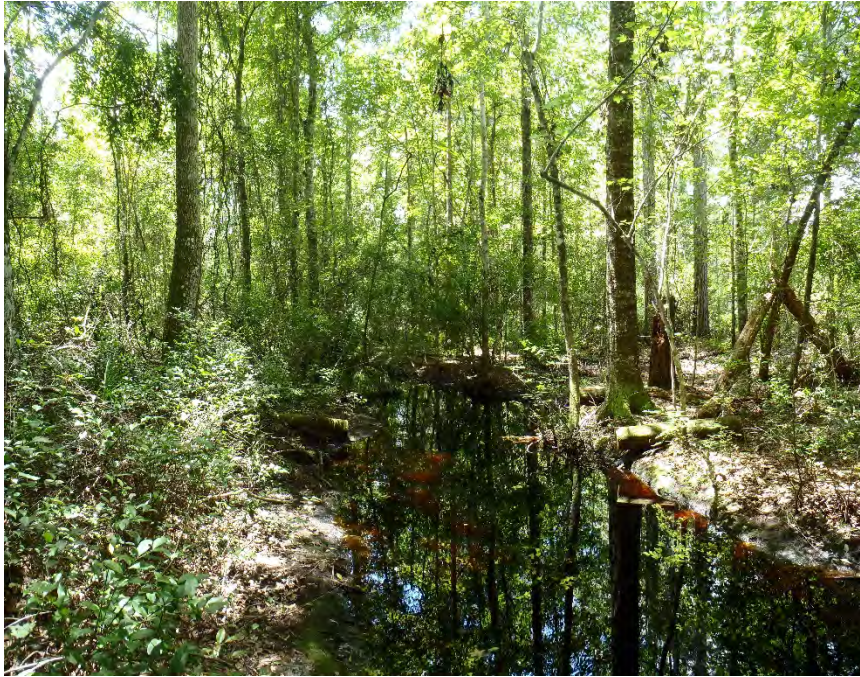
Photo 96. View of Surface Water: Excavated Creek in Wetland as seen looking northwest from GPS location 714 (Frames 1680-1681; 08/21/15).

Photo 96. View of Surface Water: Excavated Creek in Wetland as seen looking northwest from GPS location 714 (Frames 1680-1681; 08/21/15).	305
Photo 97. View of Surface Water: Excavated Creek in Wetland as seen looking southwest from GPS location 714 (Frames 1682-1683; 08/21/15).....	306
Photo 98. View of Wetland: Planted Pine-Marsh as seen looking west from GPS location 754 (Frames 1684-1685; 08/21/15).	306
Photo 99. View of Wetland: Planted Pine-Marsh as seen looking north from GPS location 790 (Frames 1686-1687; 08/21/15).	307
Photo 100. View of Wetland: Planted Pine-Marsh as seen looking northeast from GPS location 829 (Frames 1688-1689; 08/21/15).....	307
Photo 101. View of Hydric: Planted Pine Flatwoods as seen looking east from GPS location 845 (Frames 1690-1691; 08/21/15).....	308
Photo 102. View of Mesic: Planted Pine-Mesic Pine Flatwoods as seen looking west from GPS location 880 (Frames 1692-1693; 08/21/15).	308

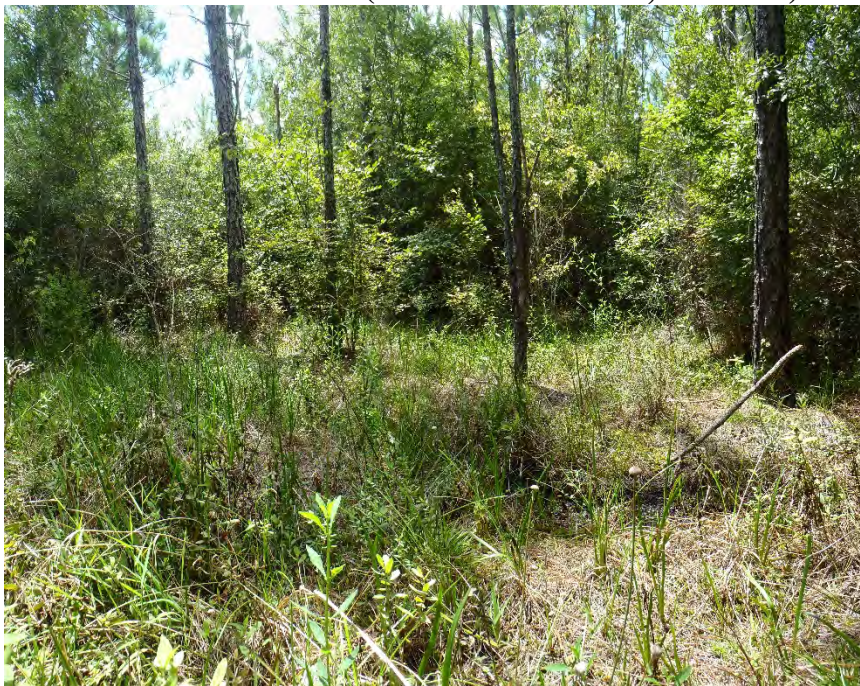
Photo 97. View of Surface Water: Excavated Creek in Wetland as seen looking southwest from GPS location 714 (Frames 1682-1683; 08/21/15).

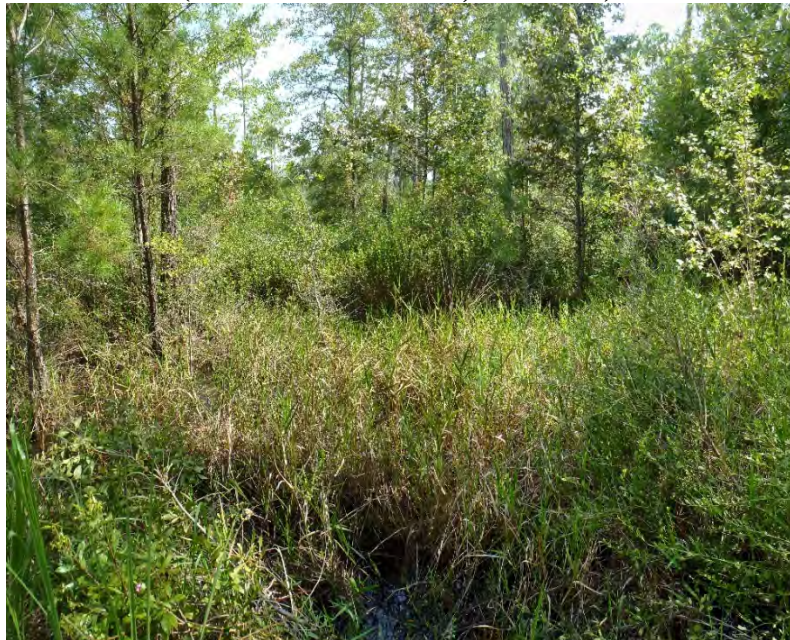
Photo 103. View of Surface Water: Excavated Creek in Wetland located on east side of the gas line right-of-way as seen looking south down gas line from GPS location 2013 (Frames 1695-1696; 08/25/15).

Photo 103. View of Surface Water: Excavated Creek in Wetland located on east side of the gas line right-of-way as seen looking south down gas line from GPS location 2013 (Frames 1695-1696; 08/25/15).....	309
Photo 104. View of Wetland: Mixed Hardwood Swamp as seen looking south from GPS location 2014 (Frames 1697-1698; 08/25/15).....	309
Photo 105. View of Wetland: Mixed Hardwood Swamp as seen looking north from GPS location 2019 (Frames 1699-1700; 08/25/15).....	310

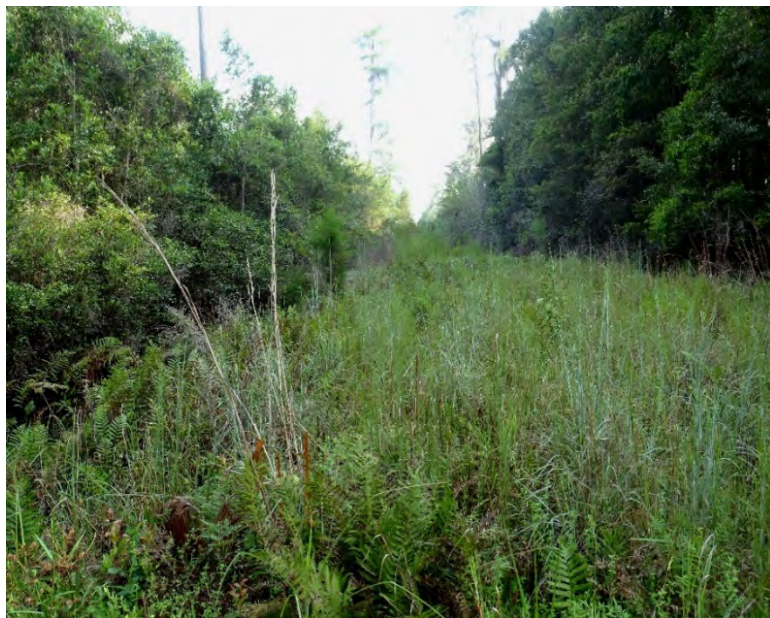
Photo 112. View of Florida Gas right-of-way as seen looking south from GPS location 2241 (Frames 1715-1716; 08/25/15).

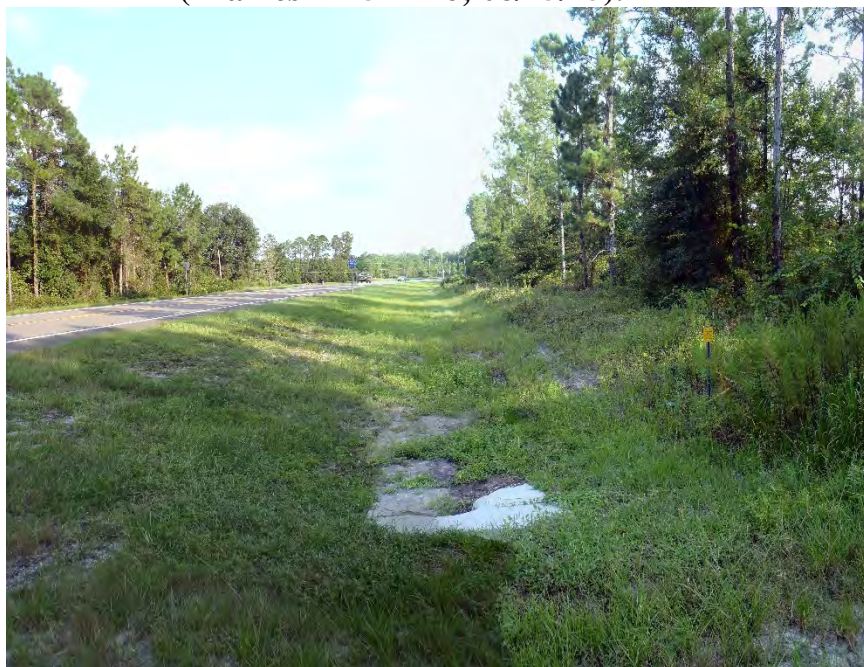
Photo 117. View of Physical Feature: Culvert as seen looking north from GPS location 2276 (Frames 1725-1726; 08/25/15).

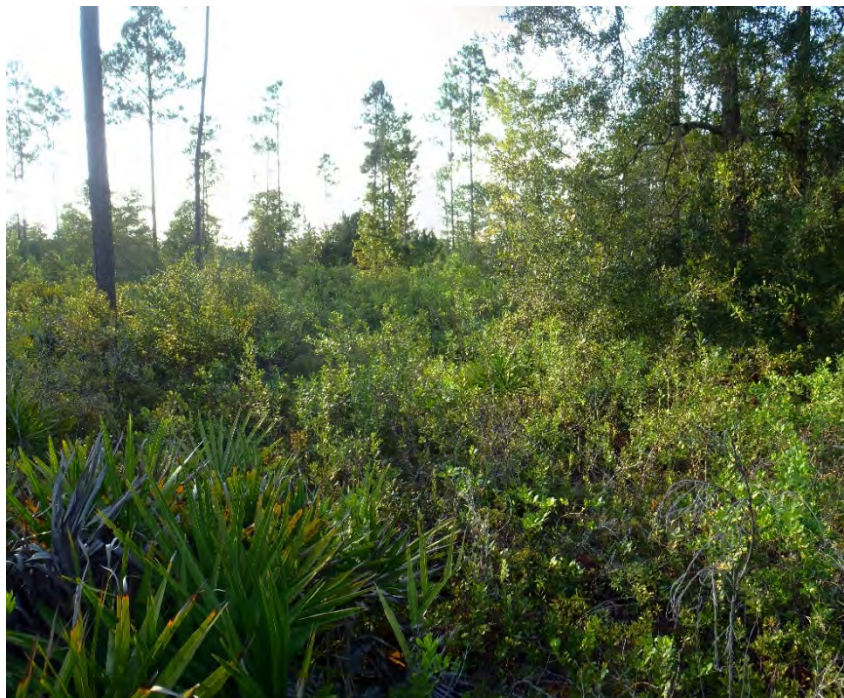
Photo 118. View of Physical Feature: Culvert as seen looking south from GPS location 2276 (Frames 1727-1728; 08/25/15).
