Natural Area Resource Assessment of the Gainesville 121 Project Site

Provided in support of a current
application for Planned Development

City of Gainesville, Florida

Ecosystem Research Corporation
2906 NW 142 Avenue
Gainesville, FL 32609

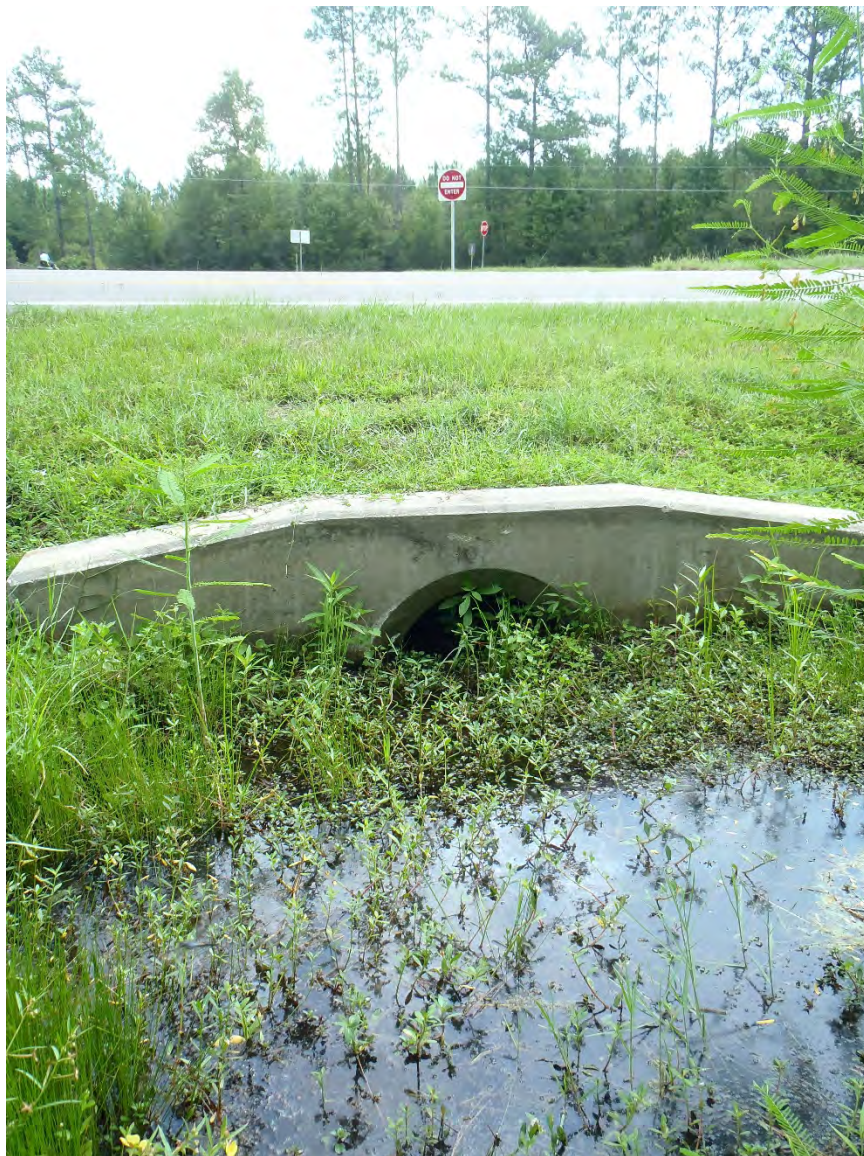
Photo 126. View of Physical Feature: Culvert as seen looking west from GPS location 2340 (Frames 1743-1744; 08/26/15).

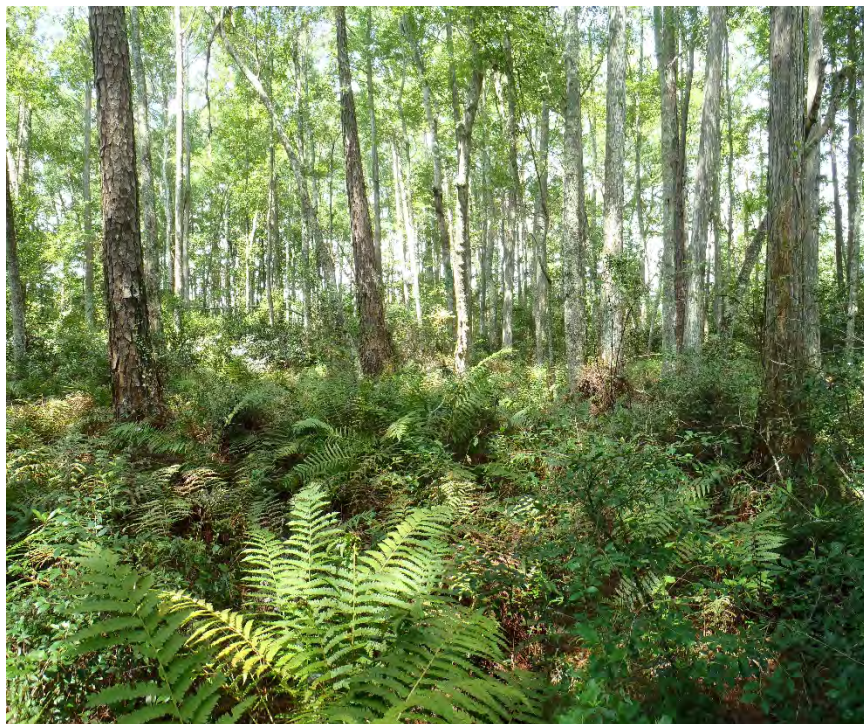
Photo 127. View of Physical Feature: Culvert at GPS location 2340 (Frame 1745; 08/26/15).

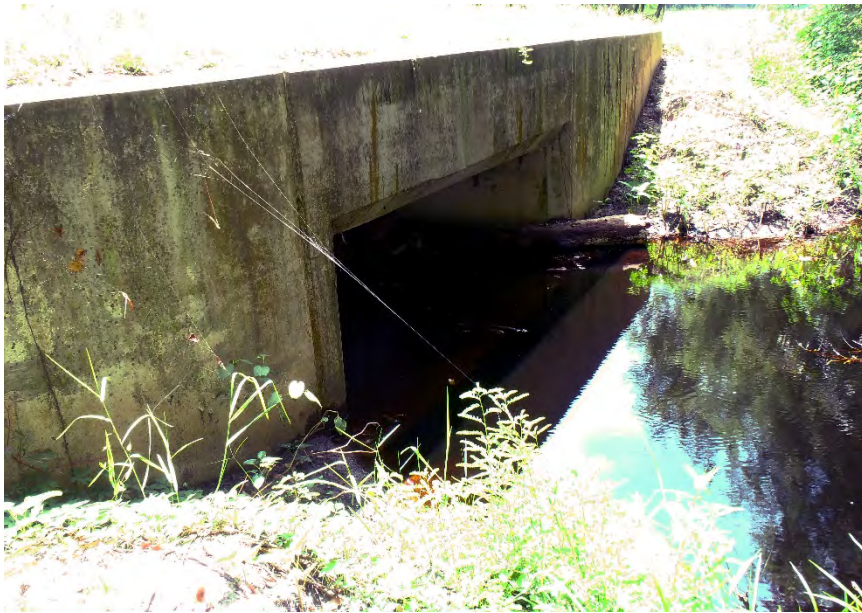
Photo 129. View of Physical Feature: Culvert as seen looking west from GPS location 2344 (Frames 1748-1749; 08/26/15).

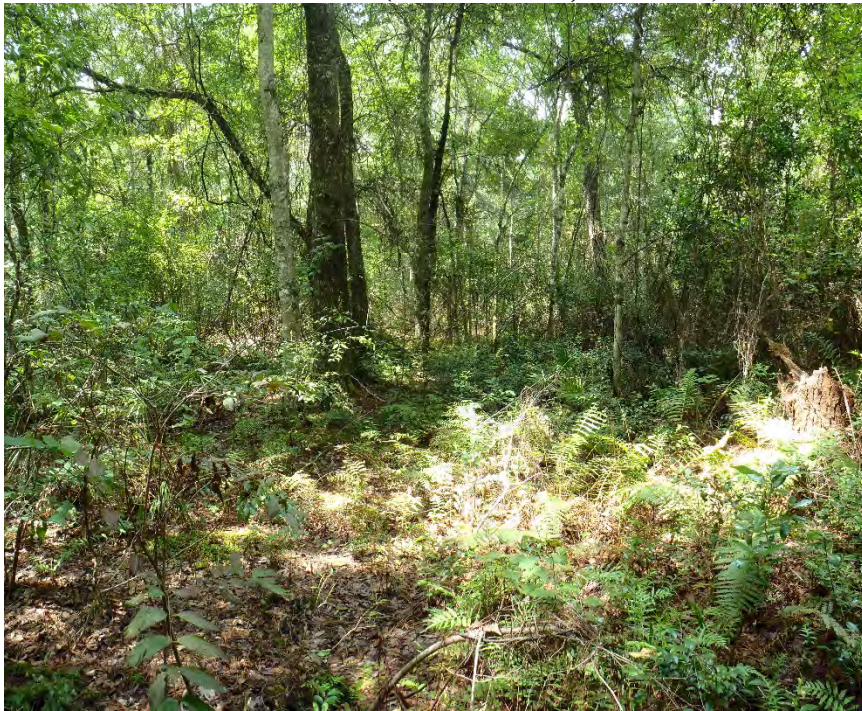
Photo 130. View of Physical Feature: Culvert at GPS location 2344 (Frame 1750; 08/26/15).

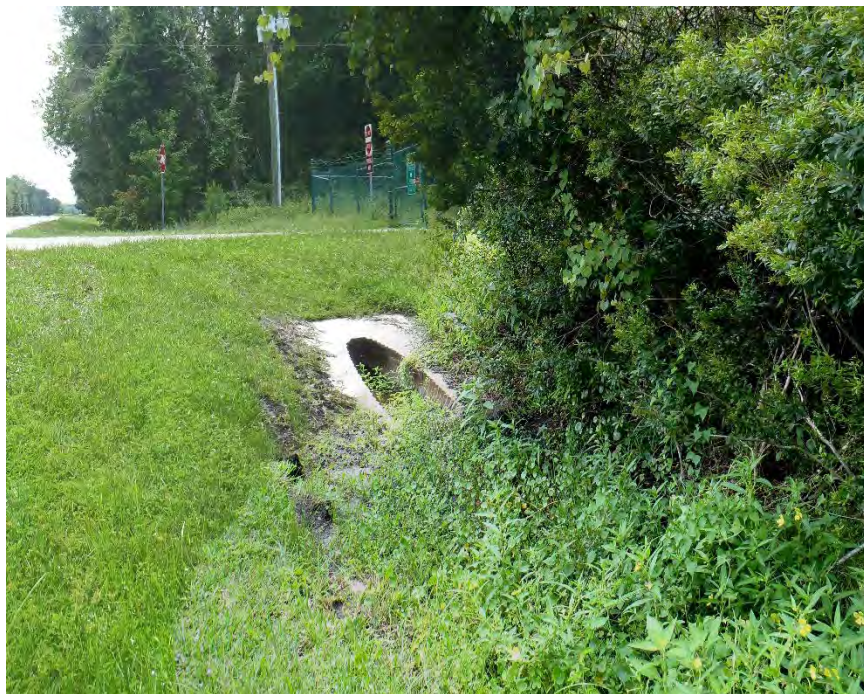
Photo 138. View of Physical Feature: Culvert as seen looking south from GPS location 1031 (Frames 1769-1670; 08/26/15).

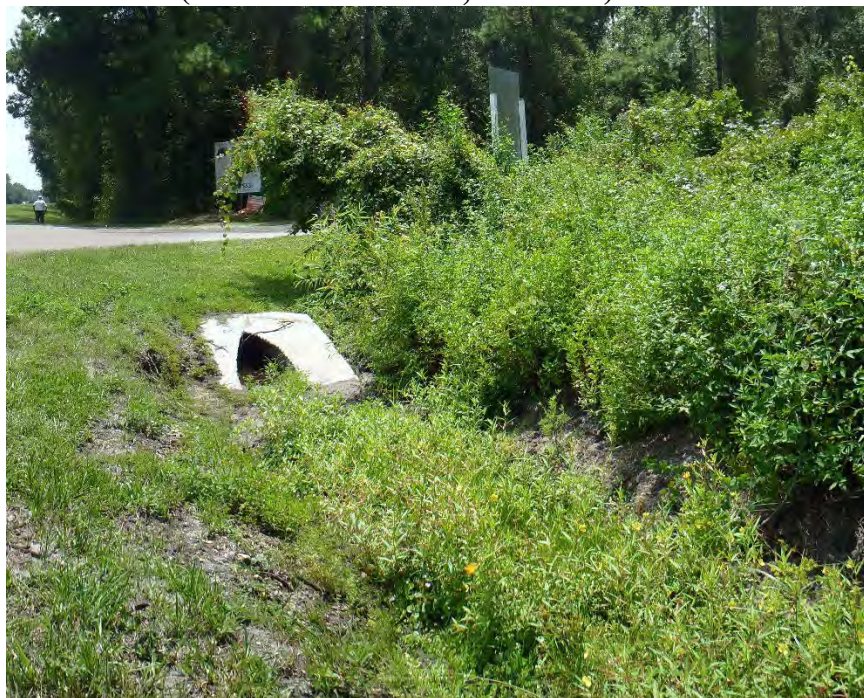
Photo 139. View of Physical Feature: Culvert as seen looking south from GPS location 1032 (Frames 1771-1772; 08/26/15).

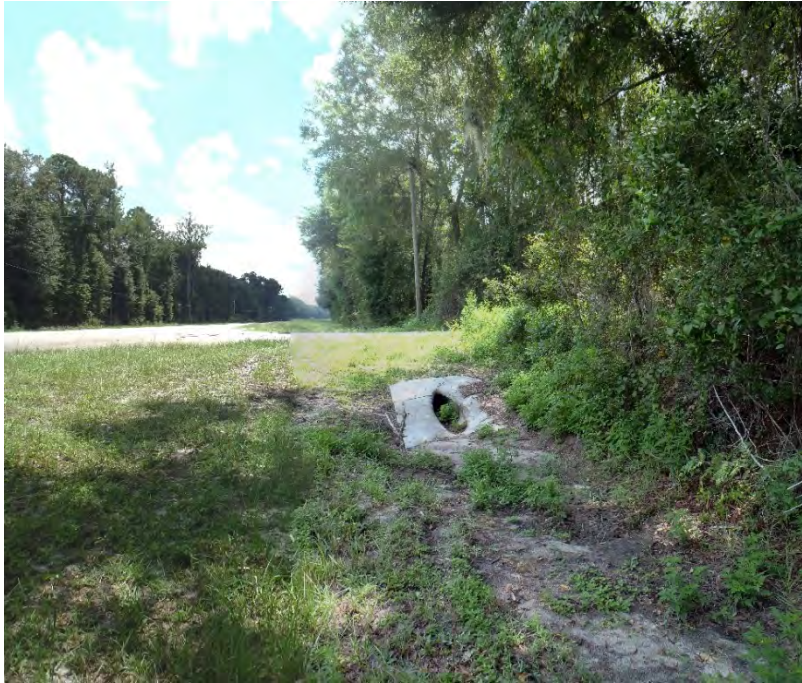
Photo 140. View of Physical Feature: Culvert as seen looking south from GPS location 1033 (Frames 1773-1774; 08/26/15).

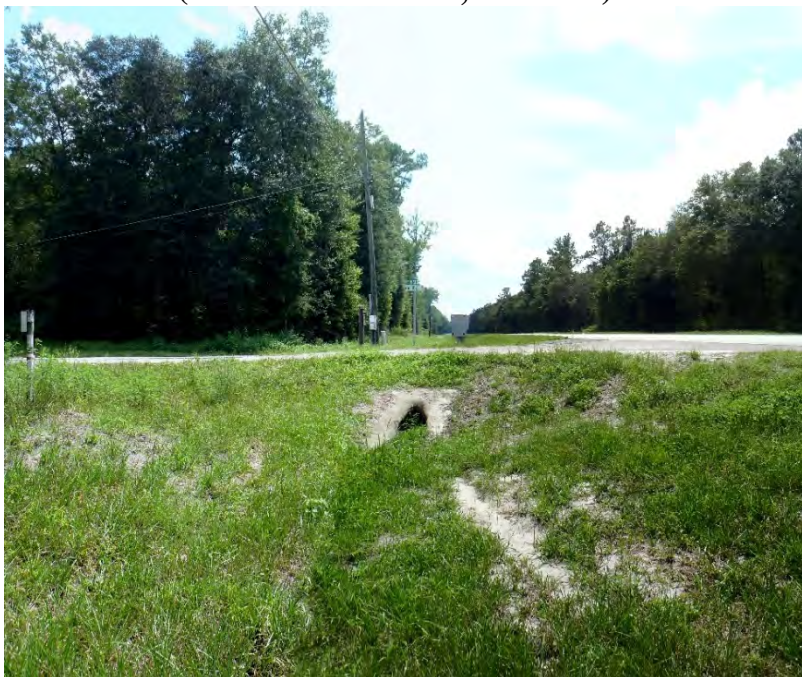
Photo 141. View of Physical Feature: Culvert as seen looking south from GPS location 1036 (Frames 1777-1778; 08/26/15).

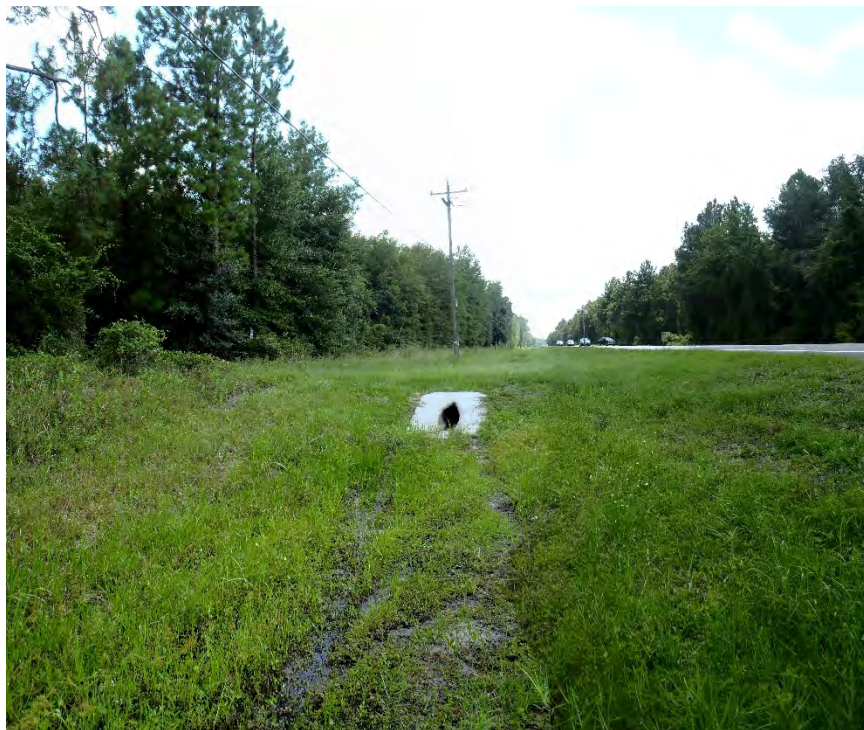
Photo 142. View of Physical Feature: Culvert as seen looking south from GPS location 1037 (Frames 1779-1780; 08/26/15).

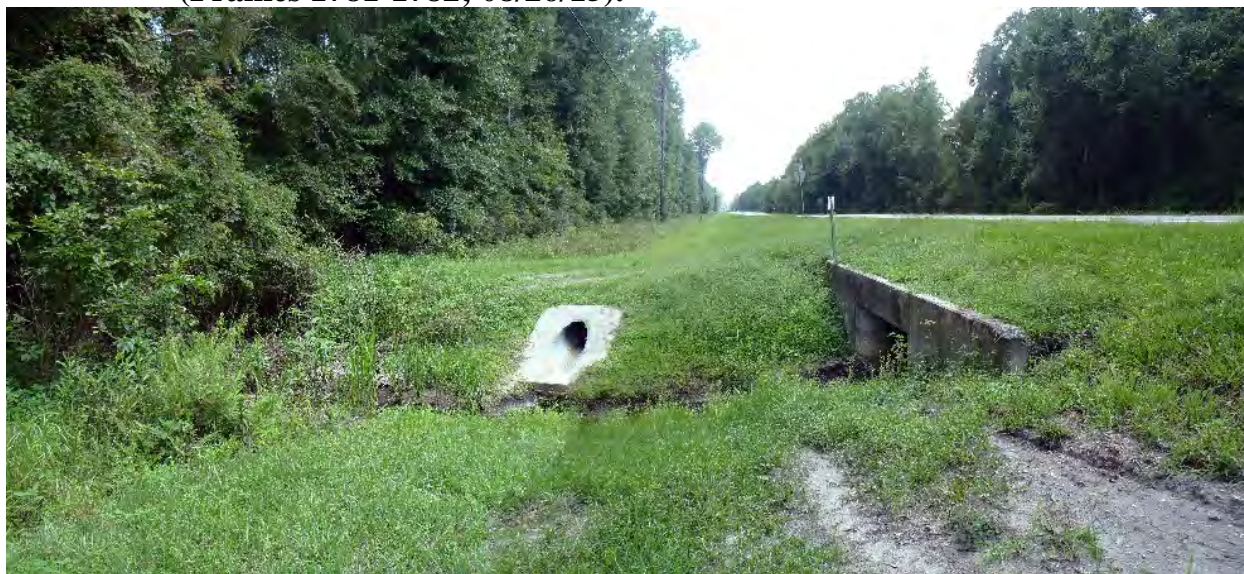
Photo 143. View of Physical Feature: Culvert as seen looking south from GPS location 1038 (Frames 1781-1782; 08/26/15).

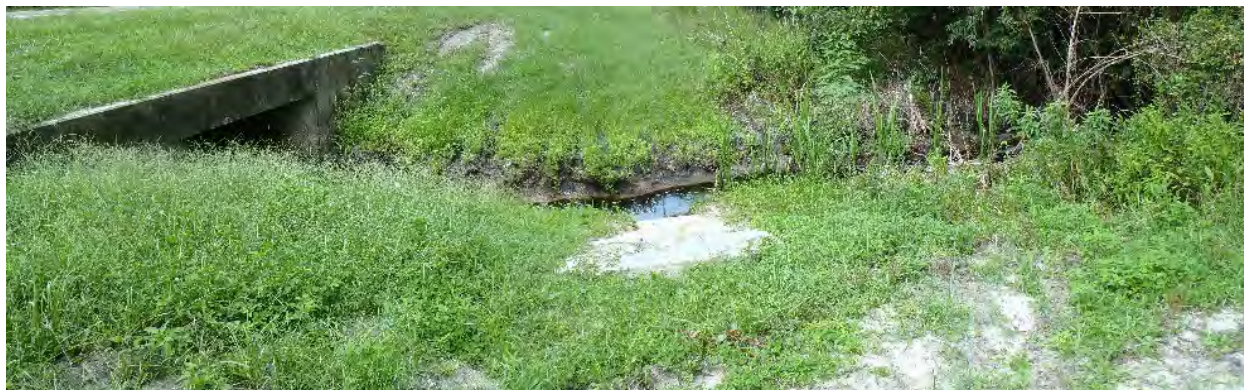
Photo 144. View of Physical Feature: Culvert as seen looking south from GPS location 1039 (Frames 1783-1784; 08/26/15).

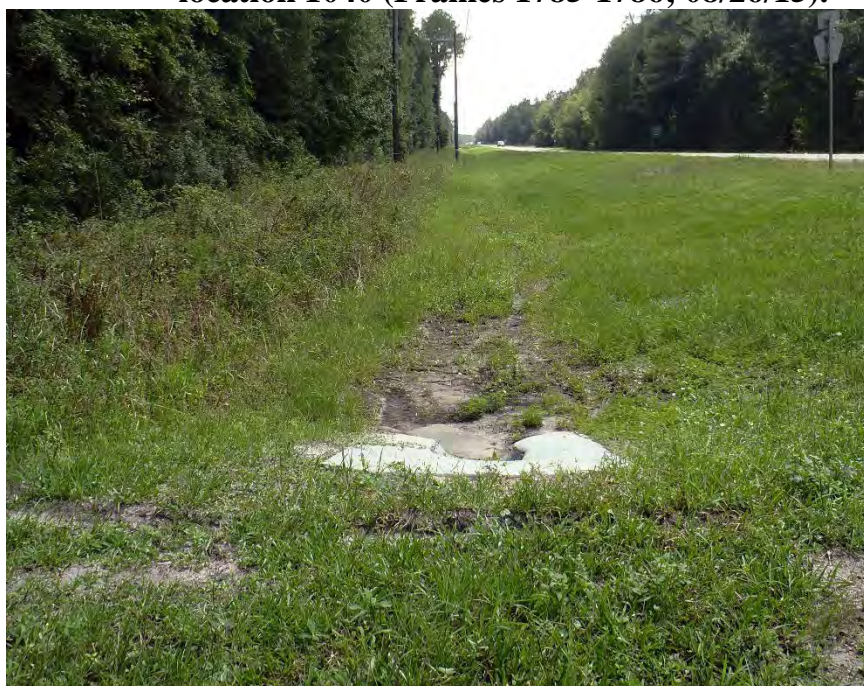
Photo 145. View of Physical Feature: Culvert as seen looking north from GPS location 1040 (Frames 1785-1786; 08/26/15).

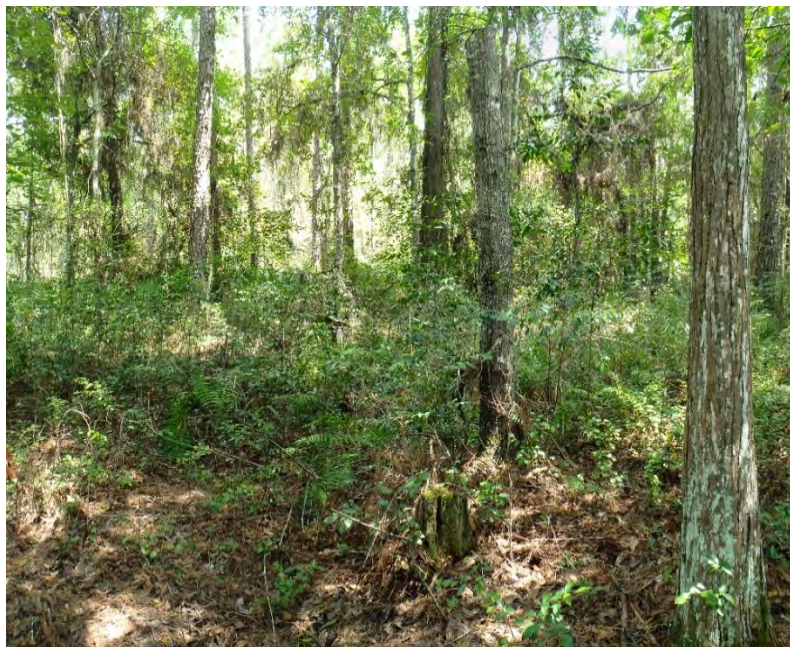
Photo 146. View of Physical Feature: Culvert as seen looking south from GPS location 1040 (Frame 1787; 08/26/15).

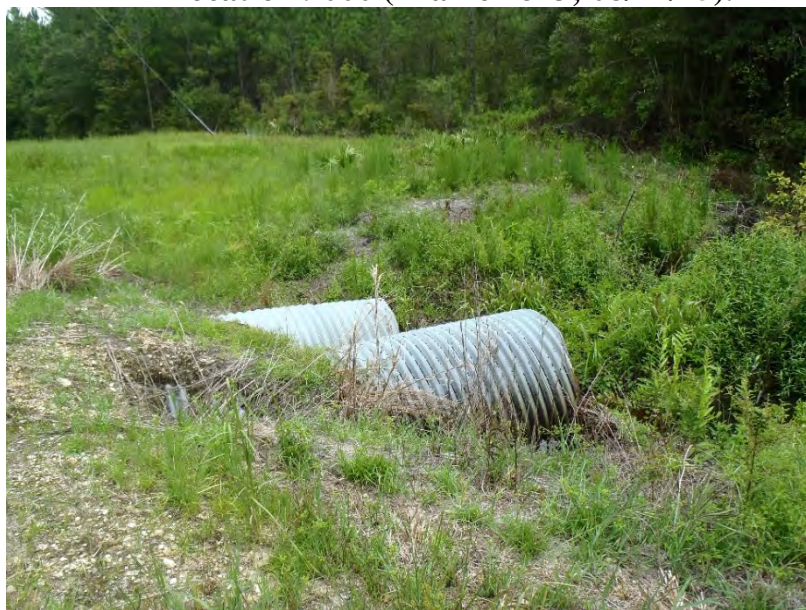
Photo 160. View of culverts on north side of power line easement within the Planted Pine-Mesic Pine Flatwoods located at GPS location 9000 (Frame 1813; 08/27/15).

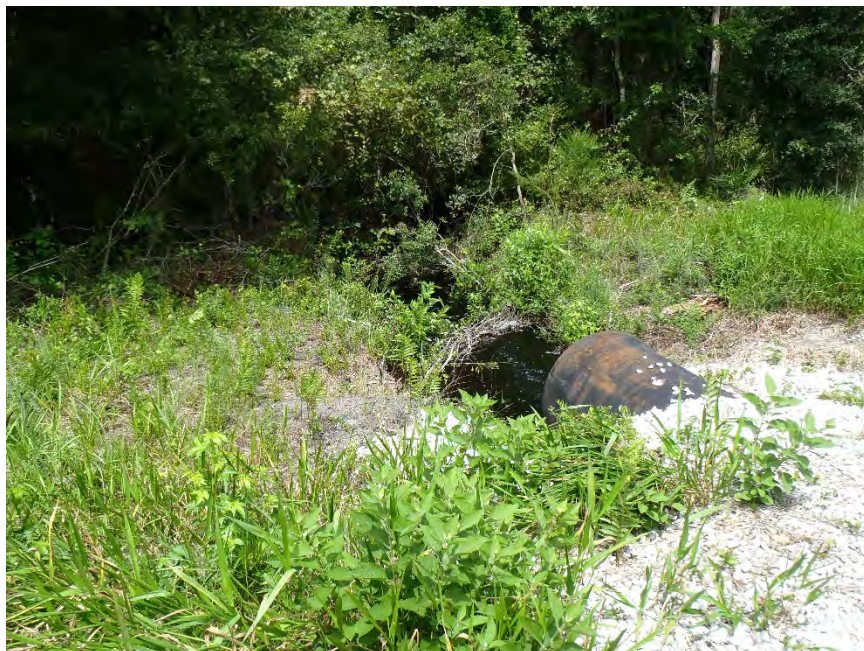
Photo 161. View of culverts on south side of power line easement within the Planted Pine-Mesic Pine Flatwoods located at GPS location 9000 (Frame 1814; 08/27/15).

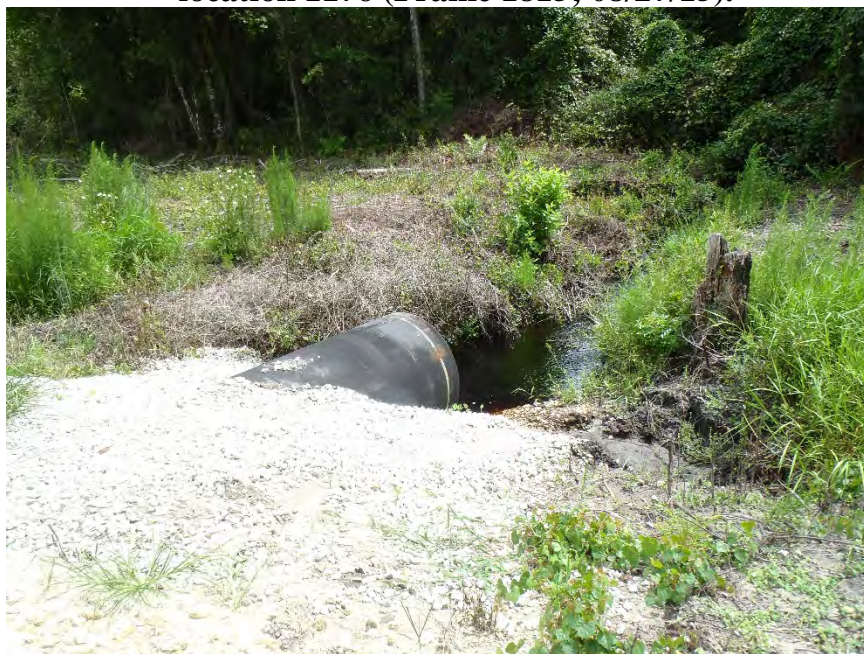
Photo 162. View of Physical Feature: Culvert located on north side of power line easement at GPS location 1176 (Frame 1815; 08/27/15).

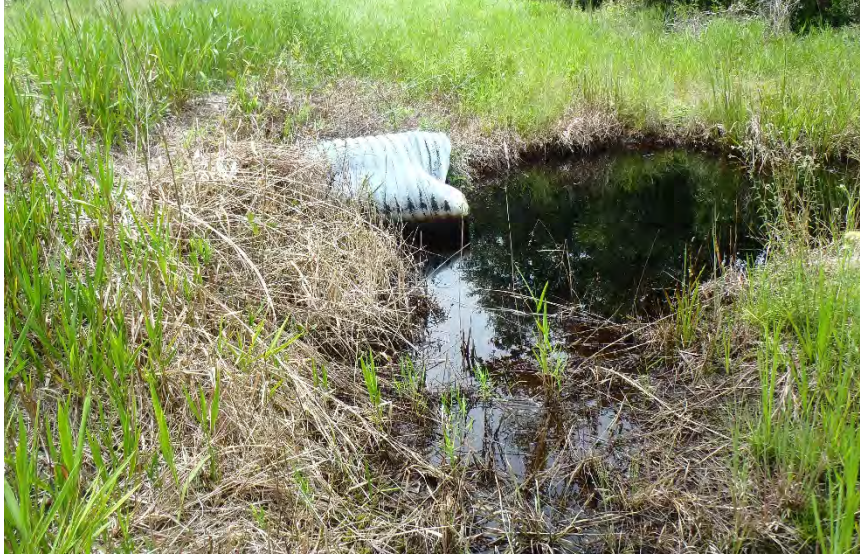
Photo 163. View of Physical Feature: Culvert located on south side of power line easement at GPS location 1176 (Frame 1816; 08/27/15).

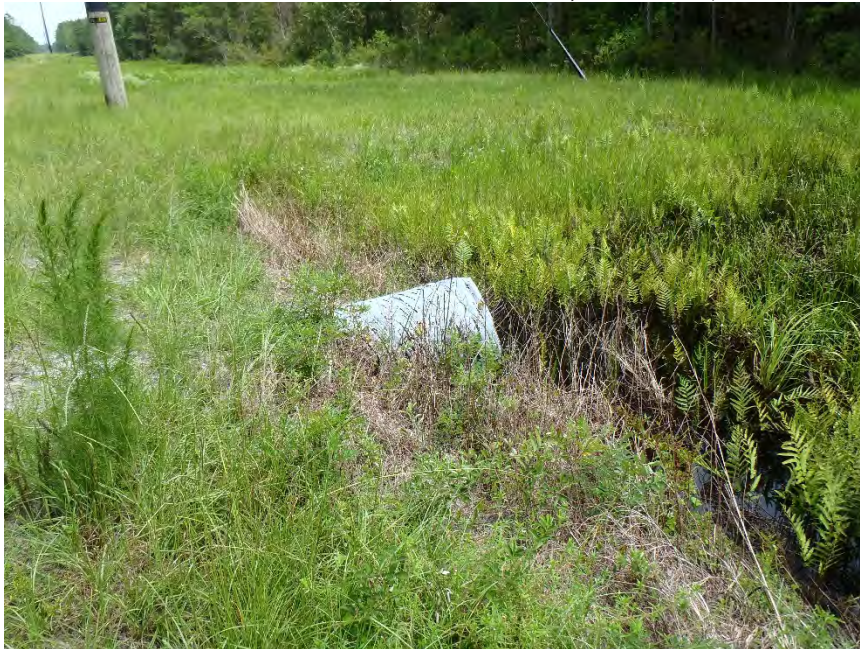
Photo 164. View of Physical Feature: Culvert located on north side of power line easement at GPS location 1177 (Frame 1817; 08/27/15).

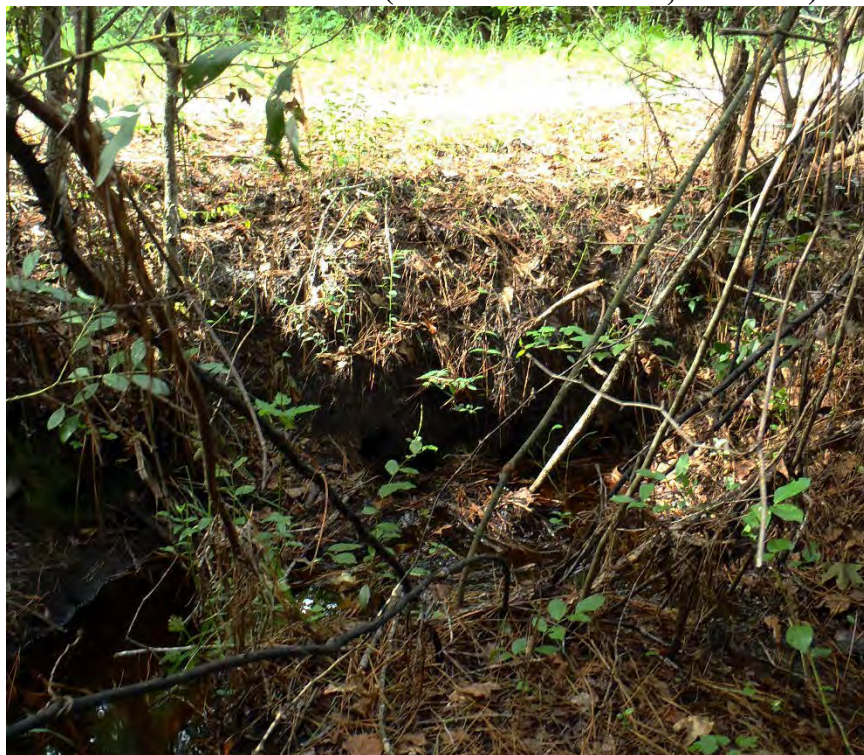
Photo 176. View of Surface Water: Excavated Creek in Wetland as seen looking southwest from GPS location 1305 (Frames 1838-1839; 08/27/15).

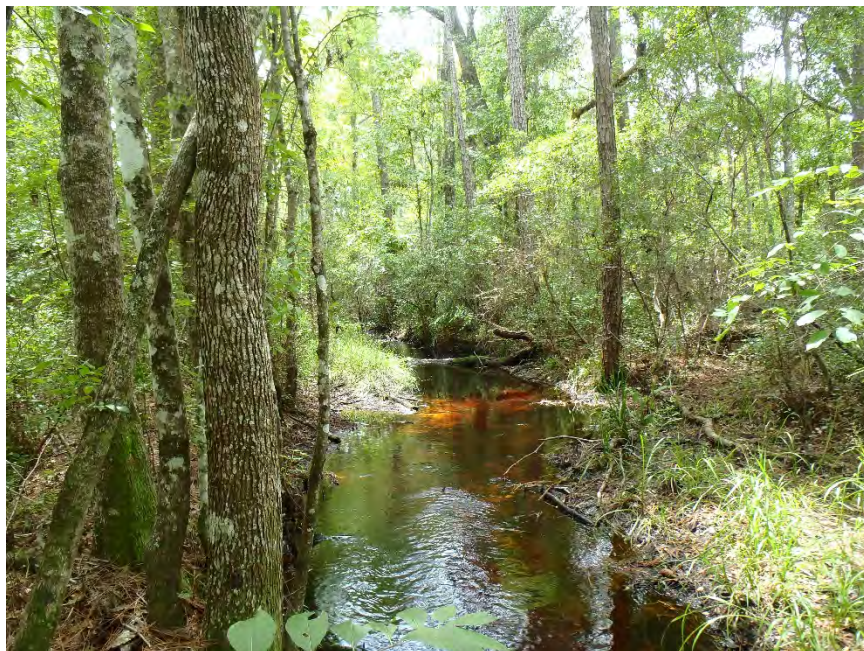
Photo 179. View of Surface Water: Excavated Creek in Wetland as seen looking north from GPS location 1343 (Frame 1846; 08/28/15).

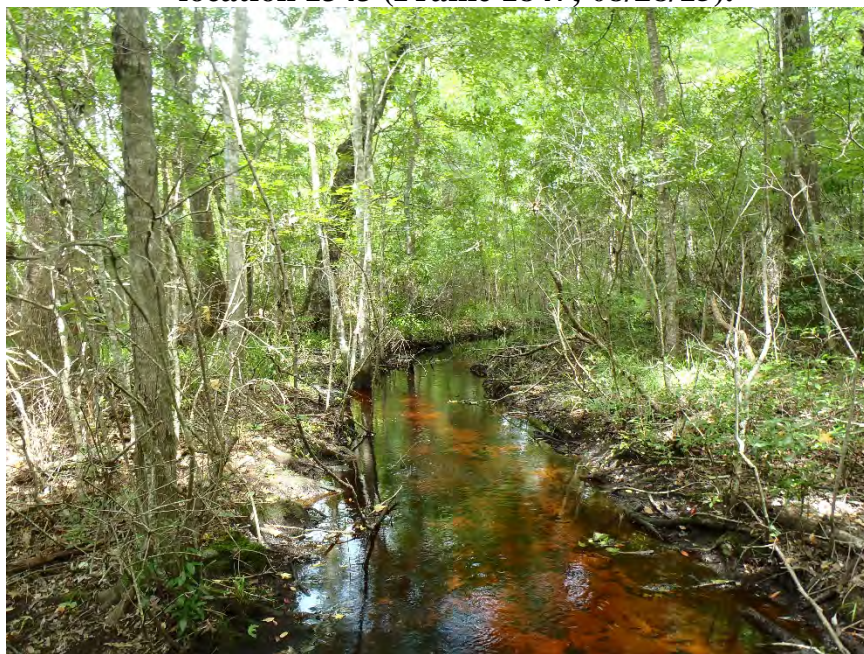
Photo 180. View of Surface Water: Excavated Creek in Wetland as seen looking south from GPS location 1343 (Frame 1847; 08/28/15).

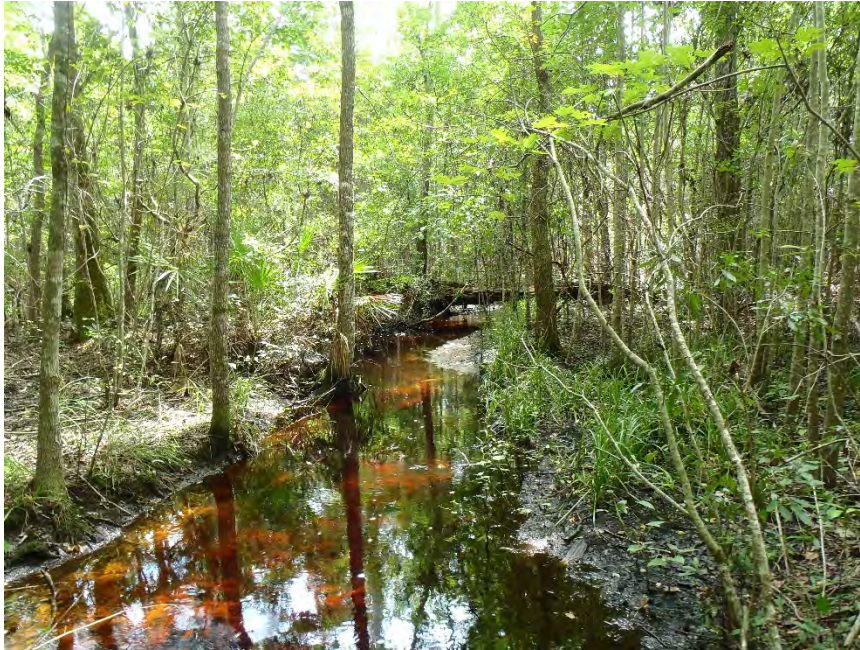
Photo 181. View of Surface Water: Excavated Creek in Wetland as seen looking north from GPS location 1343 (Frame 1852; 08/28/15).

Photo 181. View of Surface Water: Excavated Creek in Wetland as seen looking north from GPS location 1343 (Frame 1852; 08/28/15).	349
Photo 182. View of Surface Water: Excavated Creek in Wetland as seen looking south from GPS location 1343 (Frame 1853; 08/28/15).....	350
Photo 183. View of Wetland: Mixed Hardwood Swamp as seen looking south from GPS location 1348 (Frames 1848-1849; 08/28/15).....	350
Photo 184. View of Wetland: Hydric Hammock as seen looking north from GPS location 1350 (Frames 1850-1851; 08/28/15).....	351
Photo 185. View of Transitional: Planted Pine Flatwoods as seen looking west from GPS location 1414 (Frames 1854-1855; 08/28/15).....	351
Photo 186. View of Mesic: Planted Pine-Mesic Pine Flatwoods as seen looking south from GPS location 1437 (Frames 1856-1857; 08/28/15).....	352
Photo 187. View of Hydric: Planted Pine Flatwoods as seen looking southwest from GPS location 1450 (Frames 1858-1859; 08/28/15).....	352

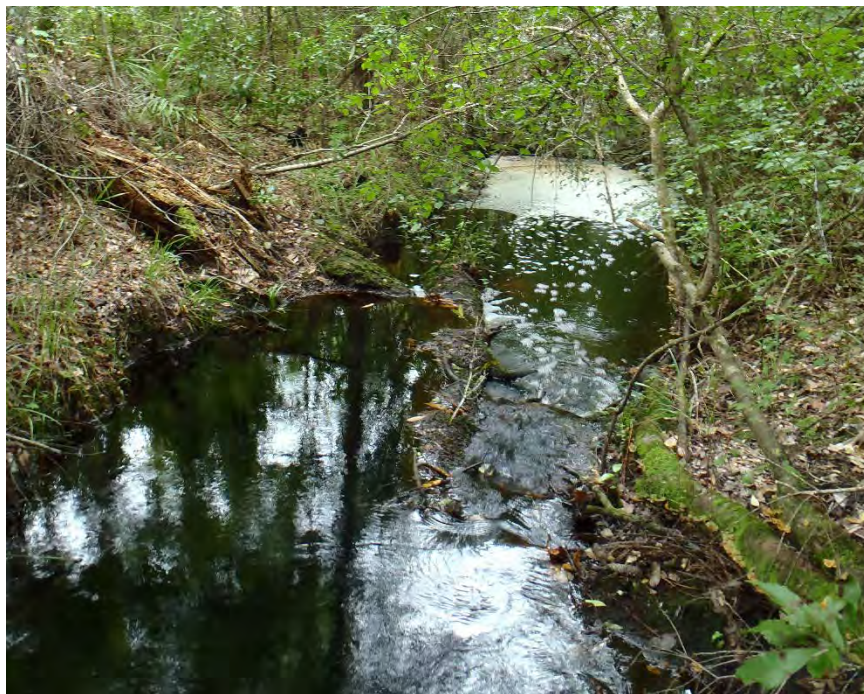
Photo 189. View of Surface Water: Excavated Creek in Wetland as seen looking west from GPS location 1473 (Frame 1862; 08/28/15).

Photo 188. View of Planted Pine-Mesic Pine Flatwoods as seen looking north from GPS location 1467 (Frames 1860-1861; 08/28/15).....	353
Photo 189. View of Surface Water: Excavated Creek in Wetland as seen looking west from GPS location 1473 (Frame 1862; 08/28/15).	353
Photo 190. View of Surface Water: Excavated Creek in Wetland as seen looking east from GPS location 1473 (Frame 1863; 08/28/15).....	354
Photo 191. Rocky Creek: view to south of east side of culverts at CR 231 at GPS location 1516 (Frame 7406; 08/28/15).....	354

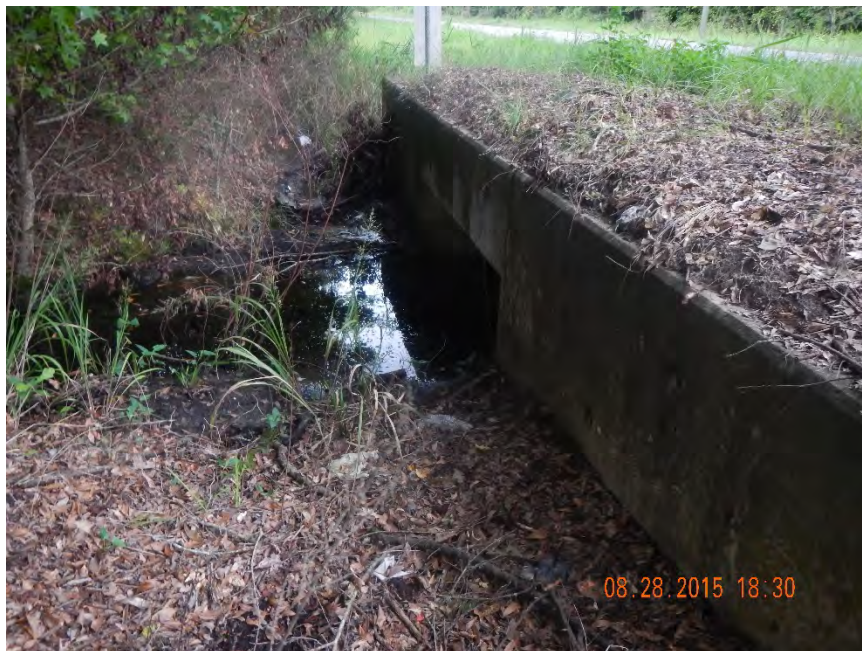
Photo 191. Rocky Creek: view to south of east side of culverts at CR 231 at GPS location 1516 (Frame 7406; 08/28/15).

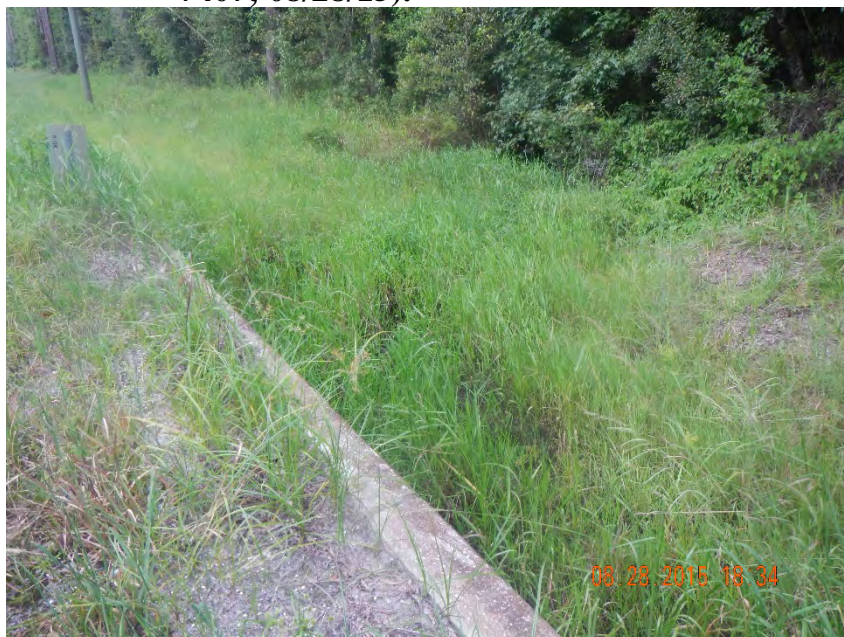
Photo 192. Rocky Creek: view to south of box culvert on east side CR 231 at GPS location 1516 (Frame 7407; 08/28/15).

Photo 192. Rocky Creek: view to south of box culvert on east side CR 231 at GPS location 1516 (Frame 7407; 08/28/15).....	355
Photo 193. Rocky Creek: view to south of box culverts on west side of CR 231 at GPS location 1516 (Frame 7408; 08/28/15).....	355
Photo 194. Rocky Creek: view to east (downstream) of CR 231 culverts located at GPS location 1517 (Frame 7410; 08/28/15).....	356
Photo 195. Rocky Creek: view to south of culverts located at GPS location 1517 on east side of CR 231 at GPS location 1517 (Frame 7411; 08/28/15).	356
Photo 196. Rocky Creek: view to south of culvert at west side of CR 231 at GPS location 1517 (Frame 7412; 08/28/15).....	357
Photo 197. View to east (upstream) of major branch of Rocky Creek at culvert located at GPS location 1518 (Frame 7414; 08/28/15).	357
Photo 198. View to south of box culverts on east side (upstream) of CR 231 in Rocky Creek at GPS location 1518 (Frame 7416; 08/28/15).....	358

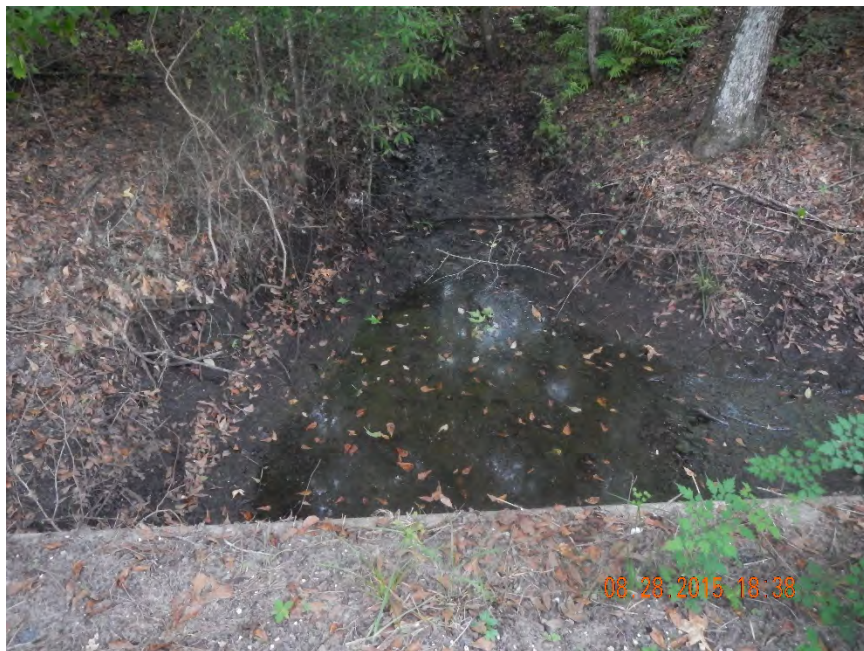
Photo 193. Rocky Creek: view to south of box culverts on west side of CR 231 at GPS location 1516 (Frame 7408; 08/28/15).

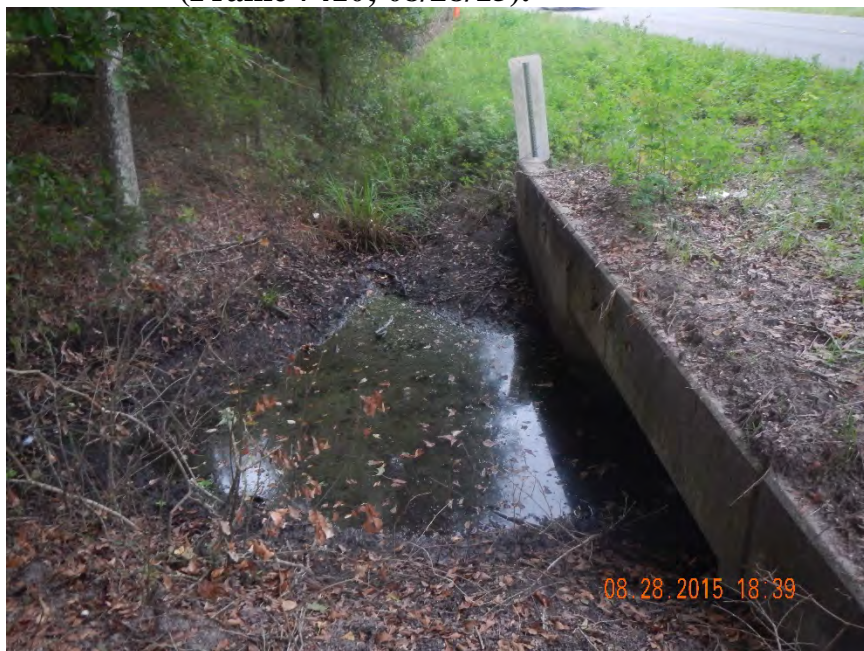
Photo 194. Rocky Creek: view to east (downstream) of CR 231 culverts located at GPS location 1517 (Frame 7410; 08/28/15).

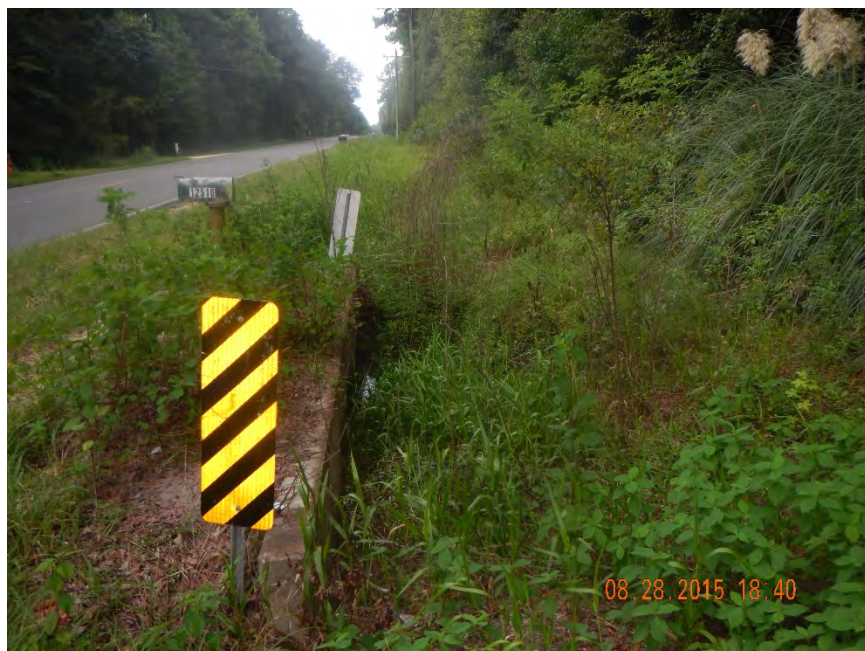
Photo 195. Rocky Creek: view to south of culverts located at GPS location 1517 on east side of CR 231 at GPS location 1517 (Frame 7411; 08/28/15).

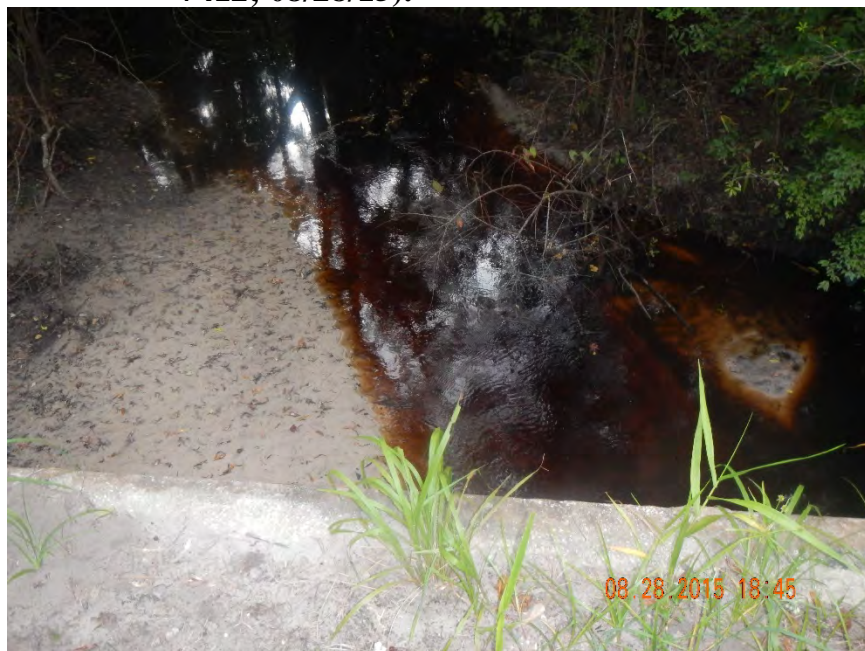
Photo 196. Rocky Creek: view to south of culvert at west side of CR 231 at GPS location 1517 (Frame 7412; 08/28/15).

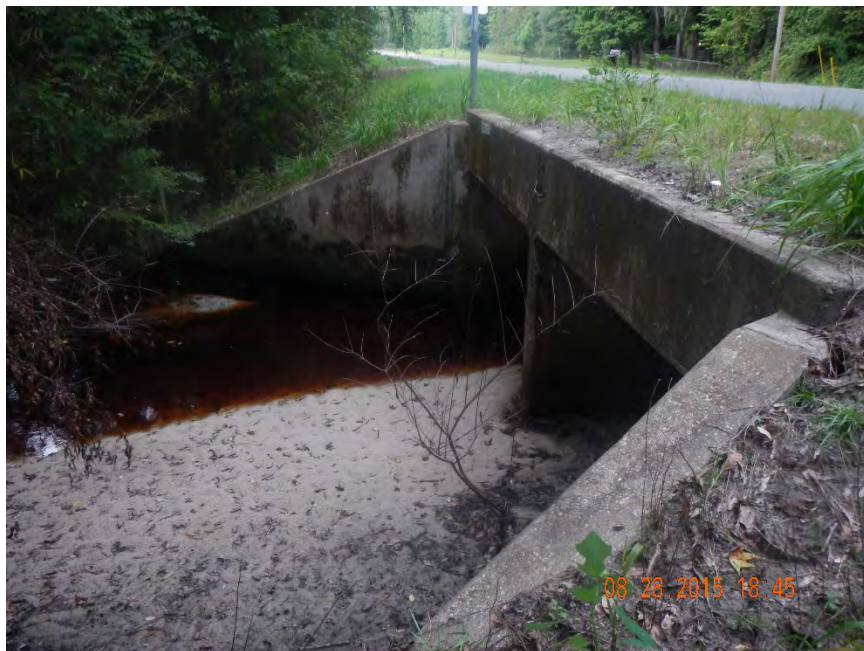
Photo 197. View to east (upstream) of major branch of Rocky Creek at culvert located at GPS location 1518 (Frame 7414; 08/28/15).

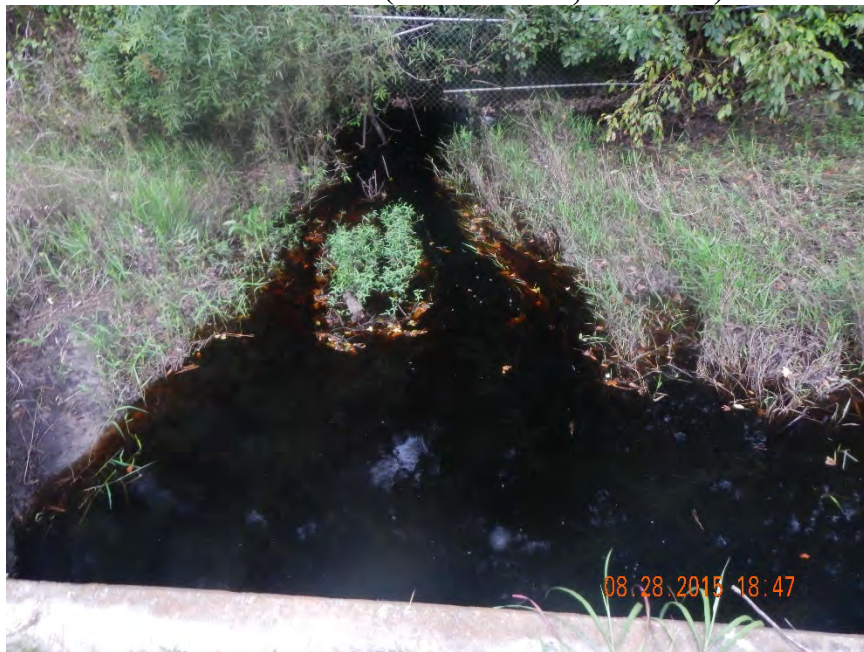
Photo 198. View to south of box culverts on east side (upstream) of CR 231 in Rocky Creek at GPS location 1518 (Frame 7416; 08/28/15).

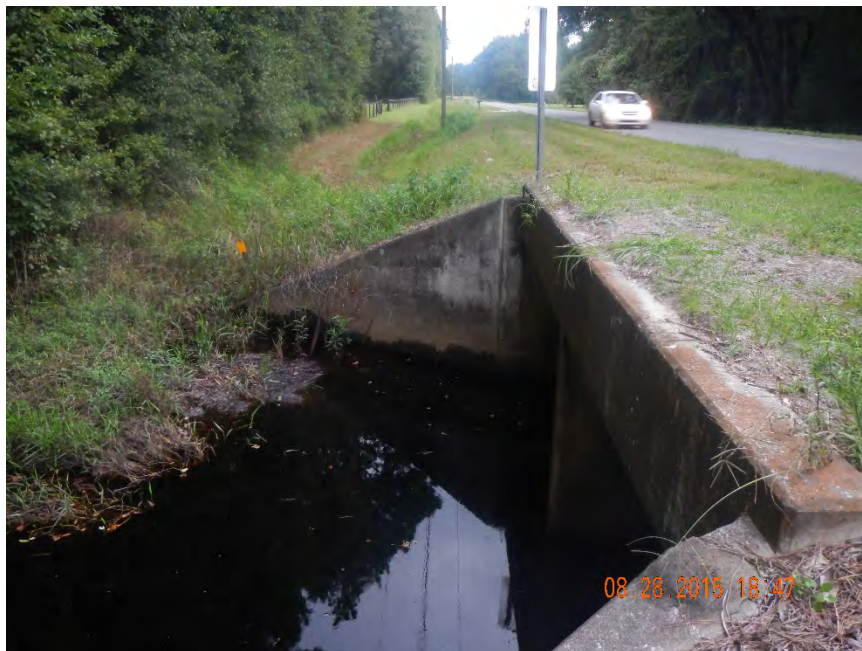
Photo 199. Rocky Creek: view to west (downstream) of major branch of Rocky Creek at culvert located at GPS location 1518 (Frame 7419; 08/28/15).

Photo 199. Rocky Creek: view to west (downstream) of major branch of Rocky Creek at culvert located at GPS location 1518 (Frame 7419; 08/28/15).	358
Photo 200. Rocky Creek: view to north along CR 231 of west side of box culverts located at GPS location 1518 (Frame 7420; 08/28/15).....	359
Photo 201. View of Wetland: Planted Pine-Marsh as seen looking southeast from GPS location 1534 (Frames 1864-1865; 08/31/15).....	359
Photo 202. View of Wetland: Planted Pine-Marsh as seen looking west from GPS location 1553 (Frames 1866-1867; 08/31/15).	360
Photo 203. View of Mesic: Planted Pine-Mesic Pine Flatwoods as seen looking west from GPS location 1568 (Frames 1868-1869; 08/31/15).	360
Photo 204. View of Wetland: Mixed Hardwood Swamp as seen looking southwest from GPS location 1578 (Frames 1870-1871; 08/31/15).....	361
Photo 205. View of Wetland: Planted Pine-Mixed Hardwoods as seen looking east from GPS location 1586 (Frames 1872-1873; 08/31/15).....	361

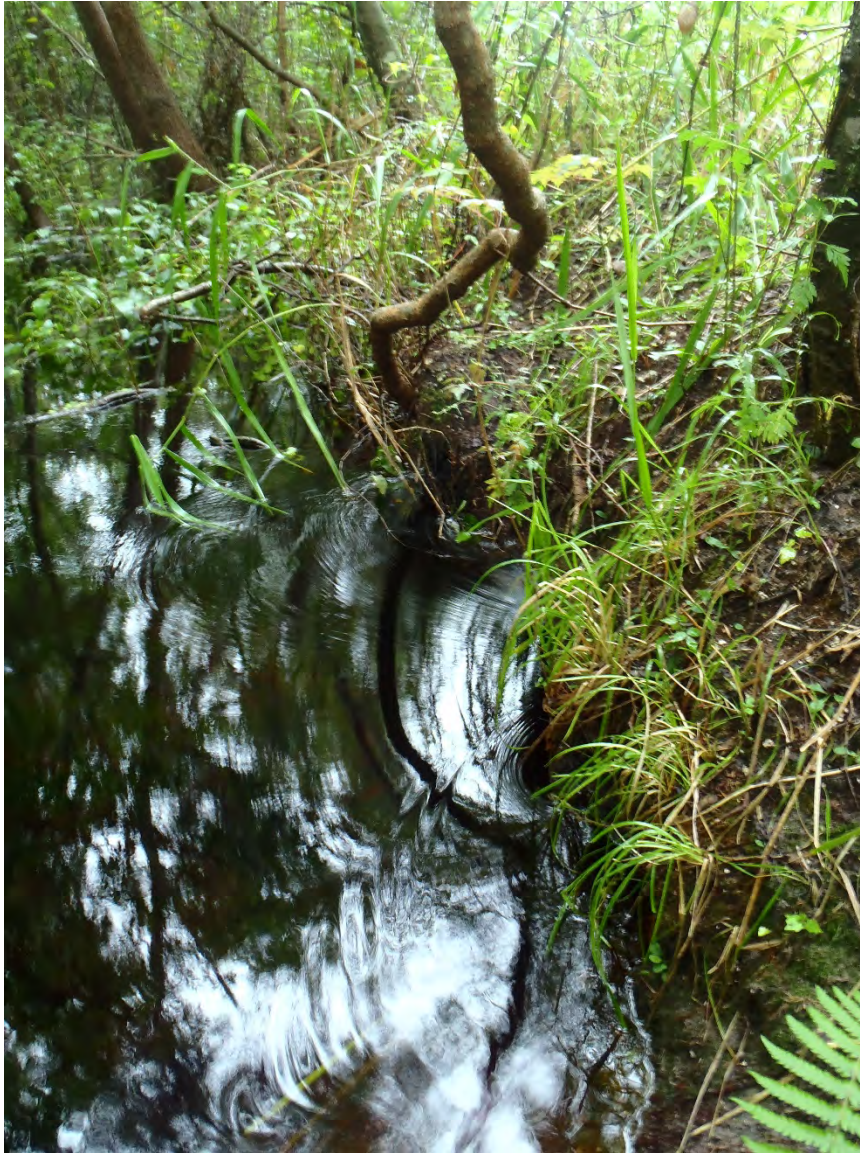
Photo 209. View of Physical Feature: Culvert located on north side of road at GPS location 1623 (Frame 1880; 08/31/15).

Photo 206. View of Wetland: Planted Pine-Mixed Hardwoods as seen looking west from GPS location 1586 (Frames 1874-1875; 08/31/15).	362
Photo 207. View of Mesic: Planted Pine-Mesic Pine Flatwoods as seen looking east from GPS location 1598 (Frames 1876-1877; 08/31/15).....	362
Photo 208. View of Wetland: Planted Pine-Marsh as seen looking east from GPS location 1605 (Frames 1878-1879; 08/31/15).	363
Photo 209. View of Physical Feature: Culvert located on north side of road at GPS location 1623 (Frame 1880; 08/31/15).....	363

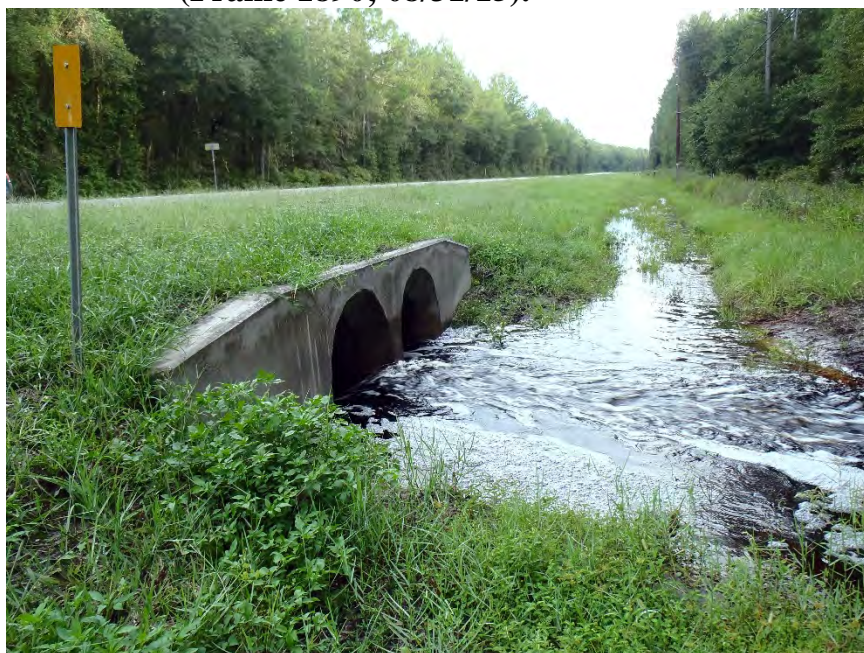
Photo 215. View of Physical Feature: Culvert located on east side of road as seen at GPS location 1693 (Frame 1890; 08/31/15).

Photo 210. View of Physical Feature: Culvert located on south side of road at GPS location 1570 (Frame 1881; 08/31/15).....	364
Photo 211. View of Mesic: Mixed Oaks-Hardwoods-Rabbit-eye Blueberry (<i>Vaccinium virgatum</i>) Understory as seen looking east from GPS location 1634 (Frames 1882-1883; 08/31/15).....	365
Photo 212. View of <i>Vaccinium virgatum</i> roots, stolon, and rhizomes as seen at GPS location 1634 (Frame 1884; 08/31/15).....	365
Photo 213. View of Wetlands: Mixed Hardwood Swamp-Bays-Fetterbush as seen looking south from GPS location 1657 (Frames 1886-1887; 08/31/15).....	366
Photo 214. View of Mesic: Mixed Oaks-Hardwoods-Rabbit-eye Blueberry Understory as seen looking north from GPS location 1676. View is of inundated forestry road (Frames 1888-1889; 08/31/15).....	366
Photo 215. View of Physical Feature: Culvert located on east side of road as seen at GPS location 1693 (Frame 1890; 08/31/15).....	367
