Natural Area Resource Assessment of the Gainesville 121 Project Site

Provided in support of a current
application for Planned Development

City of Gainesville, Florida

Ecosystem Research Corporation
2906 NW 142 Avenue
Gainesville, FL 32609

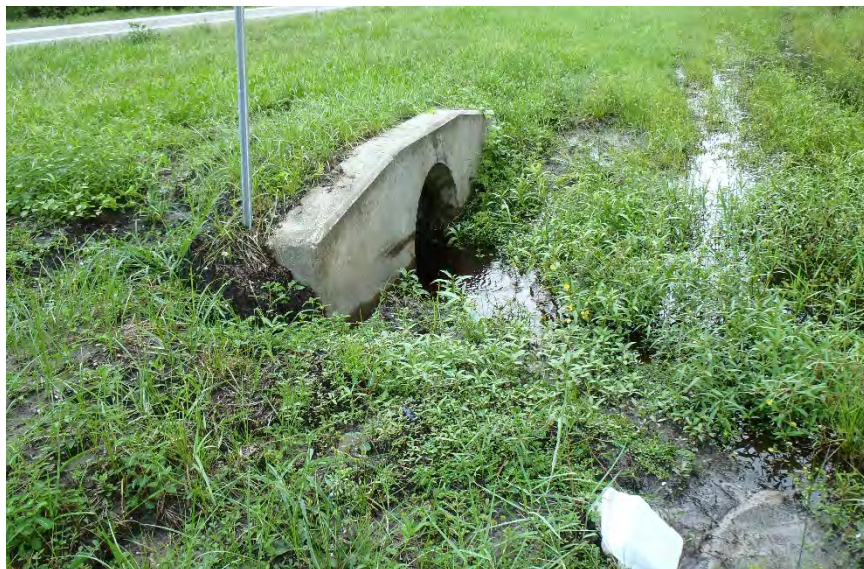
Photo 216. View of Physical Feature: Culvert located on west side of road as seen at GPS location 1694 (Frame 1891; 08/31/15).

Photo 216. View of Physical Feature: Culvert located on west side of road as seen at GPS location 1694 (Frame 1891; 08/31/15).....	367
Photo 217. View of Physical Feature: Culvert located on west side of road as seen at GPS location 1696 (Frame 1892; 08/31/15).....	368
Photo 218. View of Physical Feature: Culvert located on east side of road as seen at GPS location 1697 (Frame 1893; 08/31/15).....	368
Photo 219. View of Wetland: Mixed Hardwood Swamp as seen looking east from GPS location 5013 (Frames 1897-1898; 09/02/15).....	369
Photo 220. View of Hydric: Planted Pine Flatwoods as seen looking west from GPS location 5029 (Frames 1899-1900; 09/02/15).....	369
Photo 221. View of Wetland: Planted Pine-Mixed Hardwoods as seen looking east from GPS location 5038 (Frames 1901-1902; 09/02/15).....	370
Photo 222. View of Physical Feature Boundary: Wetland Delineation Flagging as seen looking northeast from GPS location 5044 (Frames 1903-1904; 09/02/15).....	370

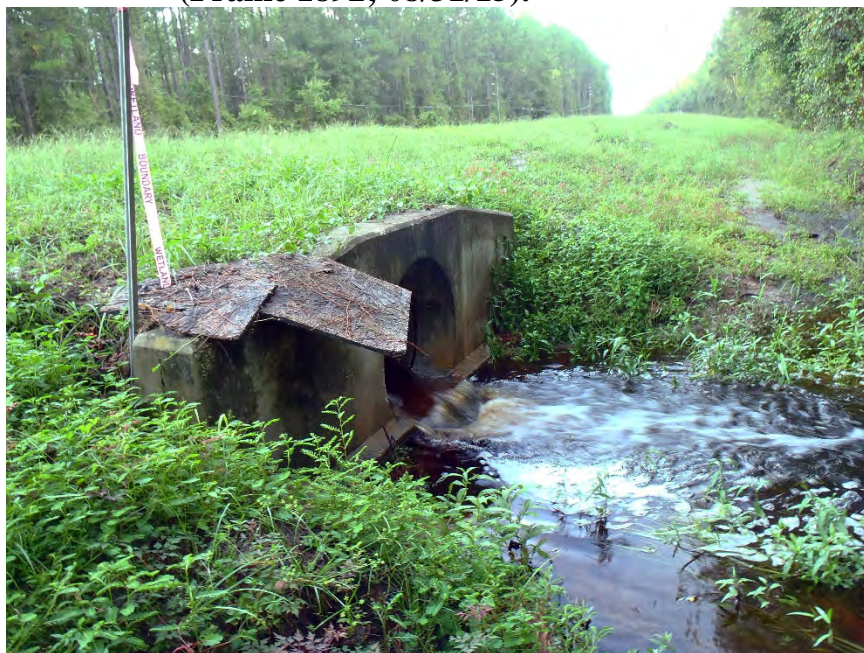
Photo 217. View of Physical Feature: Culvert located on west side of road as seen at GPS location 1696 (Frame 1892; 08/31/15).

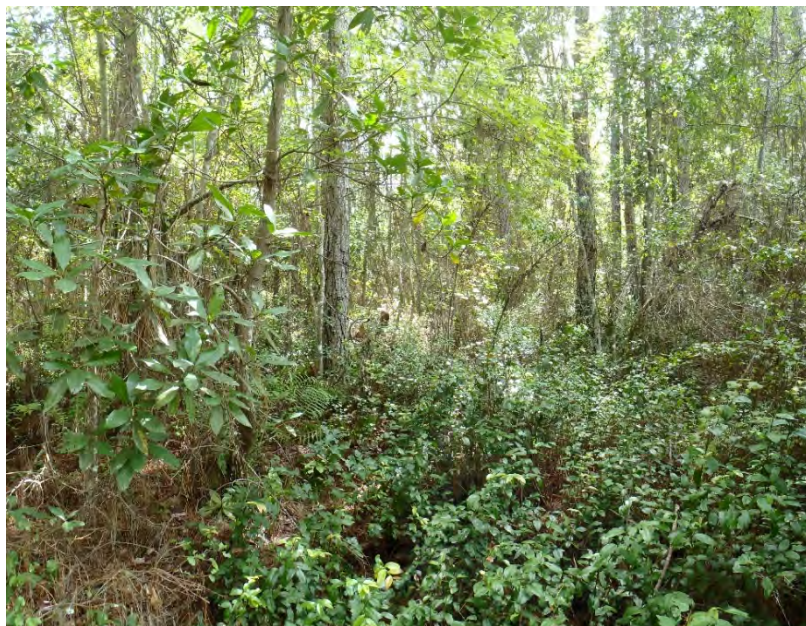
Photo 222. View of Physical Feature Boundary: Wetland Delineation Flagging as seen looking northeast from GPS location 5044 (Frames 1903-1904; 09/02/15).

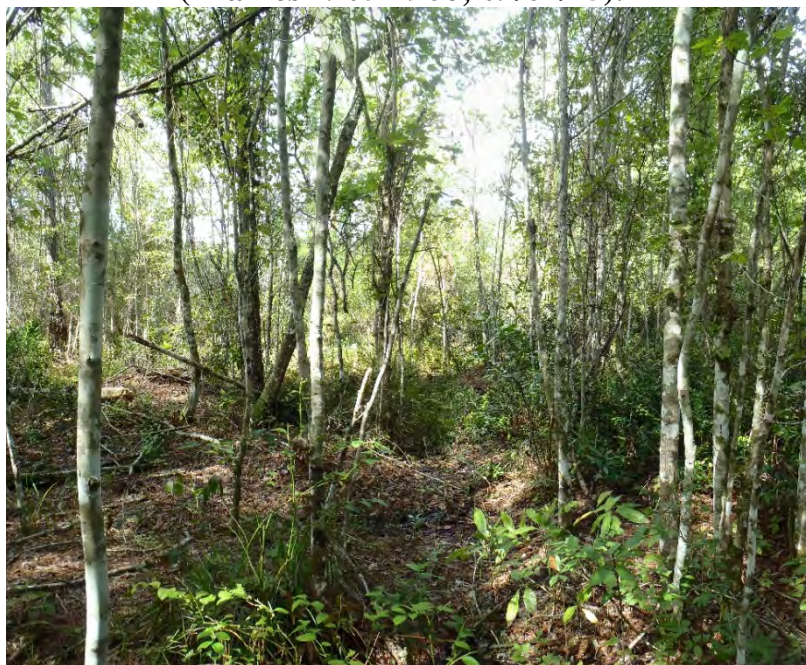
**Photo 223. View of Physical Feature Boundary:
Wetland Delineation Flagging as seen
looking southwest from GPS location 5044
(Frames 1905-1906; 09/02/15).**

Photo 223. View of Physical Feature Boundary: Wetland Delineation Flagging as seen looking southwest from GPS location 5044 (Frames 1905-1906; 09/02/15).....	371
Photo 224. View of Wetland: Mixed Hardwood Swamp as seen looking northeast from GPS location 5053 (Frames 1907-1908; 09/02/15).....	371
Photo 225. View of Surface Water: Excavated Creek in Wetland as seen looking south from GPS location 5076 (Frame 1909; 09/02/15).....	372

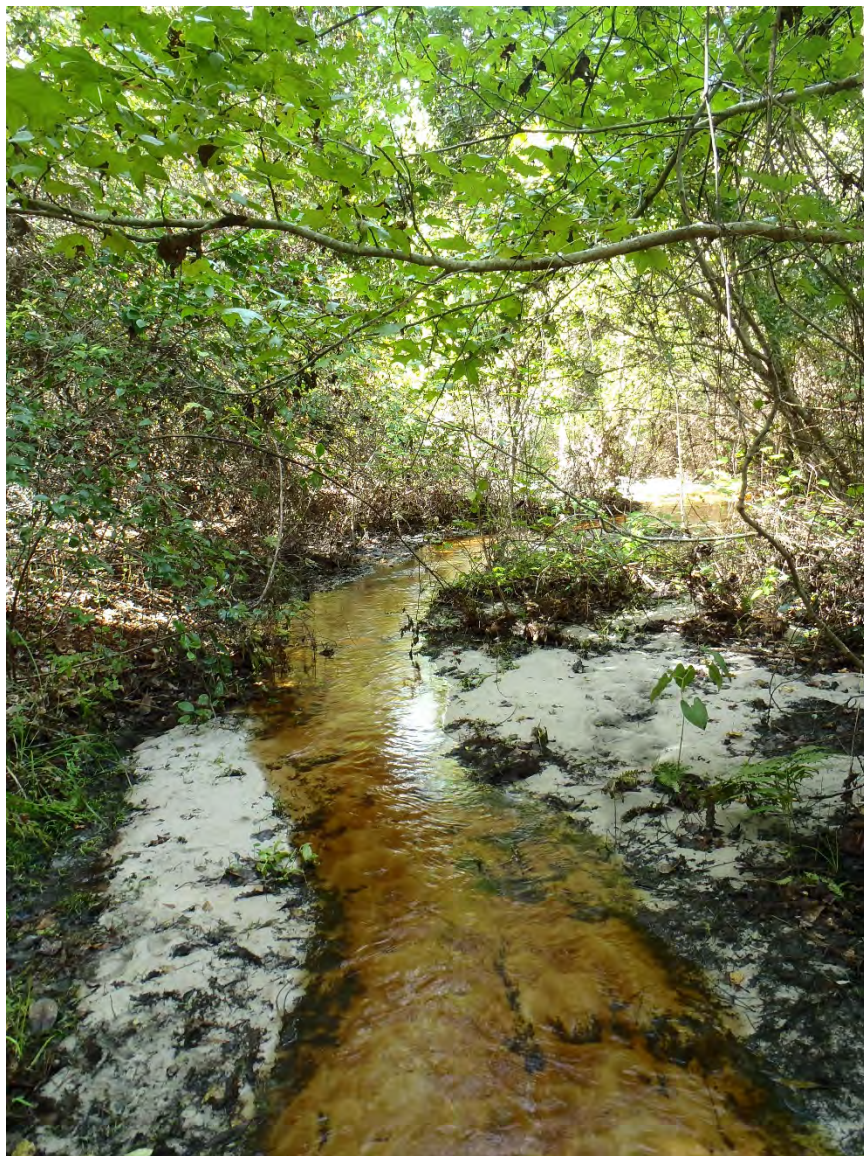
Photo 225. View of Surface Water: Excavated Creek in Wetland as seen looking south from GPS location 5076 (Frame 1909; 09/02/15).

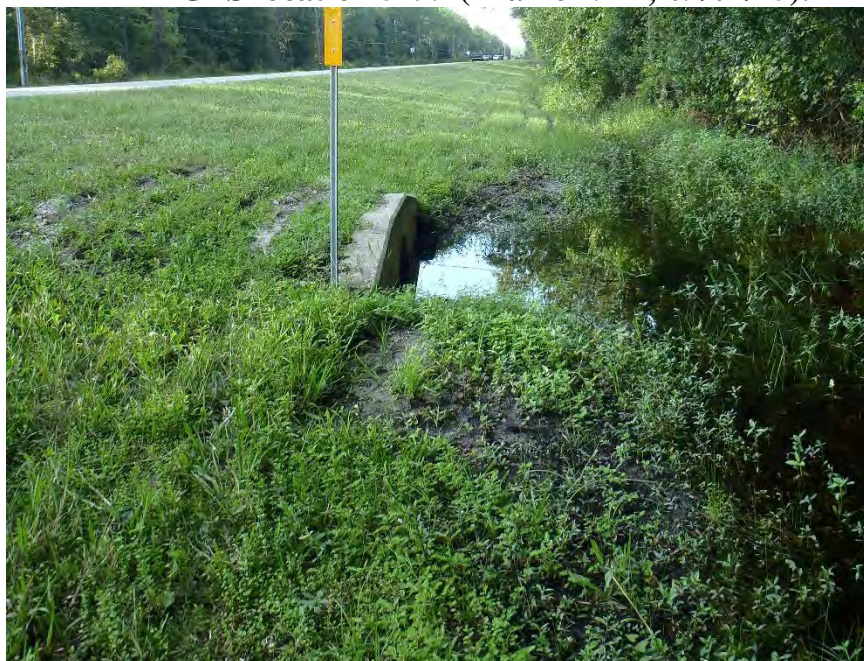
Photo 235. View of Physical Feature: Culvert located on east side of road as seen looking north from GPS location 5199 (Frame 1927; 09/02/15).

Photo 233. View of Wetland: Natural Flow-way as seen looking northeast from GPS location 5176 (Frames 1923-1924; 09/02/15).	377
Photo 234. View of Planted Pine-Mesic Pine Flatwoods as seen looking northeast from GPS location 5189 (Frames 1925-1926; 09/02/15).	377
Photo 235. View of Physical Feature: Culvert located on east side of road as seen looking north from GPS location 5199 (Frame 1927; 09/02/15).	378
Photo 236. View of Physical Feature: Culvert located on east side of road as seen looking north from GPS location 5200 (Frame 1928; 09/02/15).	378
Photo 237. View of Physical Feature: Culvert located on west side of road as seen looking north from GPS location 5201 (Frame 1929; 09/02/15).	379
Photo 238. View of Physical Feature: Culvert located on west side of road as seen looking north from GPS location 5202 (Frame 1930; 09/02/15).	379
Photo 239. View of Physical Feature: Culvert located on east side of road as seen looking north from GPS location 5203 (Frame 1931; 09/02/15).	380

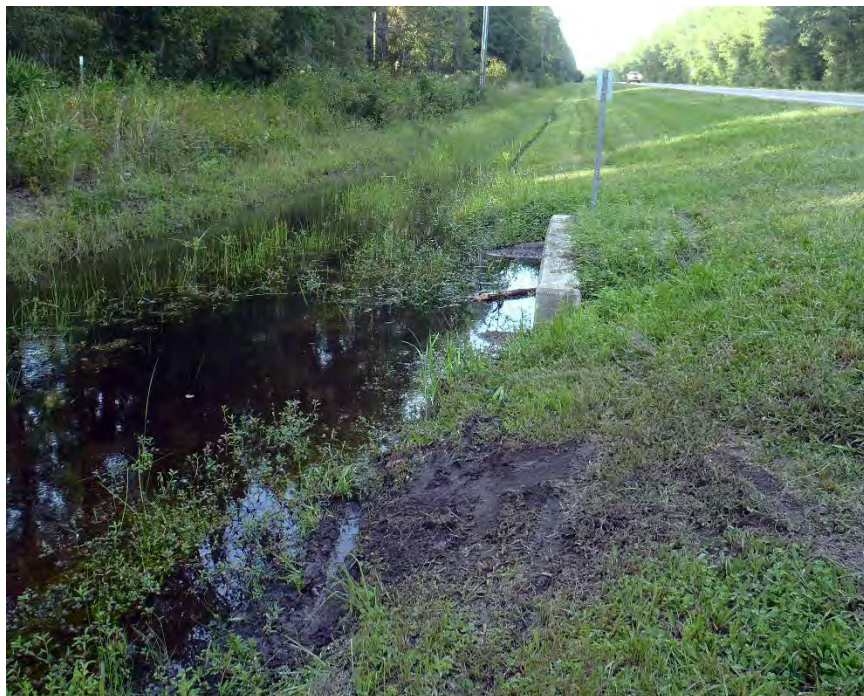
Photo 236. View of Physical Feature: Culvert located on east side of road as seen looking north from GPS location 5200 (Frame 1928; 09/02/15).

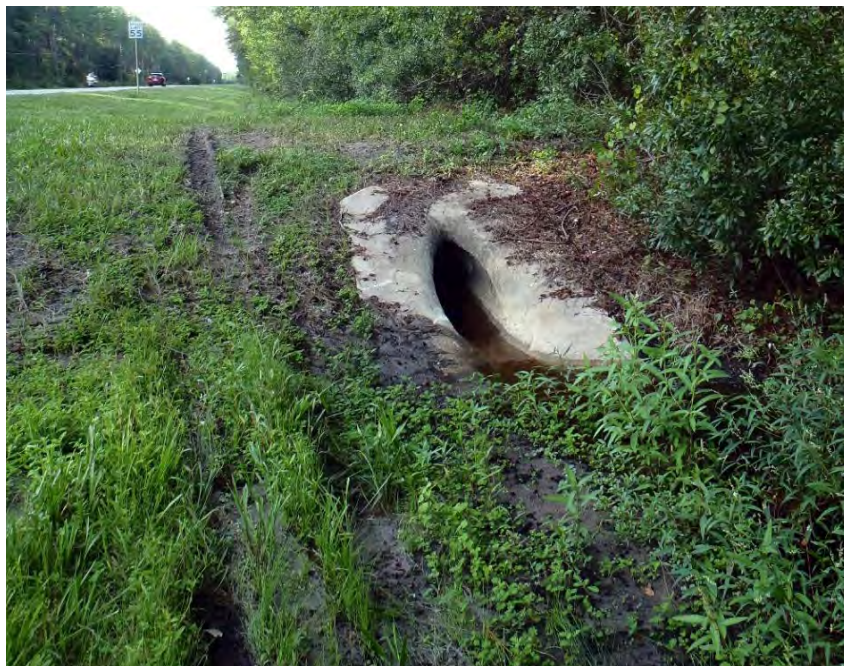
Photo 238. View of Physical Feature: Culvert located on west side of road as seen looking north from GPS location 5202 (Frame 1930; 09/02/15).

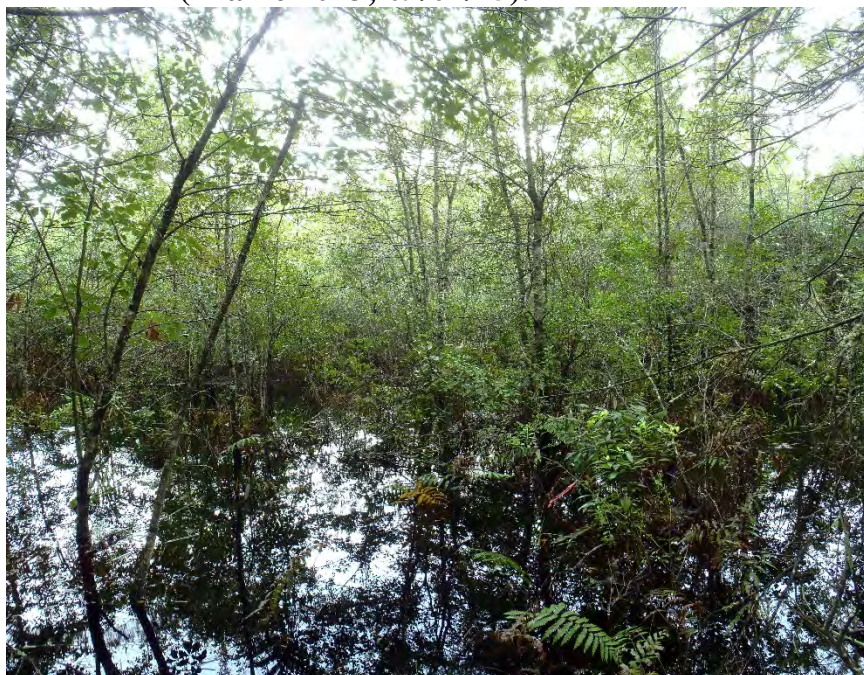
Photo 287. View of Hydric: Planted Pine Flatwoods as seen looking southwest from GPS location 5930 (Frames 2024-2025; 09/08/15).

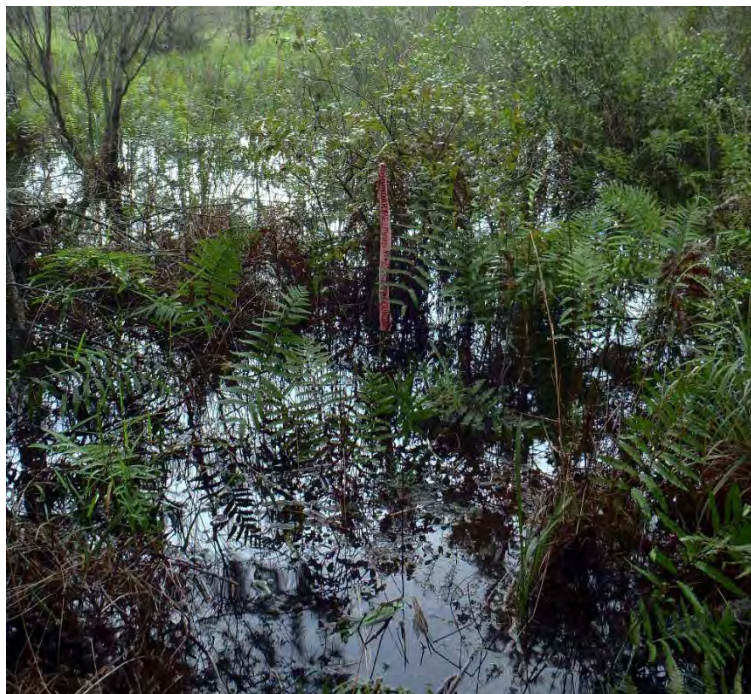
Photo 288. View of Physical Feature Boundary: Wetland Delineation Flagging within the Wetland: Planted Pine-Marsh as seen looking west from GPS location 5955 (Frame 2026; 09/08/15).

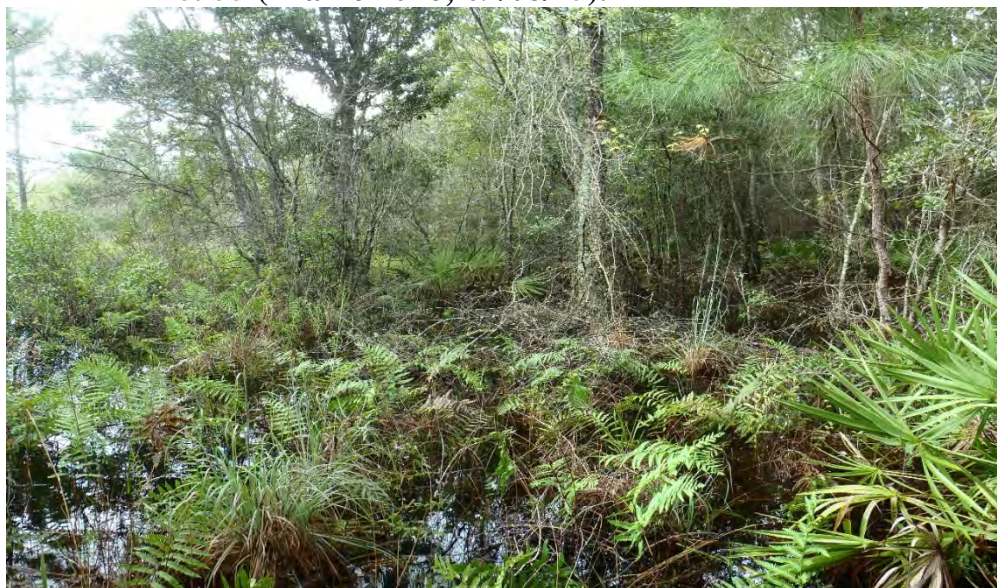
Photo 289. View of Physical Feature Boundary: Wetland Delineation Flagging within the Wetland: Planted Pine-Marsh as seen looking northwest from GPS location 5955 (Frames 2027-2028; 09/08/15).

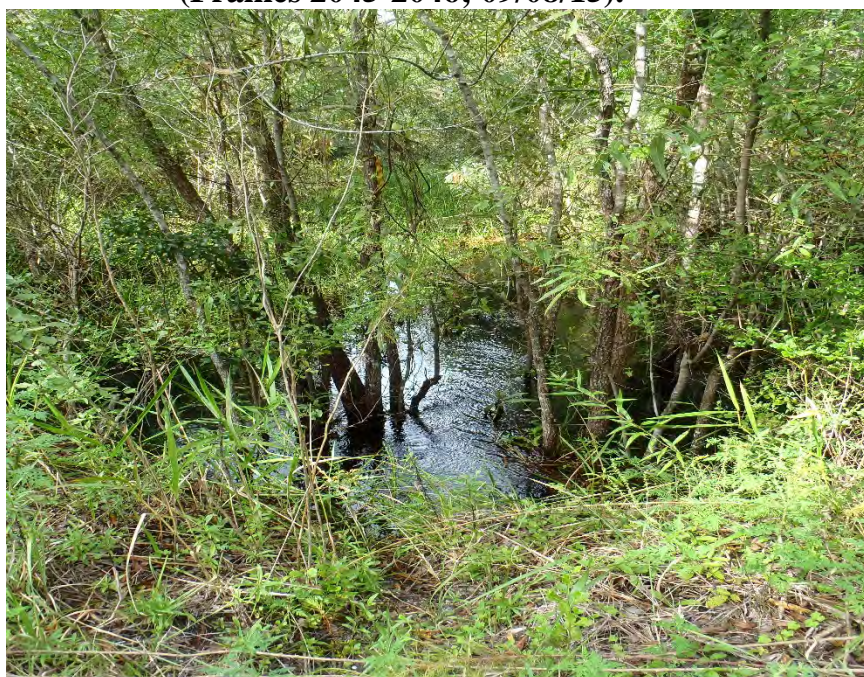
Photo 295. View of Physical Feature: Culvert as seen looking north from GPS location 6070 (Frame 2047; 09/08/15).

Photo 295. View of Physical Feature: Culvert as seen looking north from GPS location 6070 (Frame 2047; 09/08/15).	408
Photo 296. View of Wetland: Planted Pine-Marsh as seen looking east from GPS location 6104 (Frames 2048-2049; 09/08/15).	409
Photo 297. View of Wetland: Planted Pine-Marsh as seen looking north from GPS 6112 (Frames 2050-2051; 09/08/15).	409
Photo 298. View of Mesic: Planted Pine-Mesic Pine Flatwoods as seen looking northeast from GPS location 6118 (Frames 2052-2053; 09/08/15).	410
Photo 299. View of Mesic: Planted Pine-Mesic Pine Flatwoods as seen looking west from GPS location 6182 (Frames 2054-2055; 09/08/15).	410
Photo 300. View of Wetland: Natural Flow-way as seen looking east from GPS location 6199 (Frames 2056-2057; 09/08/15).	411
Photo 301. View of Wetland: Natural Flow-way as seen looking west from GPS location 6199 (Frames 2058-2059; 09/08/15).	411
Photo 302. View of Wetland: Planted Pine-Marsh as seen looking southeast from GPS location 6221 (Frames 2060-2061; 09/18/15).	412

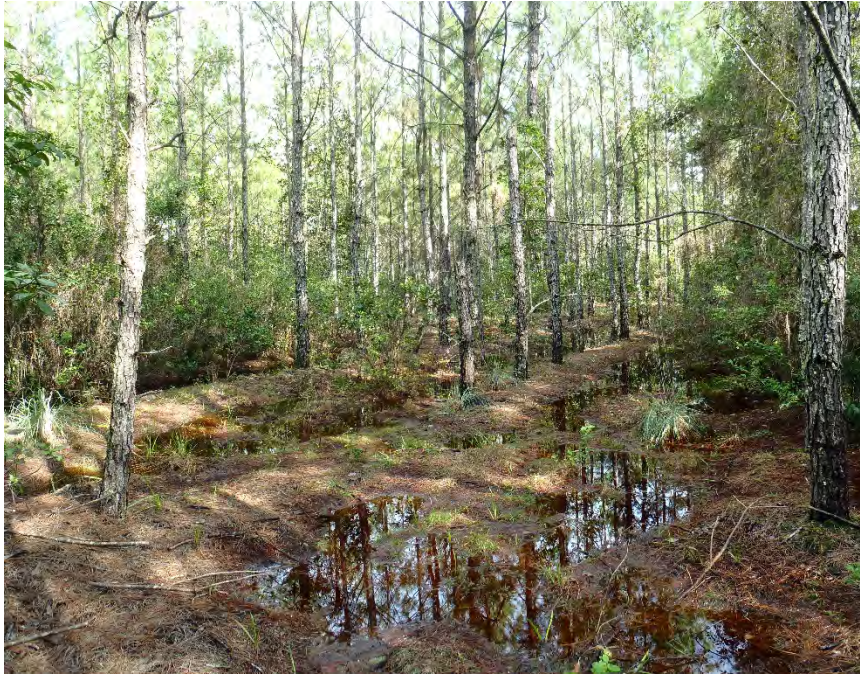
Photo 296. View of Wetland: Planted Pine-Marsh as seen looking east from GPS location 6104 (Frames 2048-2049; 09/08/15).

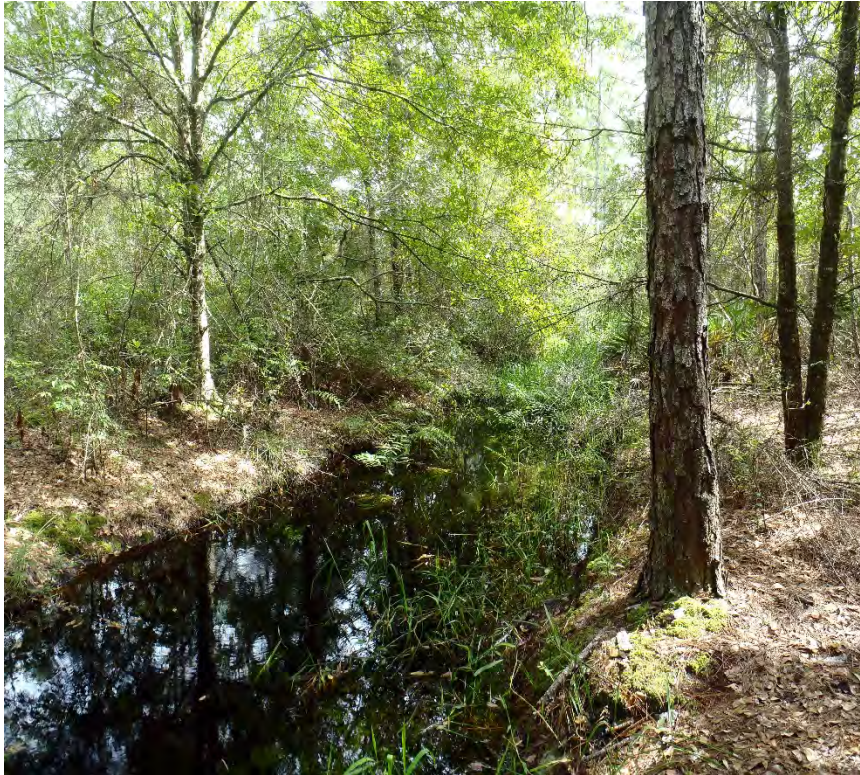
Photo 322. View of Surface Water: Excavated Creek in Wetland as seen looking south from GPS location 6613 (Frames 2104-2105; 09/10/15).

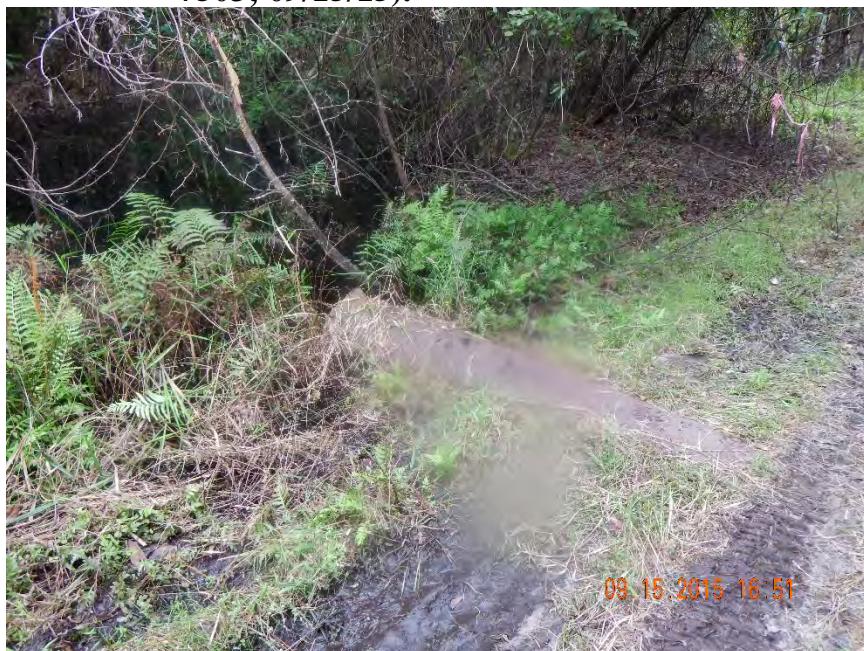
Photo 372. View to south of gas line through Wetland: Cypress-Mixed Hardwoods-Bays as seen at culvert location at GPS location 7360 (Frame 7503; 09/15/15).

Photo 372. View to south of gas line through Wetland: Cypress-Mixed Hardwoods-Bays as seen at culvert location at GPS location 7360 (Frame 7503; 09/15/15).....	447
Photo 373. View of Physical Feature: Culvert as seen looking at east end (downstream) of culvert at GPS location 7360 (Frame 7504; 09/15/15).....	447
Photo 374. View of Wetland: Cypress-Mixed Hardwoods-Bays from Physical Feature: Culvert as seen looking at west end (upstream) of culvert at GPS location 7360 (Frame 7506; 09/15/15).....	448
Photo 375. View of wetland shrubs and marsh area of Wetland: Cypress-Mixed Hardwoods-Bays community from Physical Feature: Culvert as seen looking west (upstream) from GPS location 7360 (Frame 7507; 09/15/15).....	448
Photo 376. View of cypress, pine, and disturbed vines and shrubs area of the Wetland: Cypress-Mixed Hardwoods-Bays community located west of Physical Feature: Culvert at GPS location 7360 (Frame 7508; 09/15/15).....	449

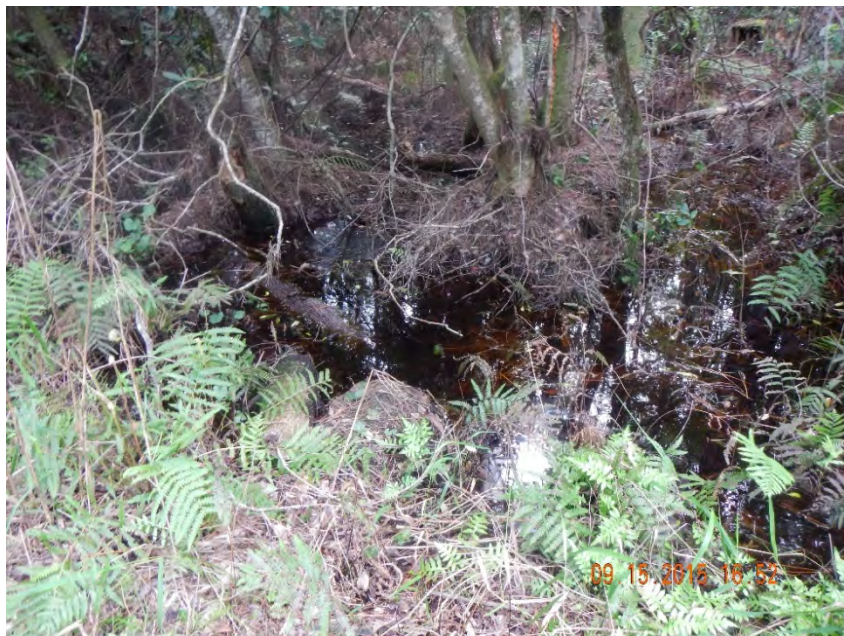
Photo 373. View of Physical Feature: Culvert as seen looking at east end (downstream) of culvert at GPS location 7360 (Frame 7504; 09/15/15).

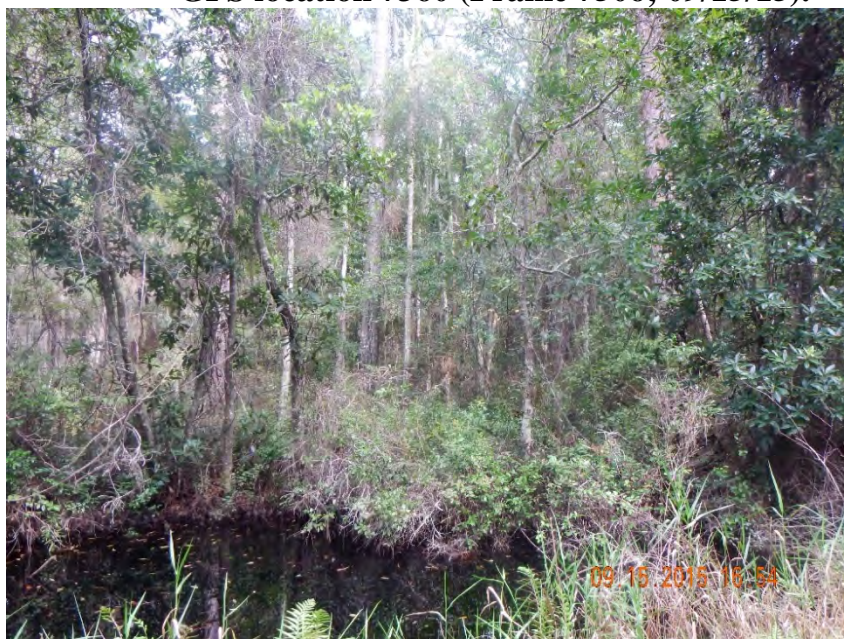
Photo 374. View of Wetland: Cypress-Mixed Hardwoods-Bays from Physical Feature: Culvert as seen looking at west end (upstream) of culvert at GPS location 7360 (Frame 7506; 09/15/15).

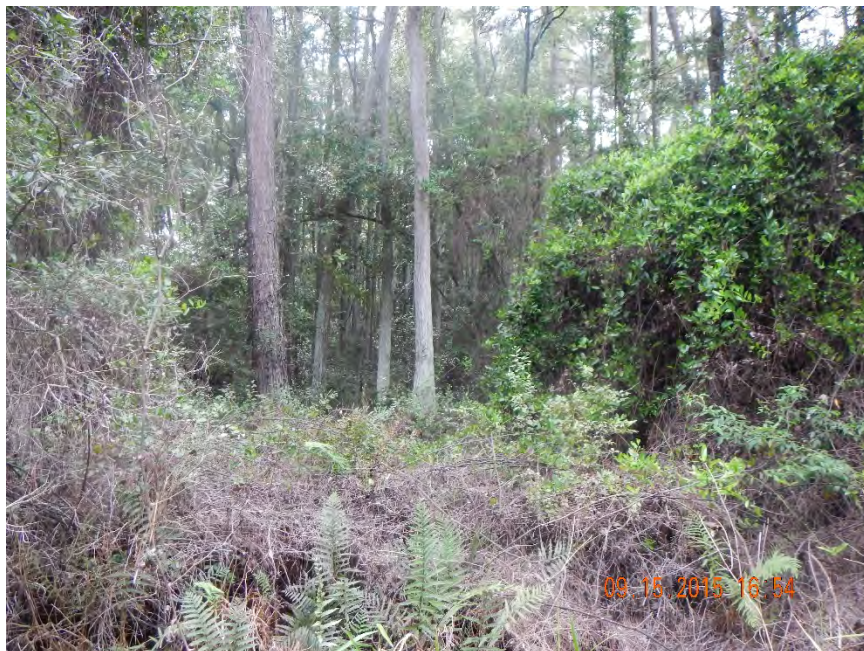
Photo 375. View of wetland shrubs and marsh area of Wetland: Cypress-Mixed Hardwoods-Bays community from Physical Feature: Culvert as seen looking west (upstream) from GPS location 7360 (Frame 7507; 09/15/15).

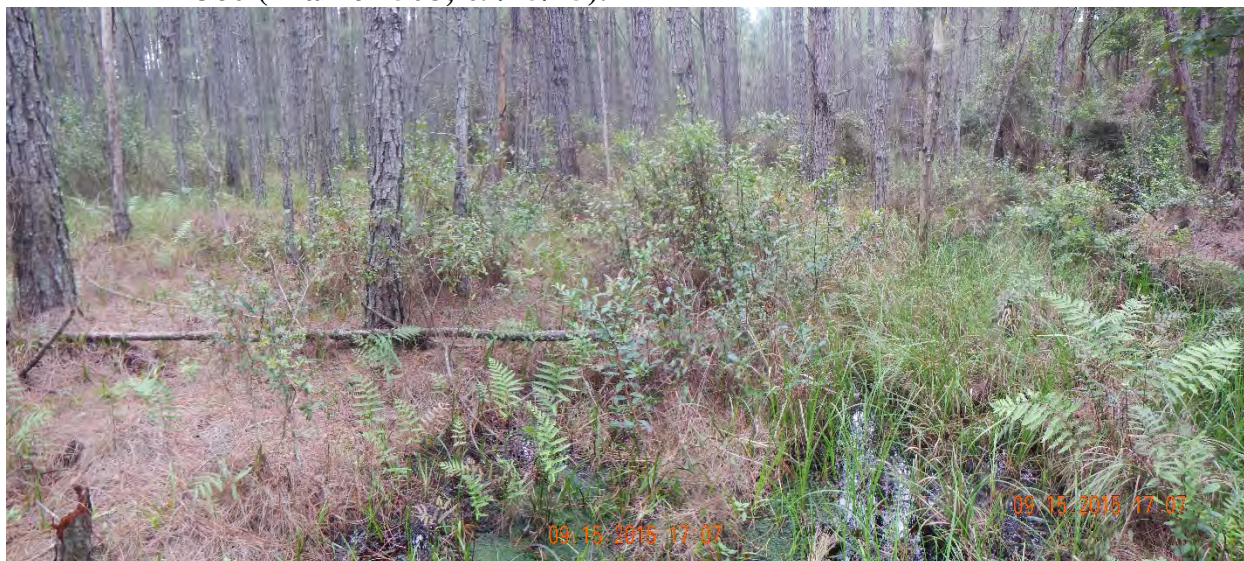
Photo 376. View of cypress, pine, and disturbed vines and shrubs area of the Wetland: Cypress-Mixed Hardwoods-Bays community located west of Physical Feature: Culvert at GPS location 7360 (Frame 7508; 09/15/15).

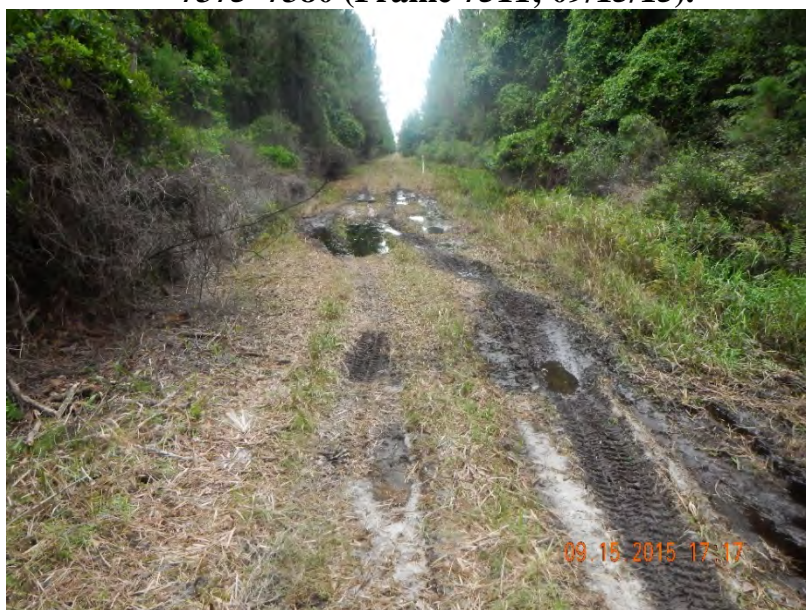
Photo 378. View of gas line as seen looking south from GPS location 7378 Wetland: Natural Flow-way, which occurs from west to east across top of gas line extending from GPS locations 7375–7380 (Frame 7511; 09/15/15).

Photo 377. View of Wetland: Planted Pine-Marsh as seen looking west from GPS location 7372 (Frames 7509-7510; 09/15/15).	449
Photo 378. View of gas line as seen looking south from GPS location 7378 Wetland: Natural Flow-way, which occurs from west to east across top of gas line extending from GPS locations 7375–7380 (Frame 7511; 09/15/15).....	450

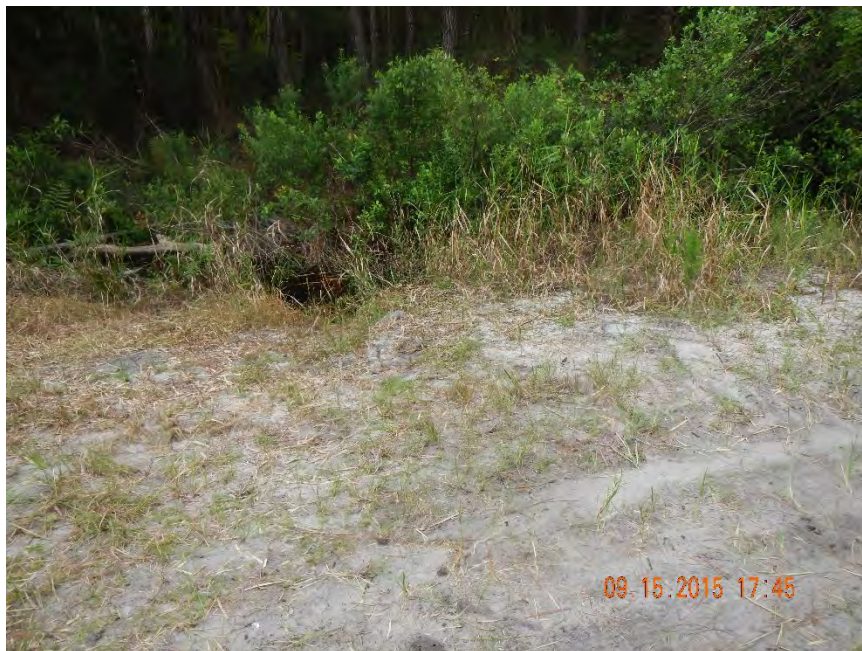
Photo 381. View of gas line (right) and forest road (left) that accesses property to the east. This photo is taken from GPS location 7403 looking southeast to south. There are several Physical Feature: Culverts at this location that route water north and east through this intersection (Frame 7515; 09/15/15).

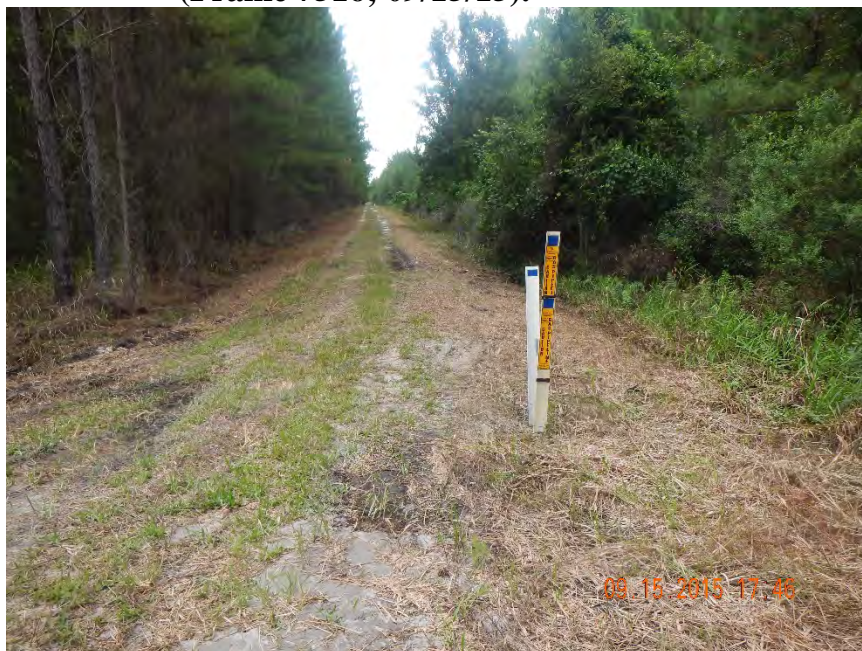
Photo 382. View of north end of Physical Feature: Culvert that runs north from GPS location 7403 to 7404 and routes water in this direction (Frame 7516; 09/15/15).

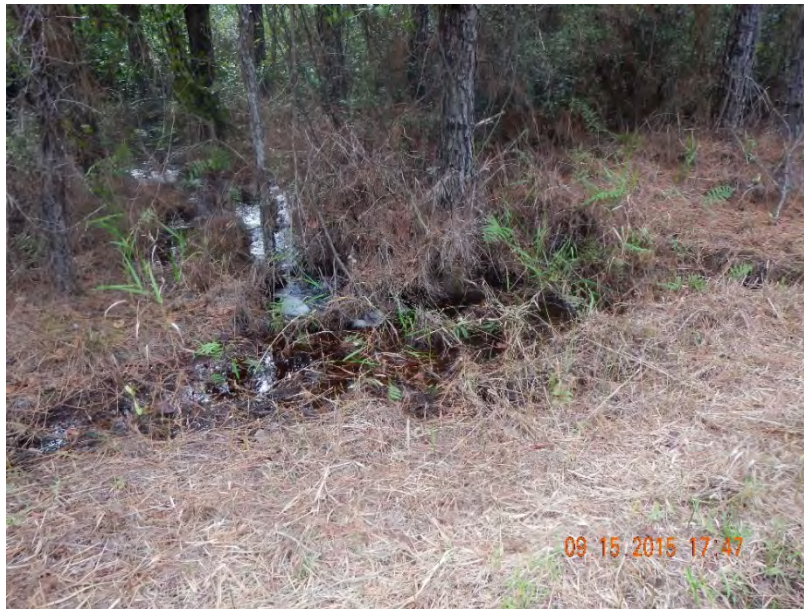
Photo 383. View to north of gas line as seen from Physical Feature: Culvert at GPS location 7404 (Frame 7517; 09/15/15).

Photo 379. View of gas line as seen looking north from GPS location 7378 Wetland: Natural Flow-way, which occurs from west to east across top of gas line extending from GPS locations 7375–7380 (Frame 7512 (09/15/15)).	450
Photo 380. View of Wetland: Planted Pine-Marsh as seen looking west from GPS location 7387 (Frames 7513-7314; 09/15/15).	451
Photo 381. View of gas line (right) and forest road (left) that accesses property to the east. This photo is taken from GPS location 7403 looking southeast to south. There are several Physical Feature: Culverts at this location that route water north and east through this intersection (Frame 7515; 09/15/15).	451
Photo 382. View of north end of Physical Feature: Culvert that runs north from GPS location 7403 to 7404 and routes water in this direction (Frame 7516; 09/15/15).	452
Photo 383. View to north of gas line as seen from Physical Feature: Culvert at GPS location 7404 (Frame 7517; 09/15/15).	452

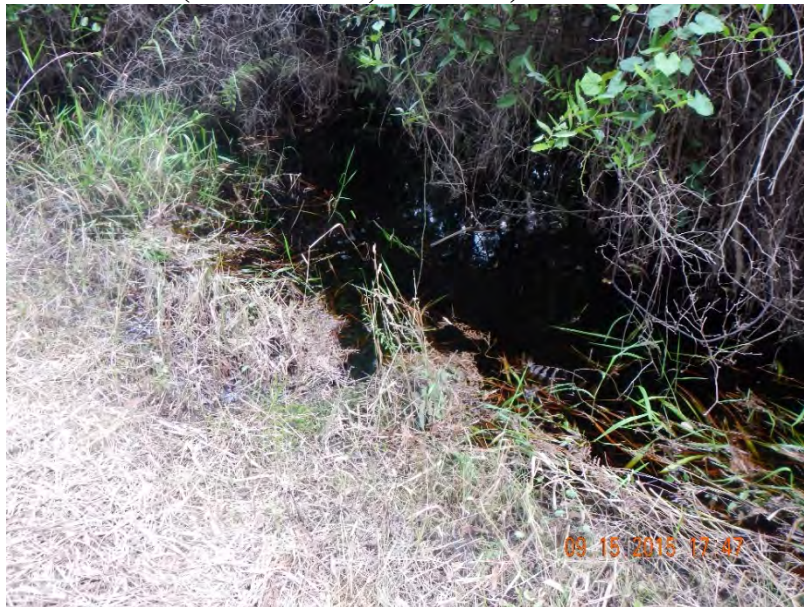
Photo 384. View of area at west end of Physical Feature: Culvert located at GPS location 7405. This is upstream area west of gas line (Frame 7518; 09/15/15).

Photo 384. View of area at west end of Physical Feature: Culvert located at GPS location 7405. This is upstream area west of gas line (Frame 7518; 09/15/15).	453
Photo 385. View of east area at east end (downstream) of Physical Feature: Culvert located at GPS location 7405. Water flows here from GRU property, north into ditch along gas line, then east into a large wetland area (Frame 7519; 09/15/15).	453
Photo 386. View of flow-way at east end of Physical Feature: Culvert located in gas line right-of-way at GPS location 7421 (Frame 7520; 09/15/15).	454
Photo 387. View of flow-way at west end of Physical Feature: Culvert located in gas line right-of-way at GPS location 7421 (Frame 7521; 09/15/15).	454
Photo 388. View of Physical Feature: Culvert area within gas line right-of-way as seen looking south from GPS location 7421 (Frame 7522; 09/15/15).	455
Photo 389. View of Wetland: Planted Pine Flatwoods as seen looking east from the jurisdictional boundary at GPS location 7430 (Frame 7524; 09/15/15).	455

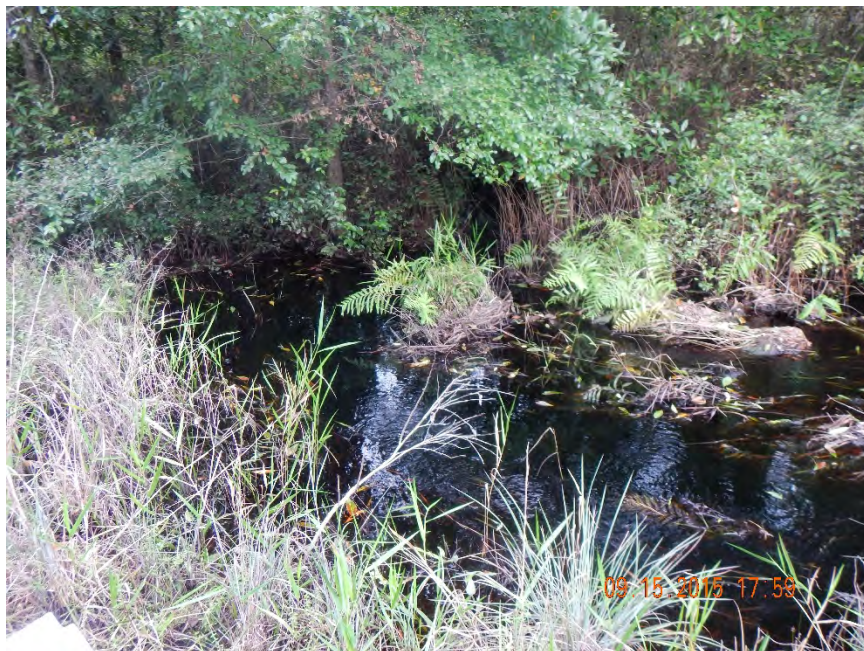
Photo 385. View of east area at east end (downstream) of Physical Feature: Culvert located at GPS location 7405. Water flows here from GRU property, north into ditch along gas line, then east into a large wetland area (Frame 7519; 09/15/15).

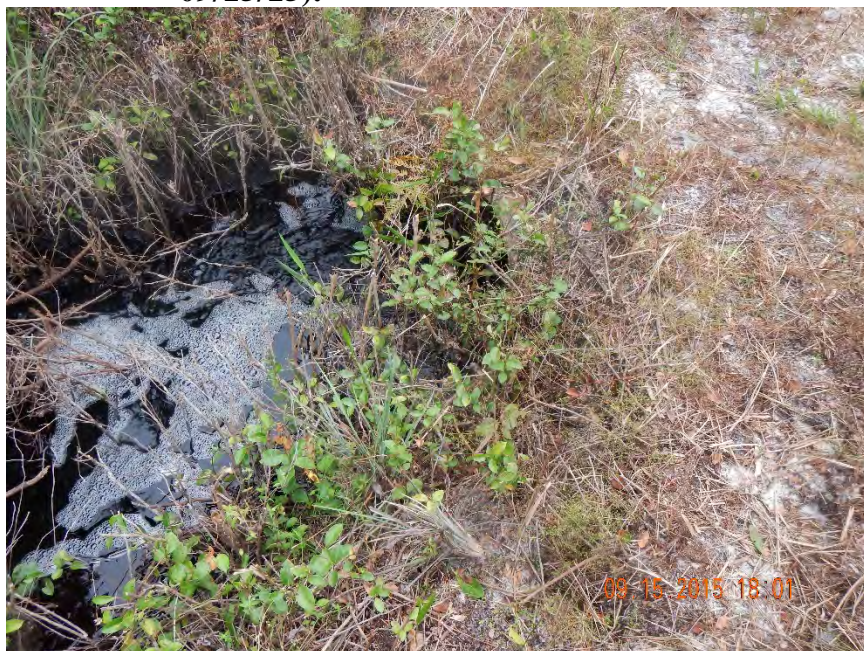
Photo 386. View of flow-way at east end of Physical Feature: Culvert located in gas line right-of-way at GPS location 7421 (Frame 7520; 09/15/15).

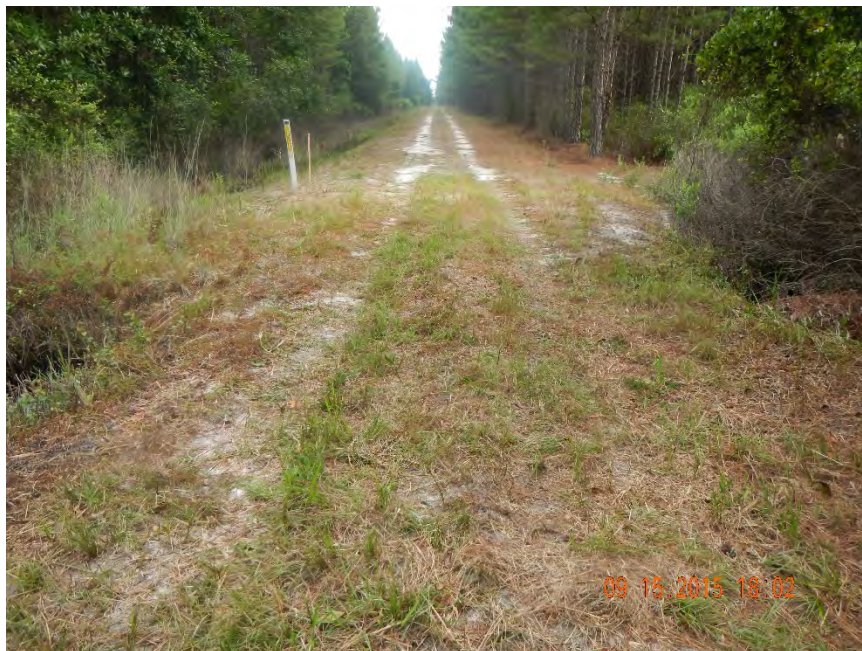
Photo 387. View of flow-way at west end of Physical Feature: Culvert located in gas line right-of-way at GPS location 7421 (Frame 7521; 09/15/15).

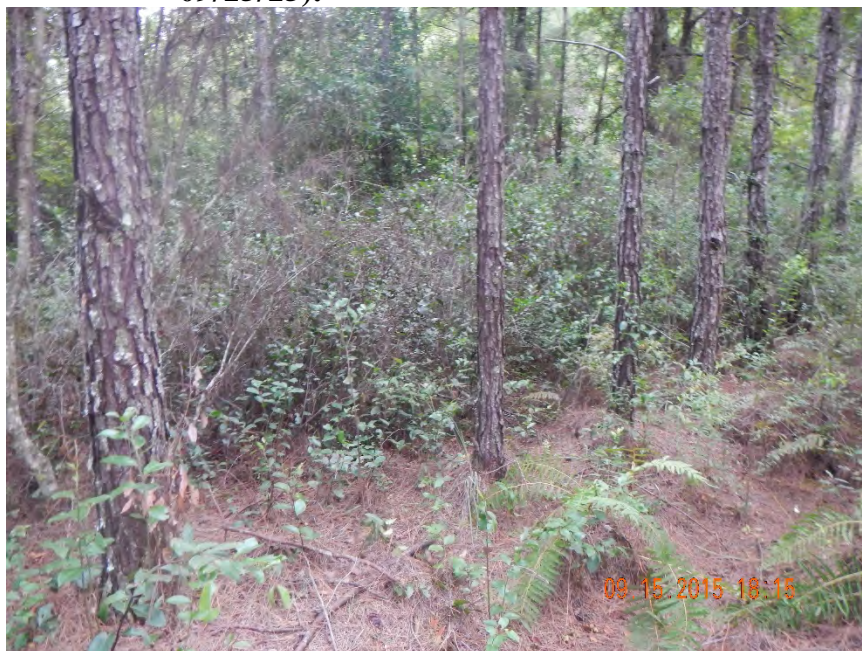
Photo 388. View of Physical Feature: Culvert area within gas line right-of-way as seen looking south from GPS location 7421 (Frame 7522; 09/15/15).

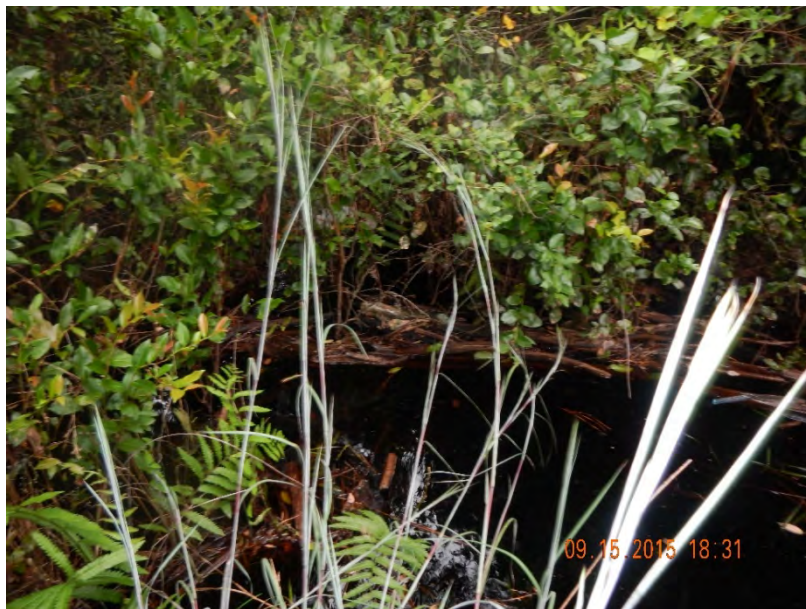
Photo 393. View of Surface Water: Excavated Ditch within Upland within a Transitional: Planted Pine Flatwoods as seen at GPS location 7456 (Frame 7529; 09/15/15).

Photo 392. View of Hydric: Planted Pine Flatwoods as seen looking west from GPS location 7449 (Frames 7527-7528; 09/15/15).....	457
Photo 393. View of Surface Water: Excavated Ditch within Upland within a Transitional: Planted Pine Flatwoods as seen at GPS location 7456 (Frame 7529; 09/15/15).....	457
Photo 394. View of Surface Water: Excavated Ditch within Upland within a Transitional: Planted Pine Flatwoods as seen looking north (downstream) from GPS location 7456 Frame 7530 (09/15/15).....	458
Photo 395. View of Surface Water: Excavated Ditch within Upland within a Transitional: Planted Pine Flatwoods as seen looking south (upstream) from GPS location 7456 (Frame 7531; 09/15/15).....	458
Photo 396. View of boundary between wet flatwoods and transitional flatwoods within the Hydric: Planted Pine Flatwoods community as seen looking east from GPS location 7459 (Frame 7532; 09/15/15).....	459
Photo 397. View of Hydric: Planted Pine Flatwoods as seen looking south from GPS location 7470 (Frame 7533; 09/15/15).....	459

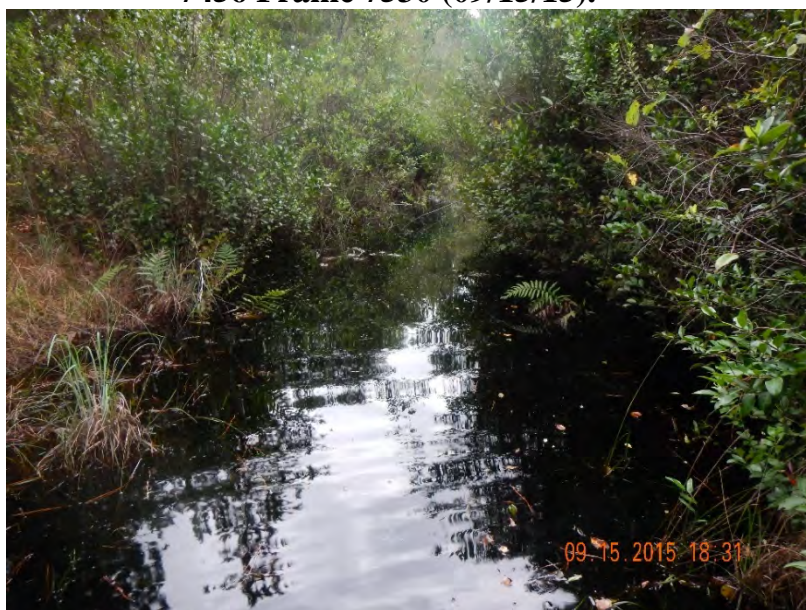
Photo 394. View of Surface Water: Excavated Ditch within Upland within a Transitional: Planted Pine Flatwoods as seen looking north (downstream) from GPS location 7456 Frame 7530 (09/15/15).

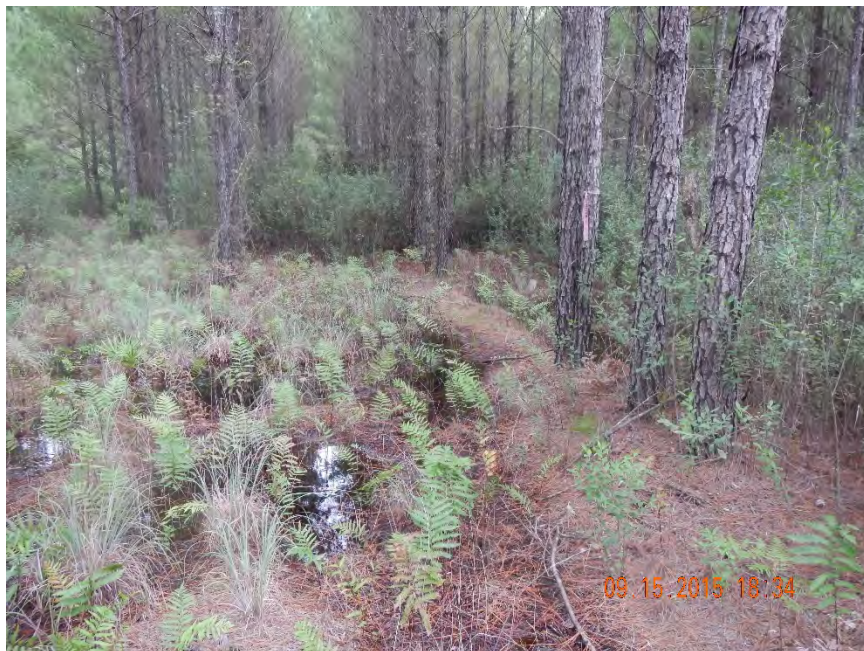
Photo 395. View of Surface Water: Excavated Ditch within Upland within a Transitional: Planted Pine Flatwoods as seen looking south (upstream) from GPS location 7456 (Frame 7531; 09/15/15).

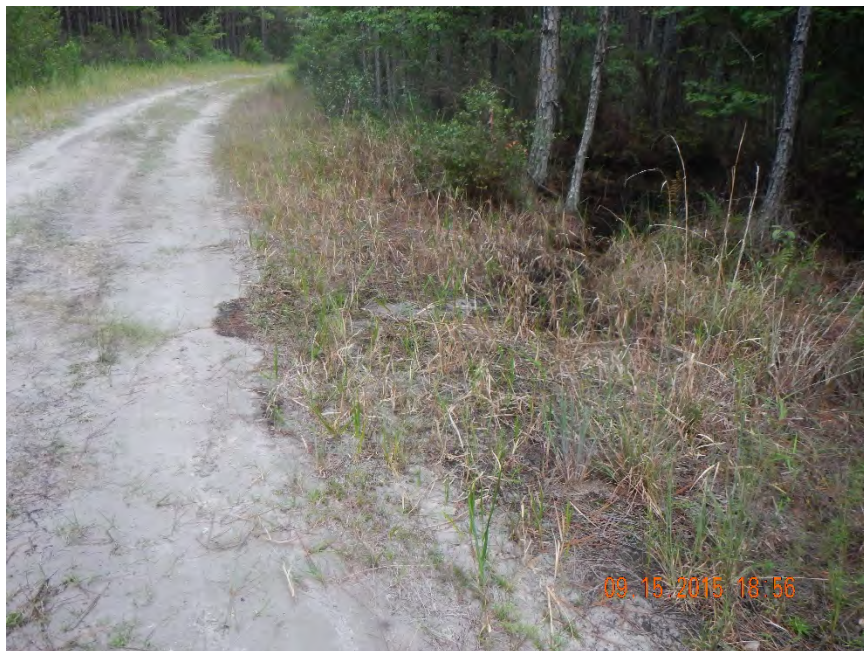
Photo 399. View of Physical Feature: Culvert as seen looking north (downstream) from GPS location 7497 (Frame 7535; 09/15/15).

Photo 398. View of Hydric: Planted Pine Flatwoods as seen looking north from GPS location 7470 (Frame 7534; 09/15/15).....	460
Photo 399. View of Physical Feature: Culvert as seen looking north (downstream) from GPS location 7497 (Frame 7535; 09/15/15).....	460
Photo 400. View of Physical Feature: Culvert as seen looking south (upstream) from GPS location 7497 (Frame 7536; 09/15/15).....	461
Photo 401. View of Hydric: Planted Pine Flatwoods as seen looking northeast from GPS location 7510 (Frame 7537; 09/15/15).....	461
Photo 402. View of Hydric: Planted Pine Flatwoods as seen looking east from GPS location 7510 (Frame 7538; 09/15/15).....	462
Photo 403. View of Surface Water: Excavated Ditch within Upland-Roadside Ditch within the Mesic: Planted Pine-Mesic Pine Flatwoods community at GPS location 7523 (Frame 7539; 09/15/15).	462
Photo 404. View of Mesic: Planted Pine-Mesic Pine Flatwoods as seen looking north from GPS location 7526 (Frame 7540; 09/15/15).	463
