Natural Area Resource Assessment of the Gainesville 121 Project Site

Provided in support of a current
application for Planned Development

City of Gainesville, Florida

Ecosystem Research Corporation
2906 NW 142 Avenue
Gainesville, FL 32609

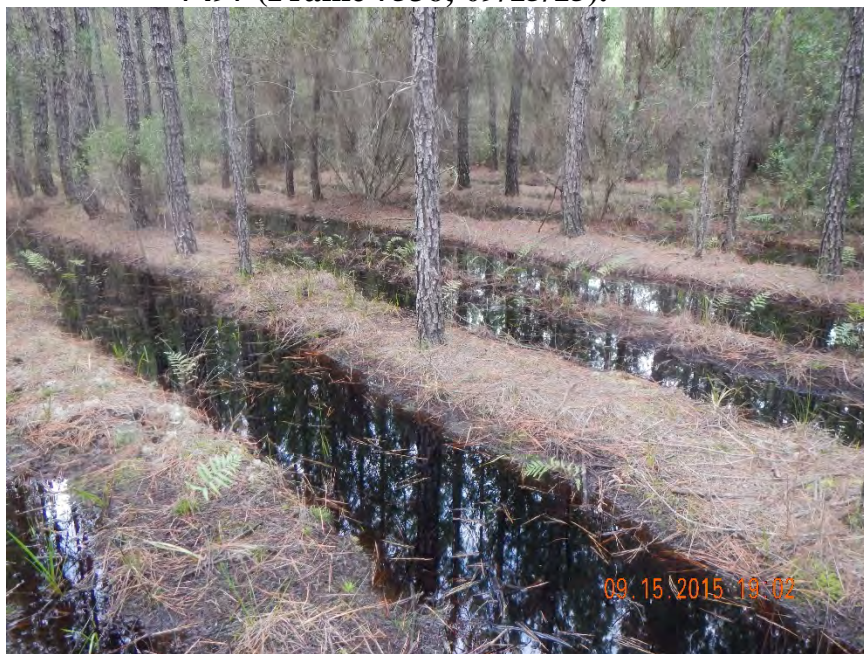
Photo 400. View of Physical Feature: Culvert as seen looking south (upstream) from GPS location 7497 (Frame 7536; 09/15/15).

Photo 398. View of Hydric: Planted Pine Flatwoods as seen looking north from GPS location 7470 (Frame 7534; 09/15/15).....	460
Photo 399. View of Physical Feature: Culvert as seen looking north (downstream) from GPS location 7497 (Frame 7535; 09/15/15).....	460
Photo 400. View of Physical Feature: Culvert as seen looking south (upstream) from GPS location 7497 (Frame 7536; 09/15/15).....	461
Photo 401. View of Hydric: Planted Pine Flatwoods as seen looking northeast from GPS location 7510 (Frame 7537; 09/15/15).....	461
Photo 402. View of Hydric: Planted Pine Flatwoods as seen looking east from GPS location 7510 (Frame 7538; 09/15/15).....	462
Photo 403. View of Surface Water: Excavated Ditch within Upland-Roadside Ditch within the Mesic: Planted Pine-Mesic Pine Flatwoods community at GPS location 7523 (Frame 7539; 09/15/15).	462
Photo 404. View of Mesic: Planted Pine-Mesic Pine Flatwoods as seen looking north from GPS location 7526 (Frame 7540; 09/15/15).	463

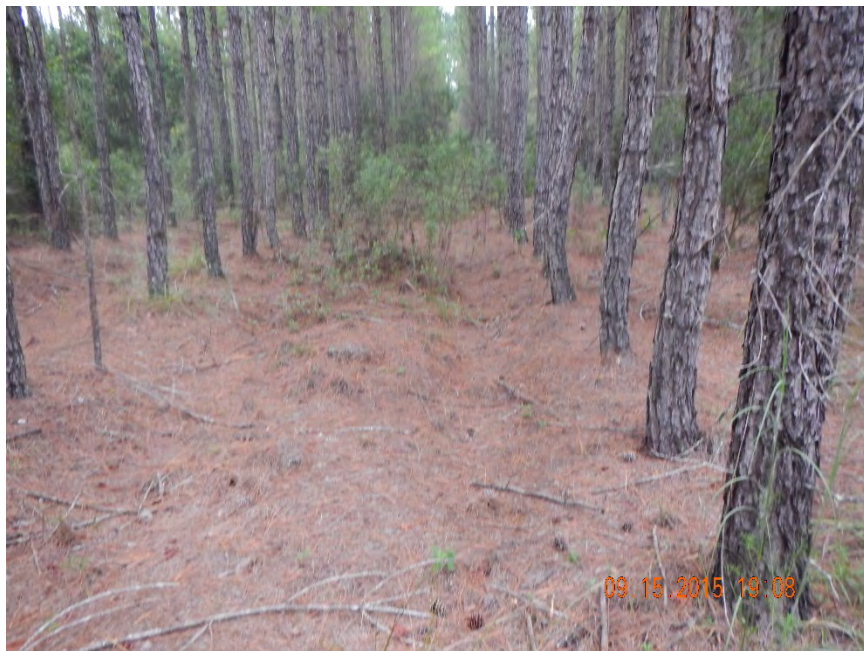
Photo 403. View of Surface Water: Excavated Ditch within Upland-Roadside Ditch within the Mesic: Planted Pine-Mesic Pine Flatwoods community at GPS location 7523 (Frame 7539; 09/15/15).

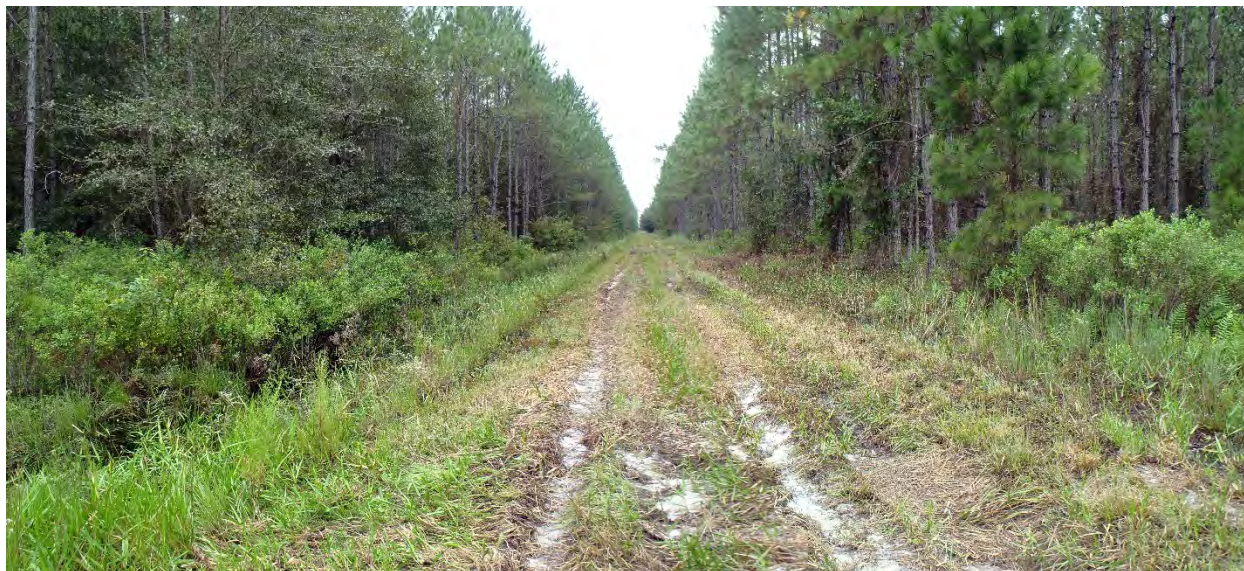
Photo 410. View of flow-way across top of gas line access road as seen looking south from GPS location 7756. Flow-way extends from GPS location 7756 south to 7757, a distance of 325 ft (Frames 2183-2184; 09/18/15).

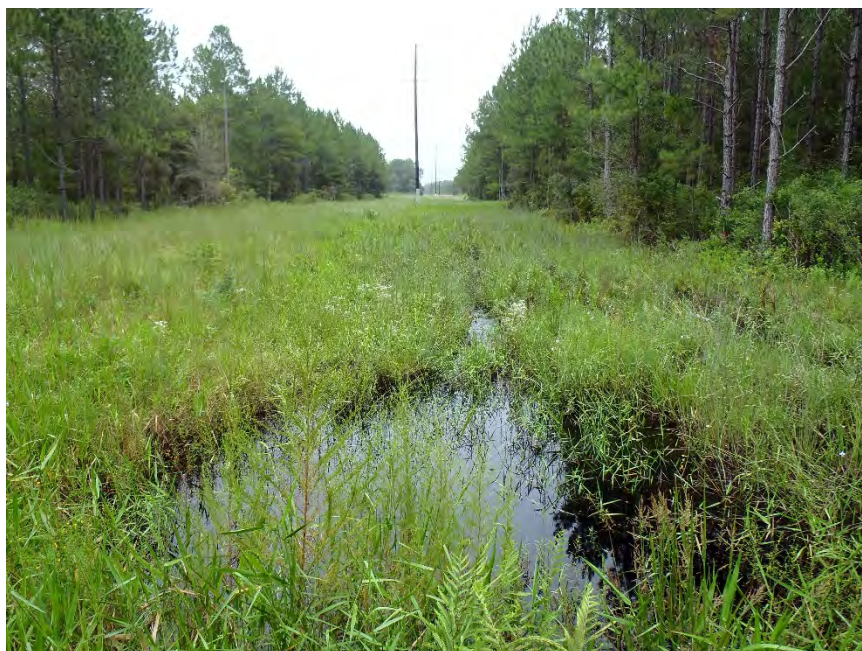
Photo 411. View of wetland marsh on south side of power line easement as seen looking east from Physical Structure: Culvert located at GPS location 7756 (Frame 2185; 09/18/15).

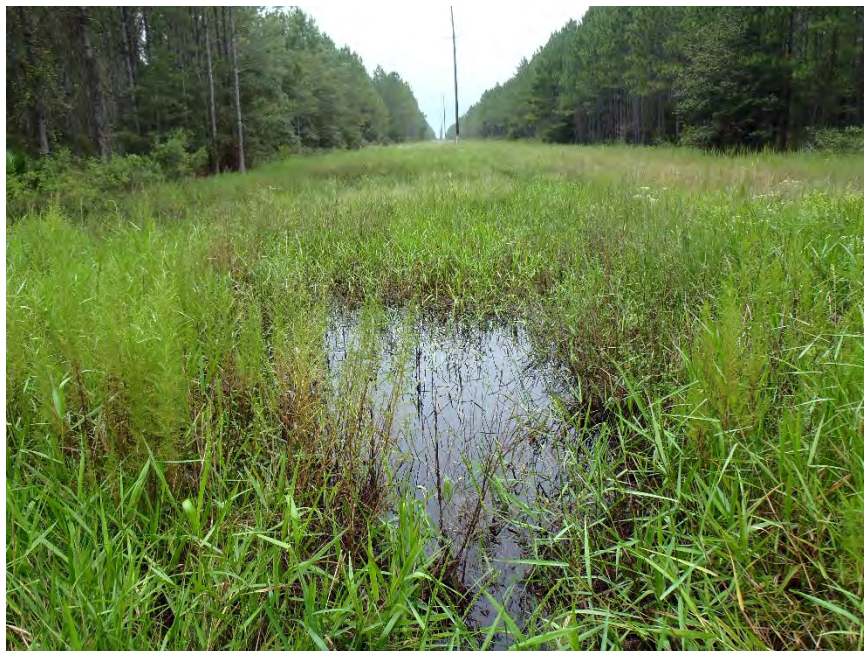
Photo 412. View of wetland marsh located south of power line access road as seen looking west from culvert located at GPS location 7756 (Frame 2186; 09/18/15).

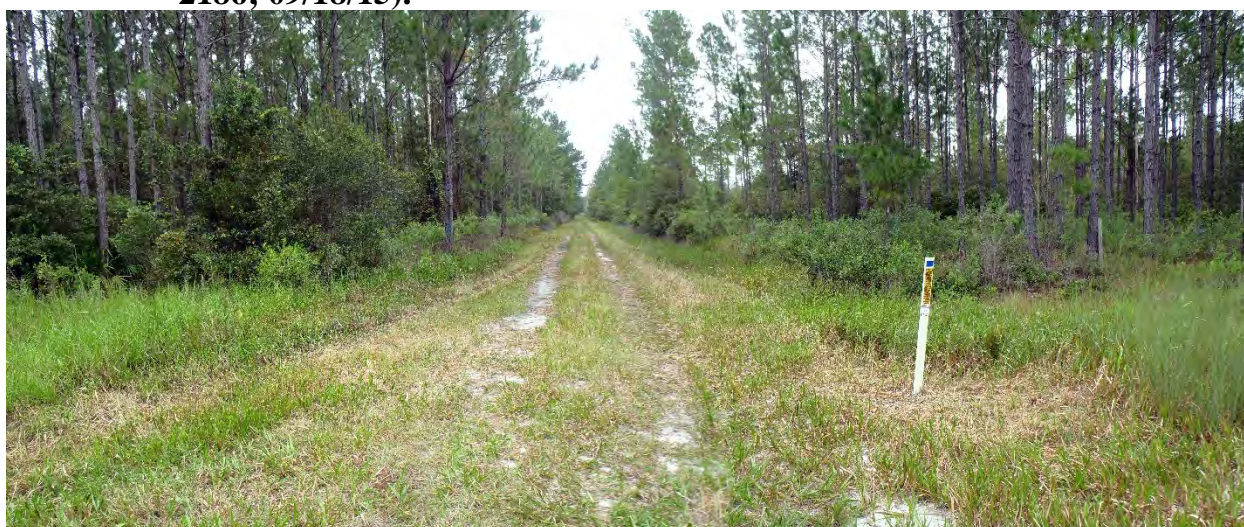
Photo 413. View of gas line easement as seen looking north from culvert located at GPS location 7765 (Frames 2179-2180; 09/18/15).

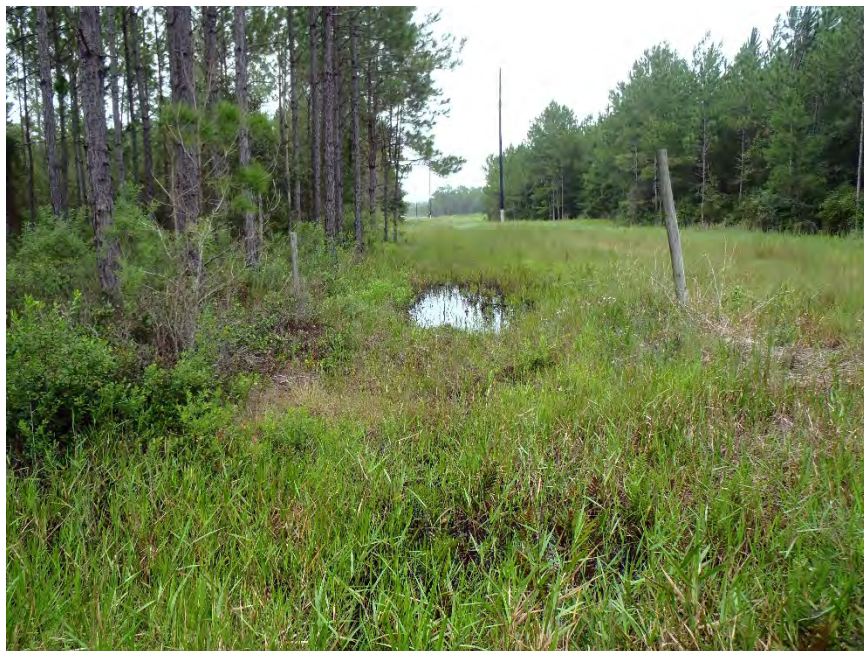
Photo 414. View of wetland marsh on north side of power line access road as seen looking east from culvert at GPS location 7765 (Frame 2181; 09/18/15).

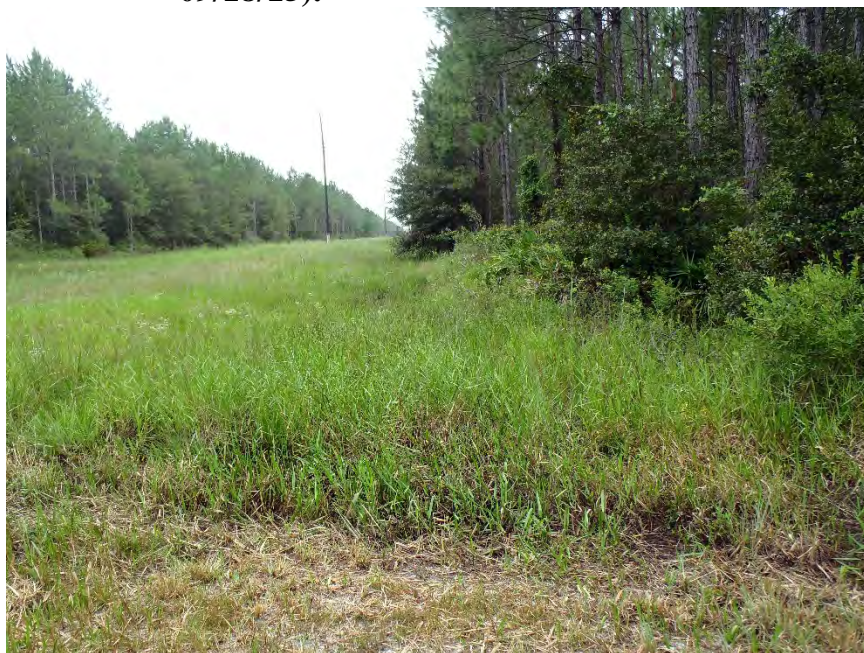
Photo 415. View of wetland marsh on north side of power line access road as seen looking west from culvert located at GPS location 7765 (Frame 2182; 09/18/15).

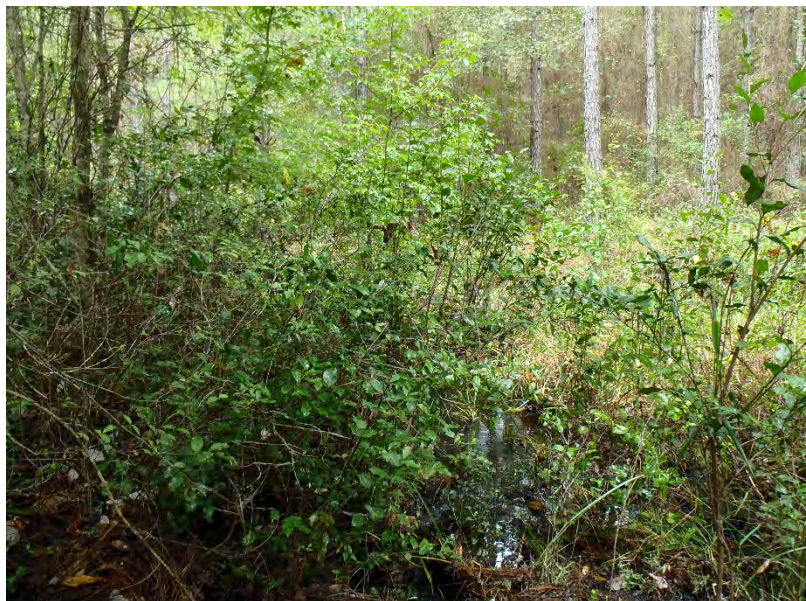
Photo 418. View of Surface Water: Excavated Ditch within Upland as seen looking east from GPS location 7843 (Frame 2191; 09/18/15).

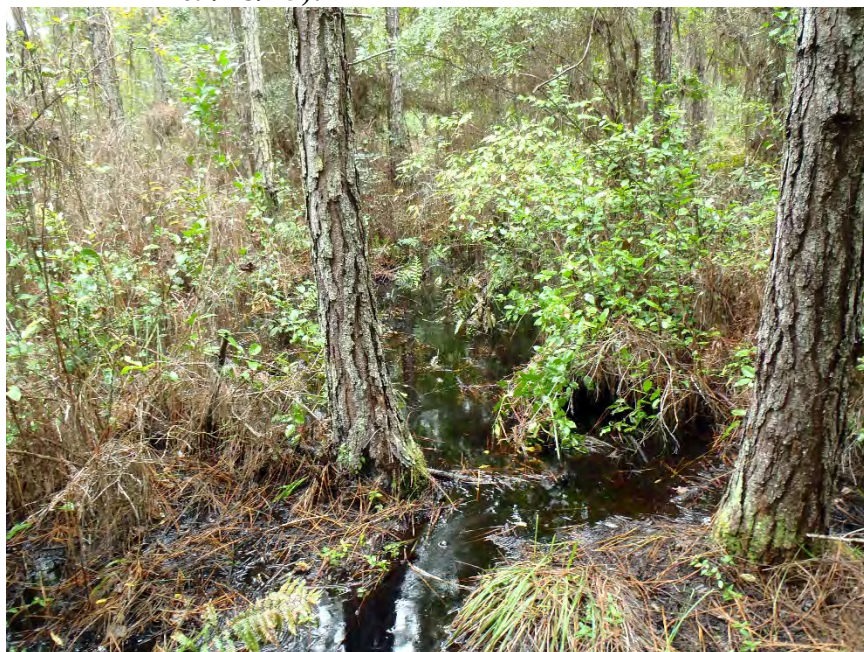
Photo 419. View of Surface Water: Excavated Ditch within Upland as seen looking west from GPS location 7843 (Frame 2192; 09/18/15).

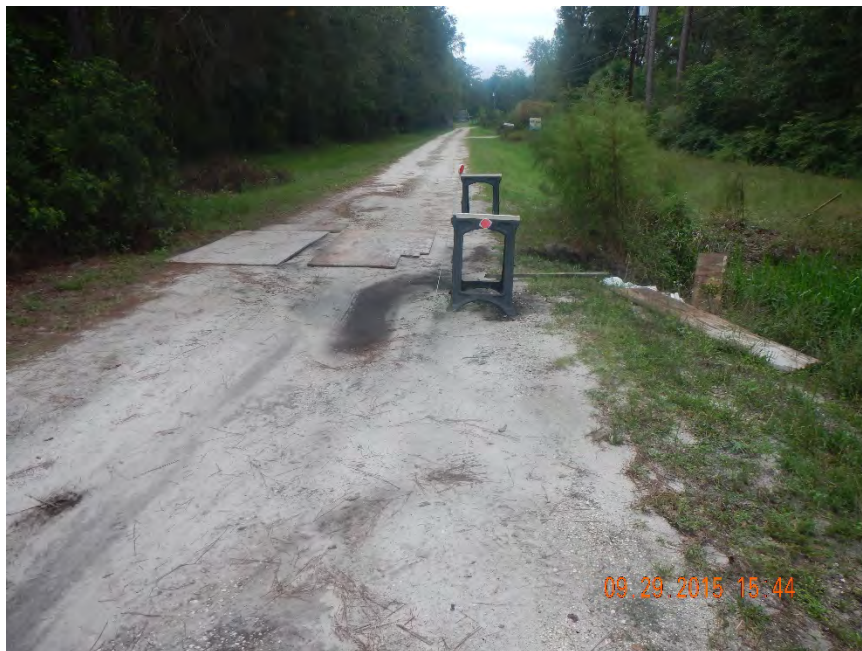
Photo 434. View of eroded Physical Feature: Culvert as seen looking east from GPS locations 8099-8100 (Frame 7646; 09/29/15).

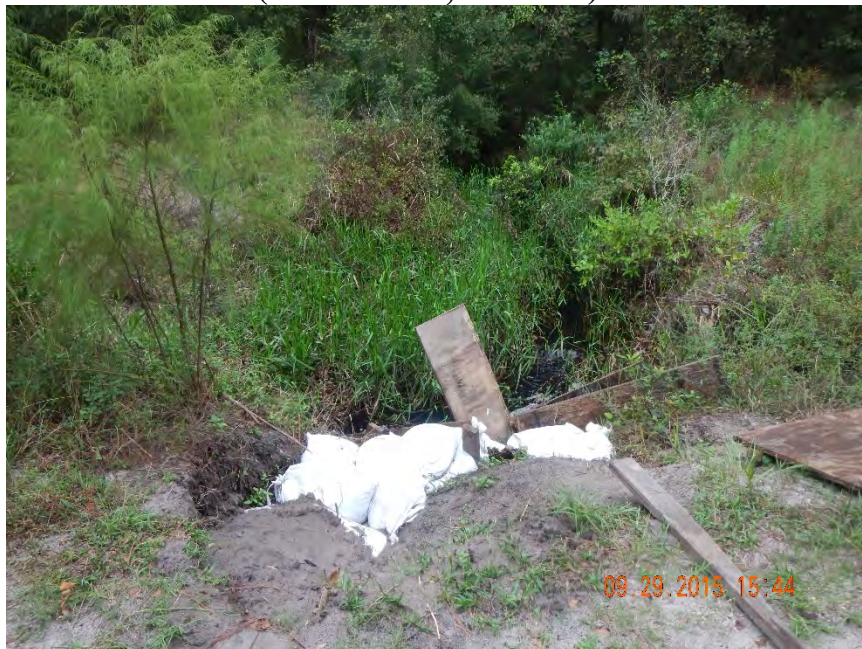
Photo 435. View of eroded Physical Feature: Culvert as seen looking north from GPS location 8100 (Frame 7647; 09/29/15).

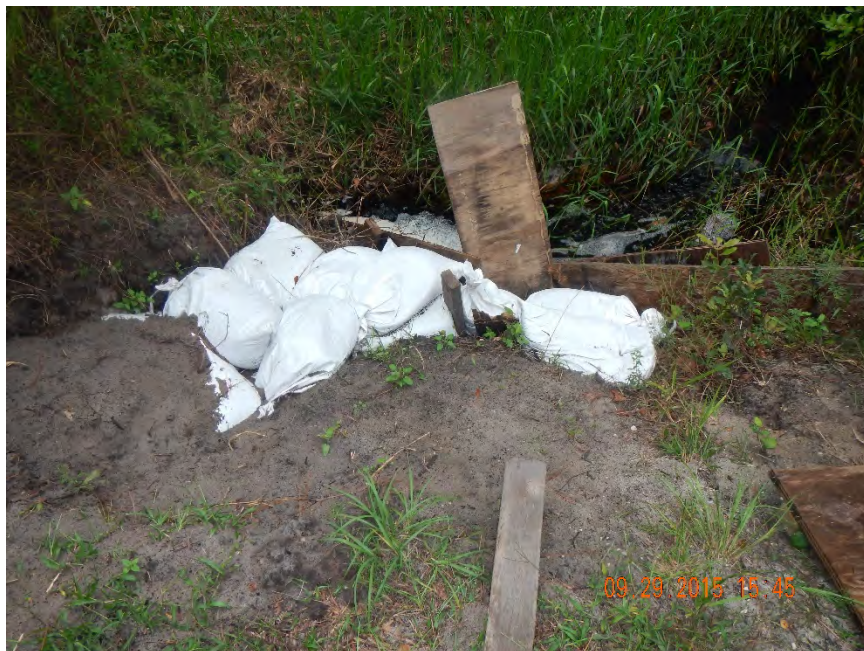
Photo 436. View of eroded Physical Feature: Culvert as seen looking south from GPS location 8099 (Frame 7648; 09/29/15).

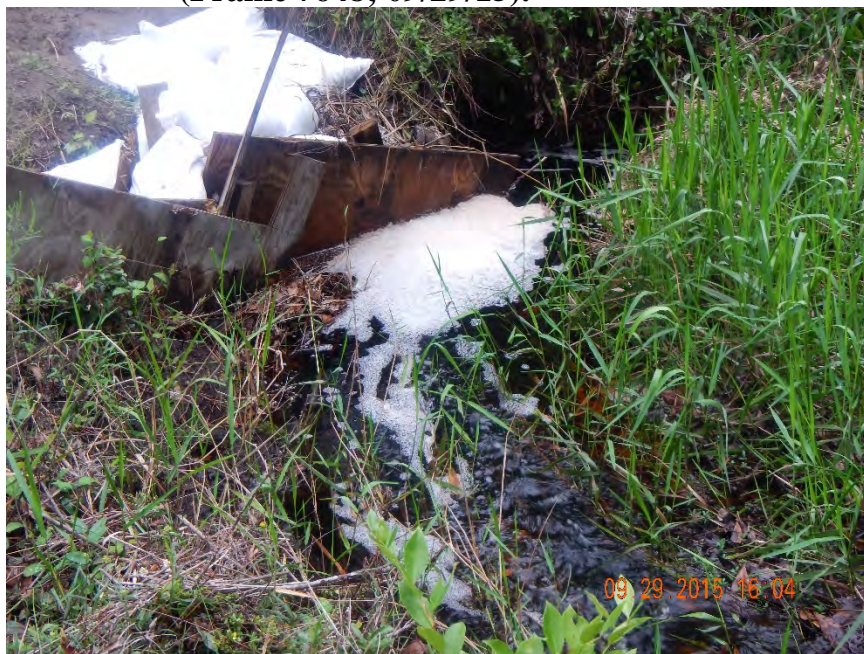
Photo 437. View of flow at Physical Feature: Culvert at GPS location 8099. View is to north on south side of road. Flow has eroded south side of road (Frame 7652; 09/29/15).

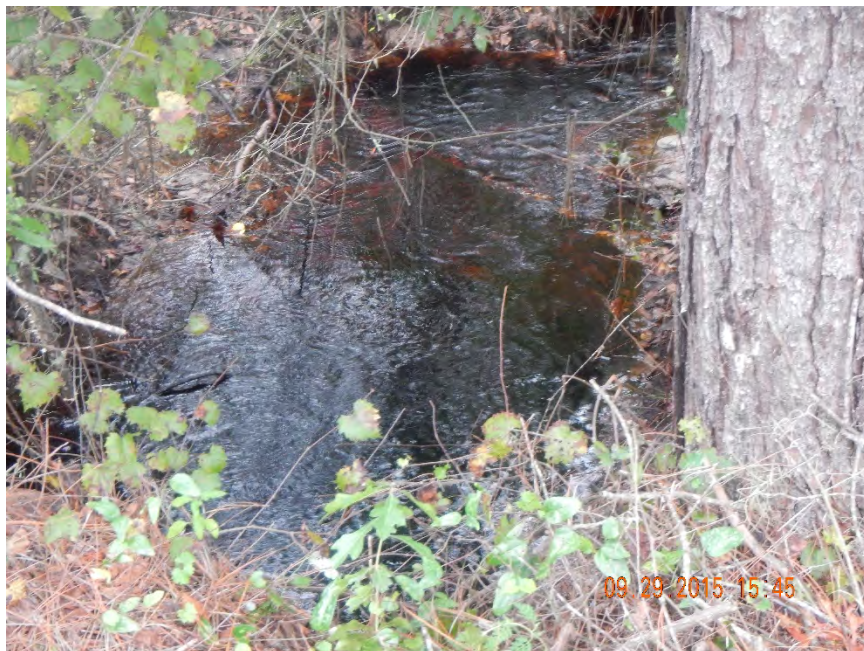
Photo 438. View of flow at Physical Feature: Culvert at GPS location 8100. Flow is to north on north side of road (Frame 7649; 09/29/15).

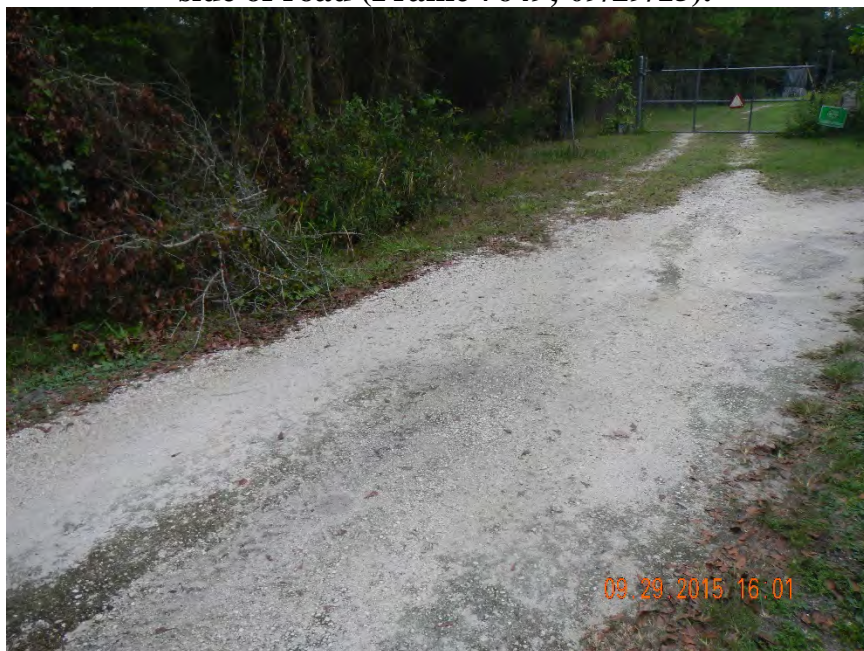
Photo 439. View of Physical Feature: Culvert at GPS locations 8101-8102. View is of north side of culvert (Frame 7650; 09/29/15).

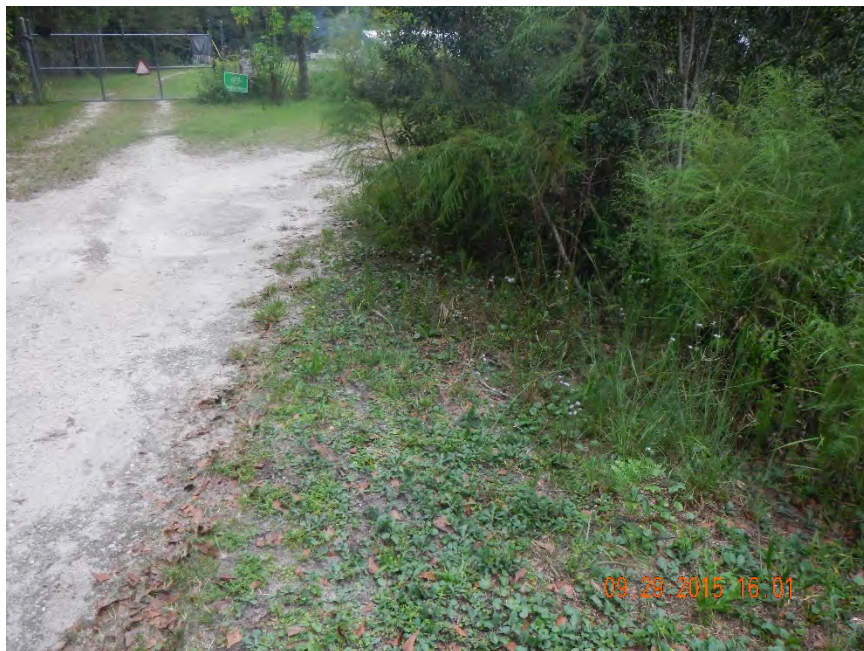
**Photo 440. View of south side of Physical Feature:
Culvert at GPS locations 8101-8102 (Frame
7651; 09/29/15).**

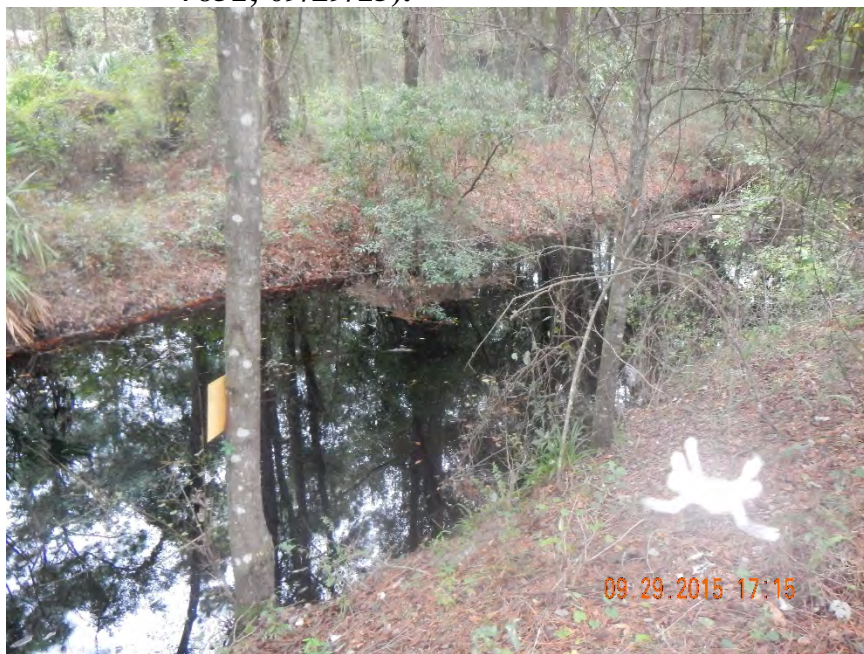
**Photo 441. View of offsite excavated ditch through an
upland as seen from the Fill: Old Roads-
Berms-Windrows at GPS location 8106
(Frame 7653; 09/29/15).**

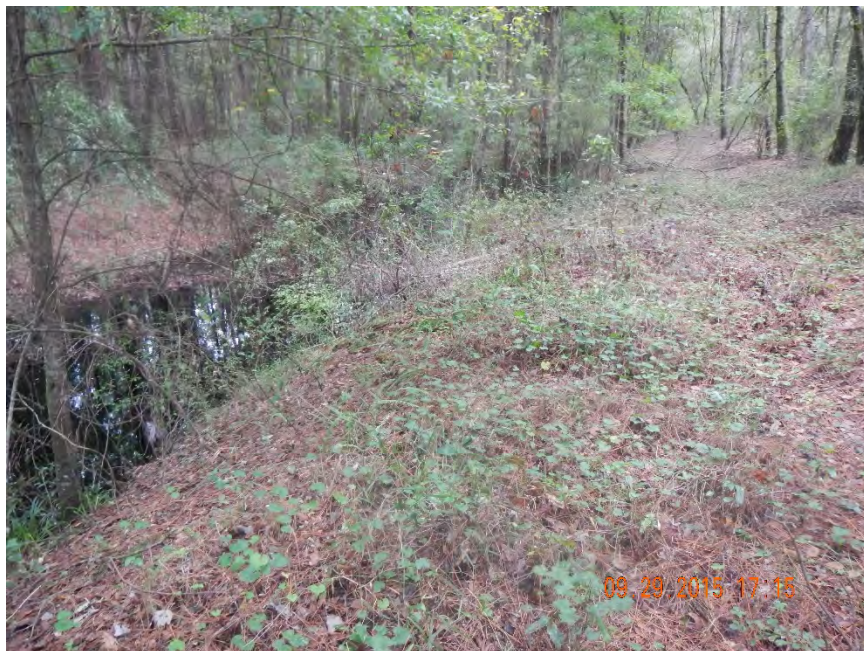
Photo 442. View of berm on south side of Fill: Old Roads-Berms-Windrows as seen looking east from GPS location 8106 (Frame 7654; 09/29/15).

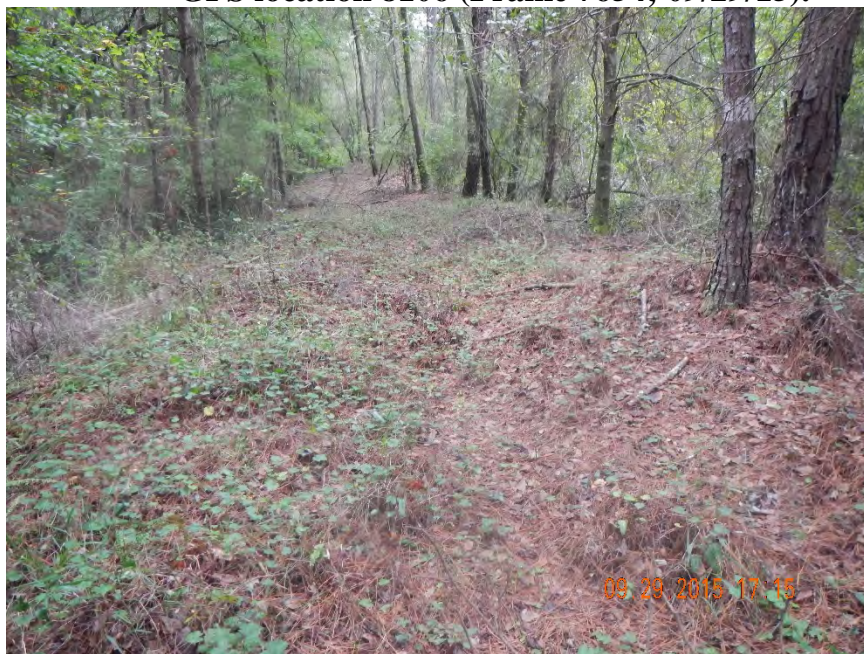
Photo 443. View of berm on south side of excavated ditch as seen looking east from GPS location 8110 (Frame 7655; 09/29/15).

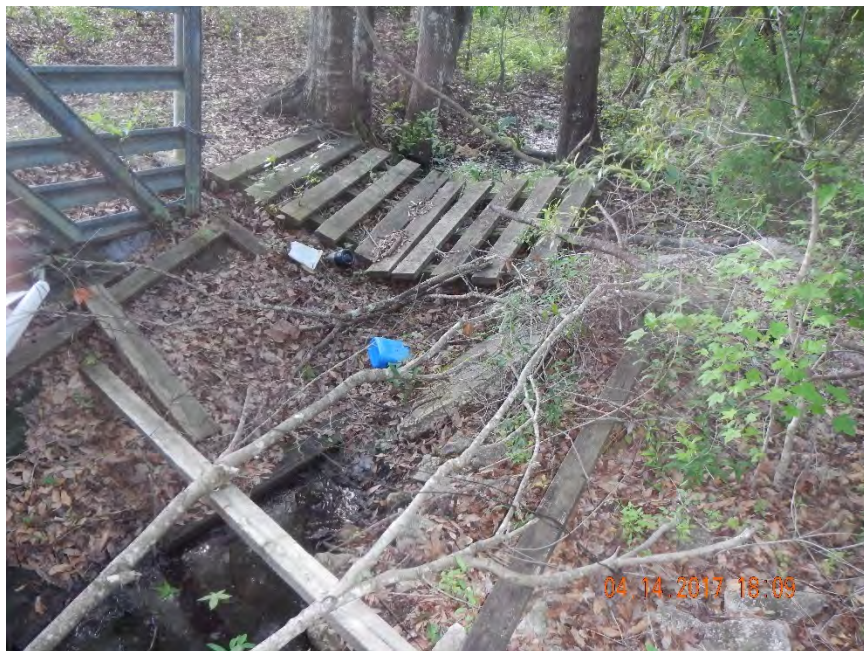
Photo 536. View of collapsed culvert and roadway at offsite drainage divide as seen looking west from GPS location 10304 (Frame 1451; 04/14/17).

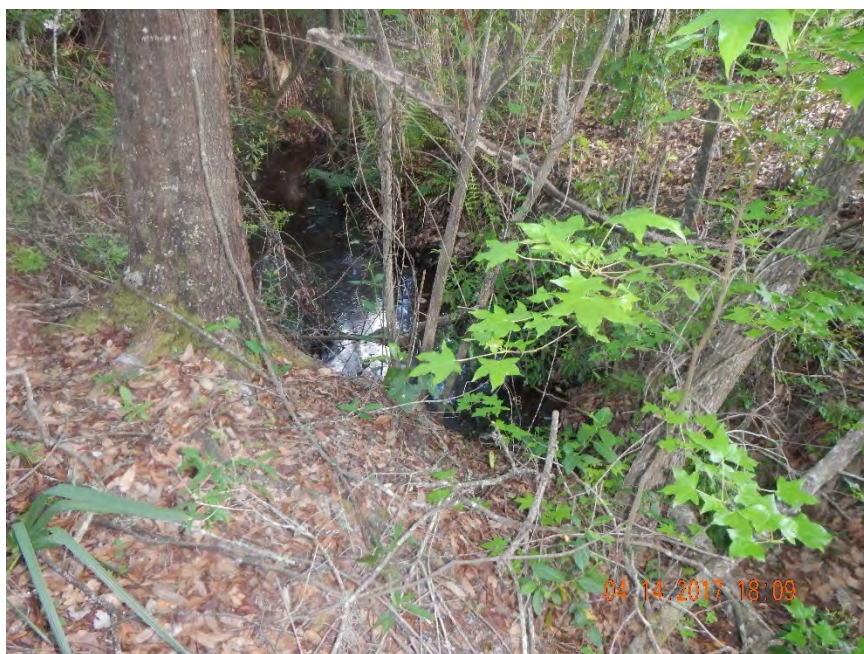
Photo 537. View of ditch south of drainage divide as seen looking south from GPS location 10304 (Frame 1452; 04/14/17).

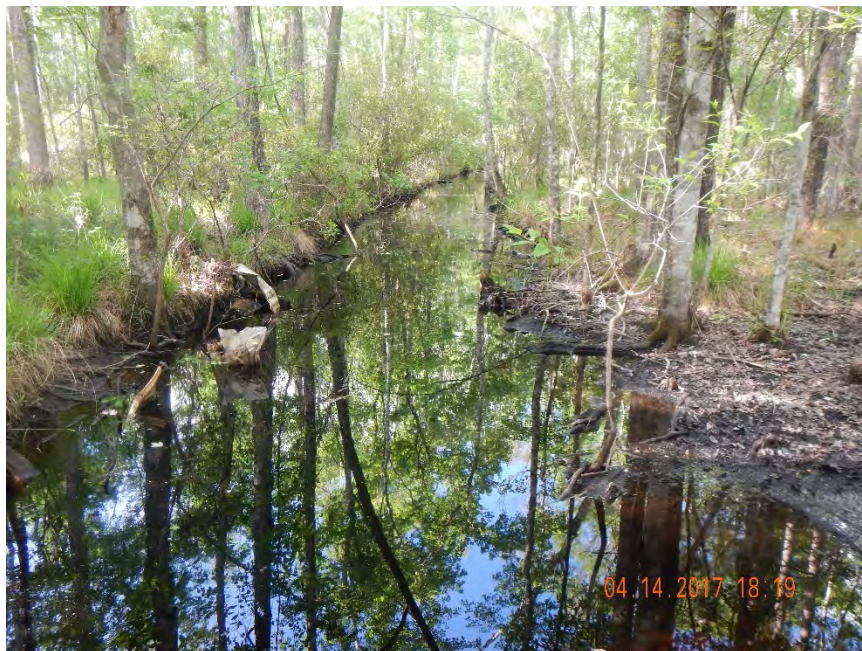
Photo 540. View of berm (left side [west]) and excavated ditch that flows north within the Cypress-Mixed Hardwood-Bay Swamp community as seen at GPS location 10322 (Frame 1456; 04/14/17).

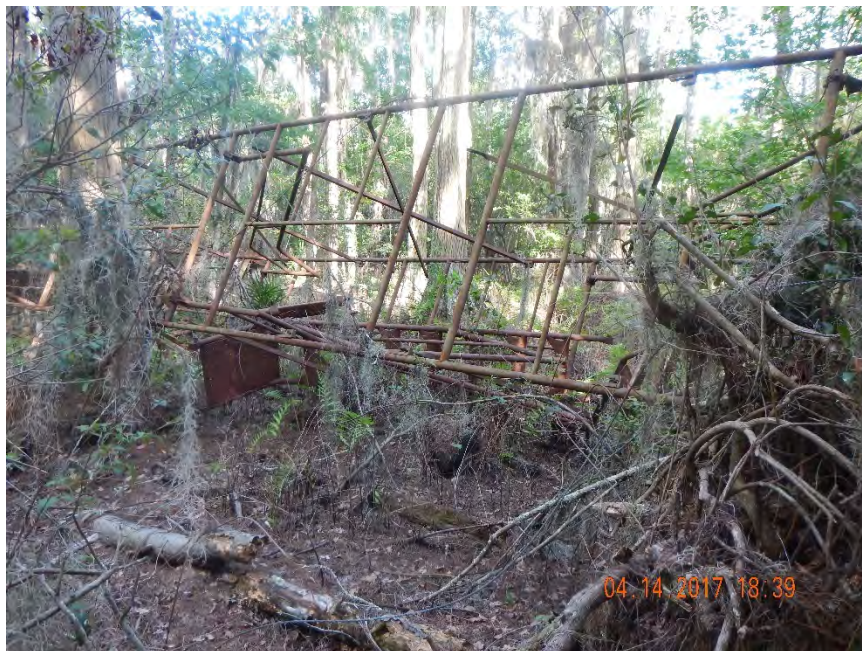
Photos 543 through 549 show dilapidated structures remaining in an historical disturbed cypress dome located at GPS location 10356. This dome was a study site for experimental sewage disposal in wetlands that was conducted by the Center for Wetlands at the University of Florida from 1973 to 1979. This wetland is referred to as the sewage dome in *Cypress Swamps* by K. C. Ewel and H. T. Odum (editors), University of Florida Presses (1984; see page 70). ERC staff visited this wetland in 1980. The wetland was one of three (3) cypress domes in the area used to study the effects of effluent from the Whitney Trailer Park on the wetland systems.

Photo 543. Experimental tower.

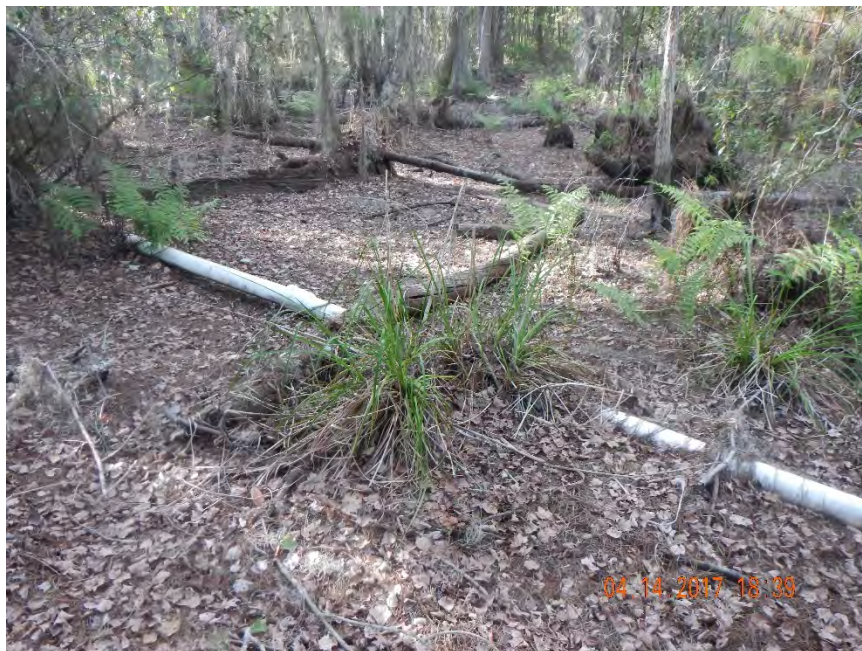
Photo 544. Sewage line.

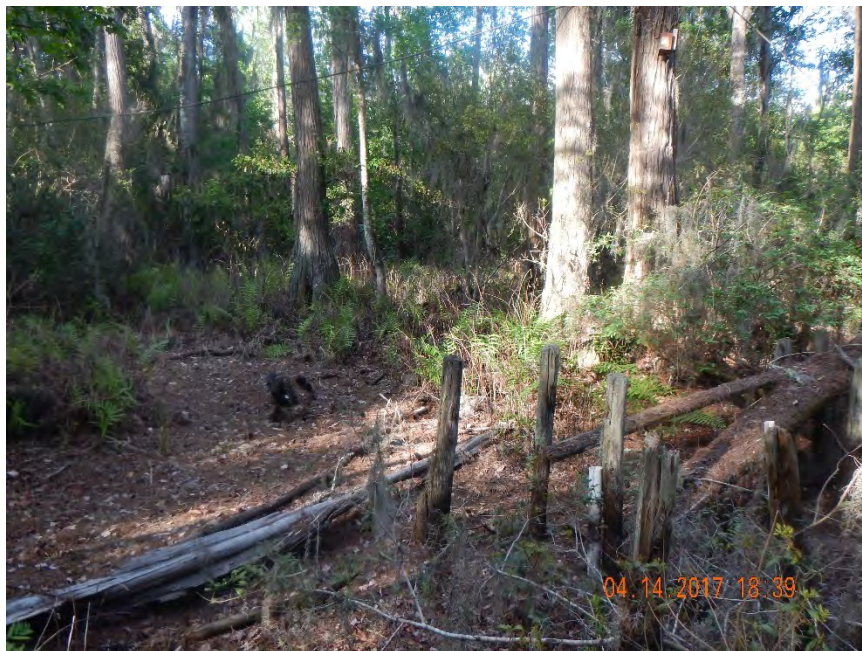
Photo 545. Boardwalk.

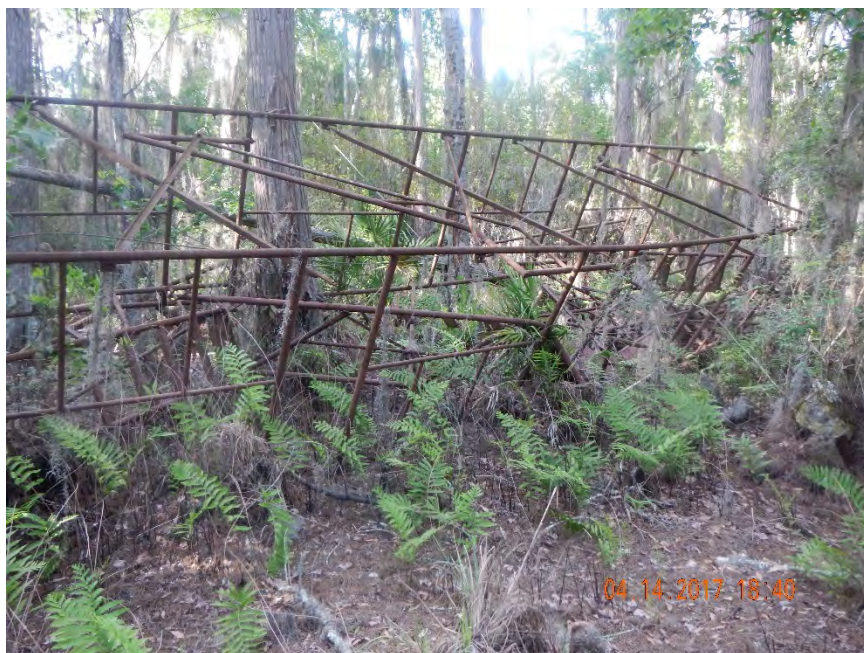
Photo 548. Tower.

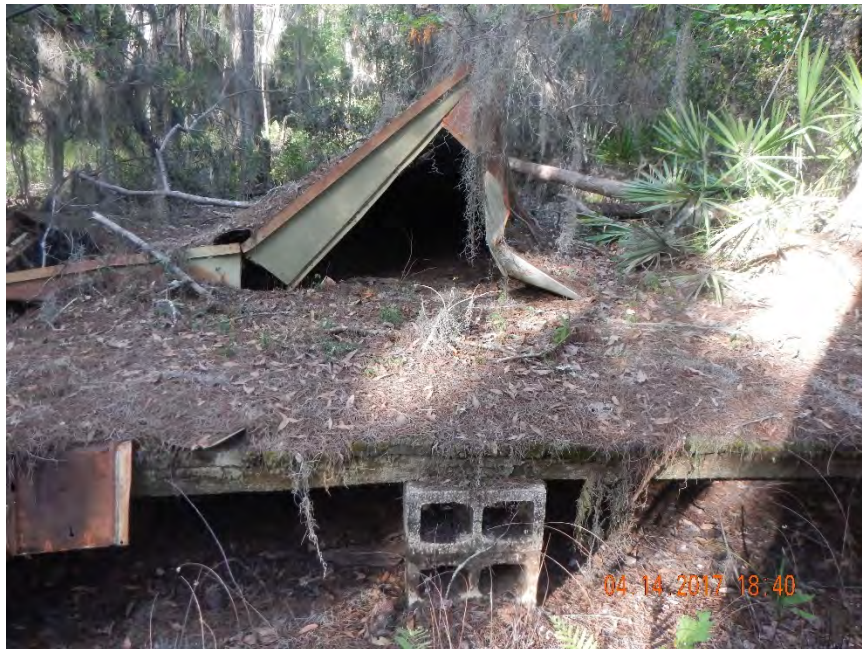
Photo 549. Work platform.

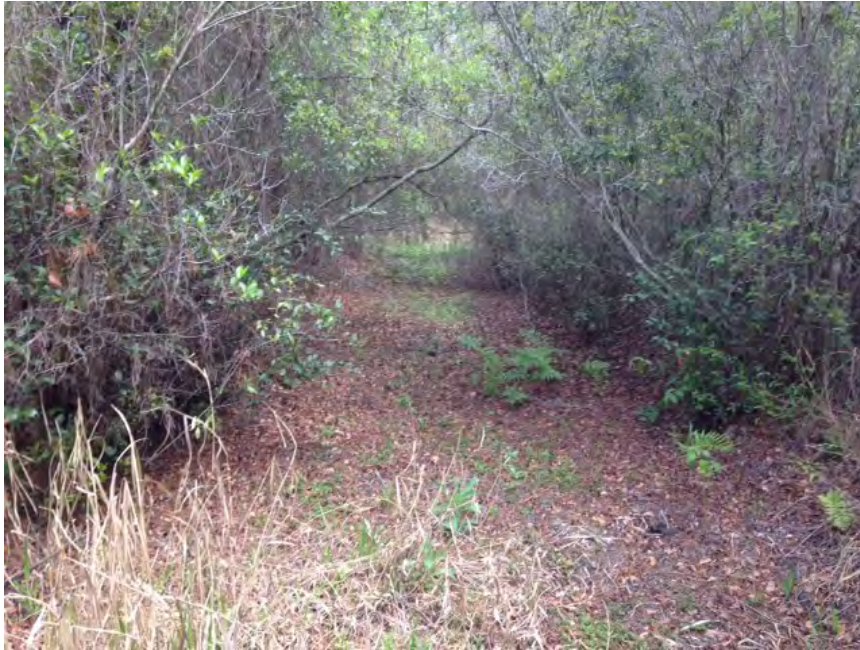
Photo 555. View of excavated ditch located at GPS location 10407 (Frame 592; 04/18/17).

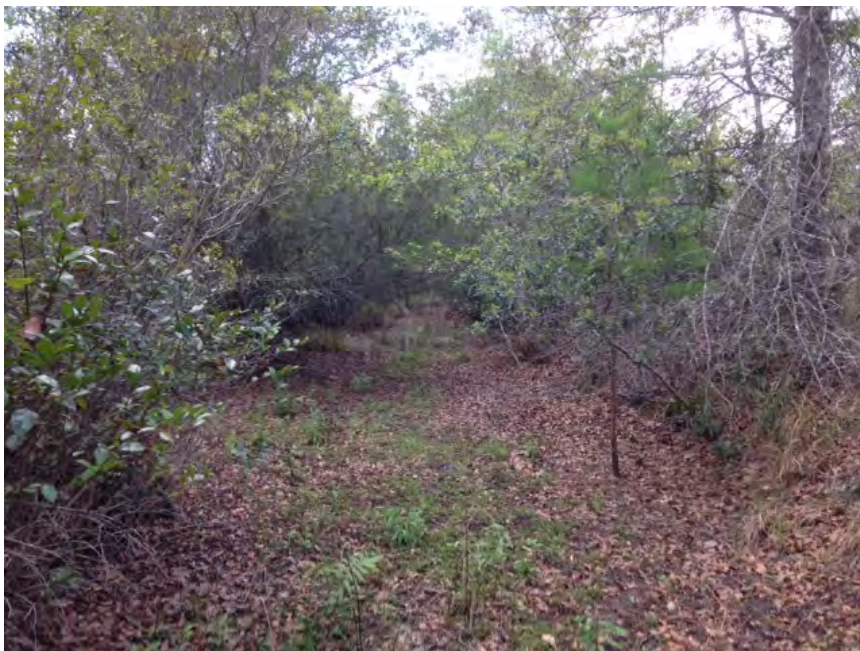
Photo 556. View of excavated ditch located at GPS location 10407 (Frame 593; 04/18/17).
